AVIATION SAFETY DIGEST

DEPARTMENT OF
CIVIL AVIATION

No. 30 JUNE, 1962

Prepared in the Division of Air Safety Investigation
Department of Civil Aviation

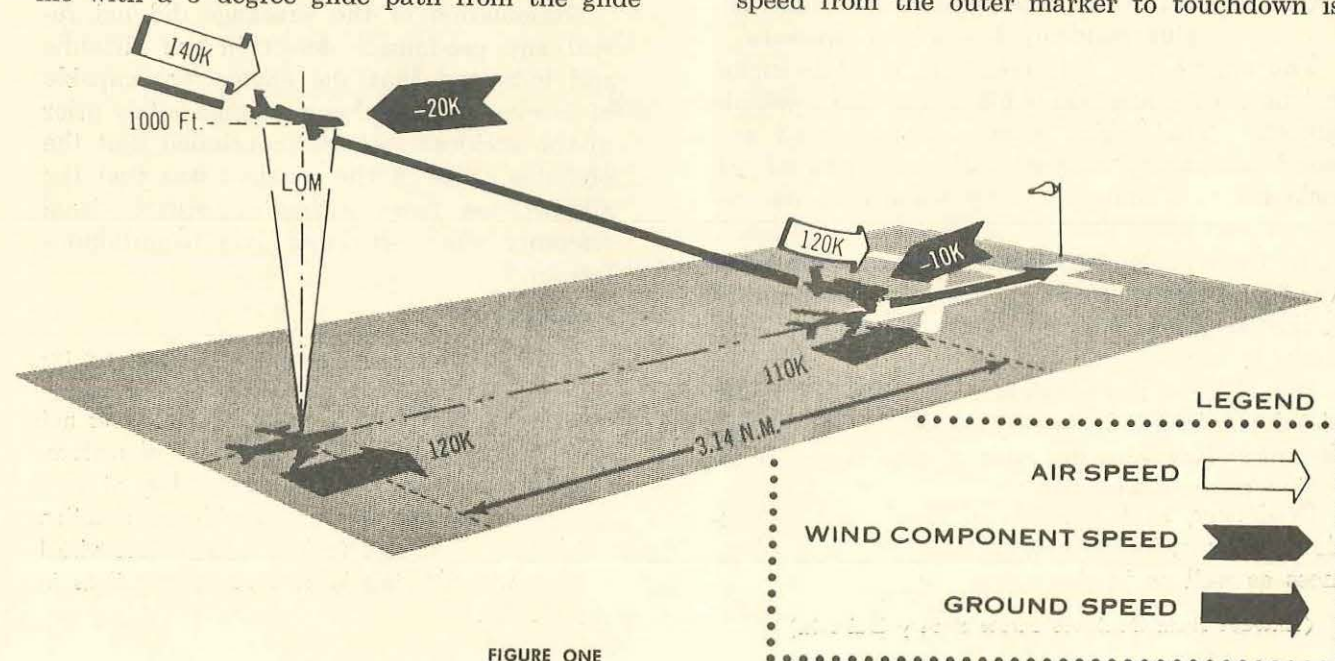
FIGURE ONE

Figure 1 illustrates a normal glide path profile with a 3 degree glide path from the glide

From Figure 1 we can compute that the elapsed time from outer marker to touchdown in this case is 1.64 minutes, which results in an average ground speed of 115 knots and an average rate of descent of 610 feet per minute. Also, normal airspeed deceleration from outer marker to touchdown is 20 knots and the ground speed deceleration in this case is 10 knots. The change in ground speed becomes a very important consideration when analysing abnormal wind shear conditions because it involves the problem of rapidly accelerating or decelerating an aircraft mass of up to 150 tons during the landing approach.

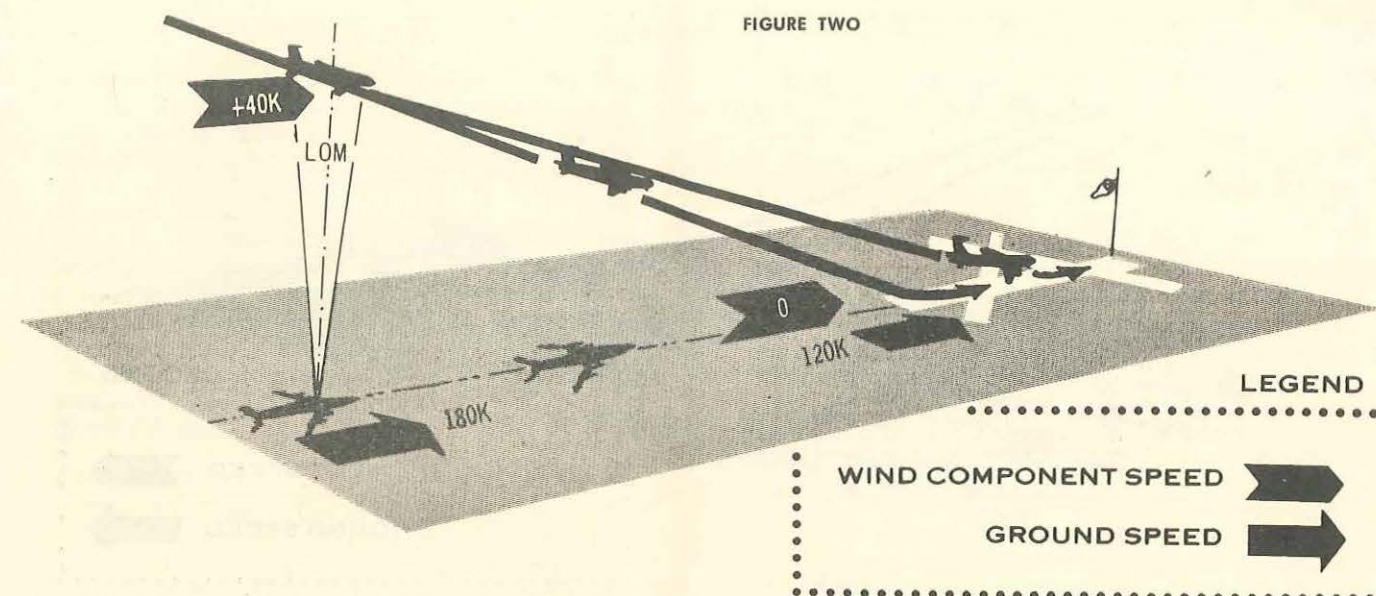
FIGURE TWO

In Figure 2 we consider an abnormal tailwind approach in which a 40 knot tailwind exists at the outer marker with a zero surface wind. As can be computed in this case, the average ground speed from the outer marker to touchdown is

150 knots, which results in an elapsed time of 1.24 minutes and an average rate of descent of 800 feet per minute for a precisely executed approach. Comparing this example with Figure 1, we see that while the airspeed is decelerated 20 knots in both cases the ground speed in the latter case must be decelerated 60 knots in a faster time than the 20 knot deceleration in the normal approach of Figure 1. This is the root of the problem, for whenever the wind environment changes faster than the aircraft mass can be accelerated or decelerated, the wind variations must be reflected by changes in airspeed. In the tailwind situation depicted in Figure 2, should the pilot be unable to decelerate his aircraft in the faster time required, he would find his airspeed had increased, very likely he would have gone above glide path in an effort to hold desired airspeed, and he would have to go around. (Assuming of course, he wisely resists the temptation to land long). One more point, the more gradual the shear the more likely the pilot is to be able to decelerate to remain on glide path and at desired indicated airspeed.

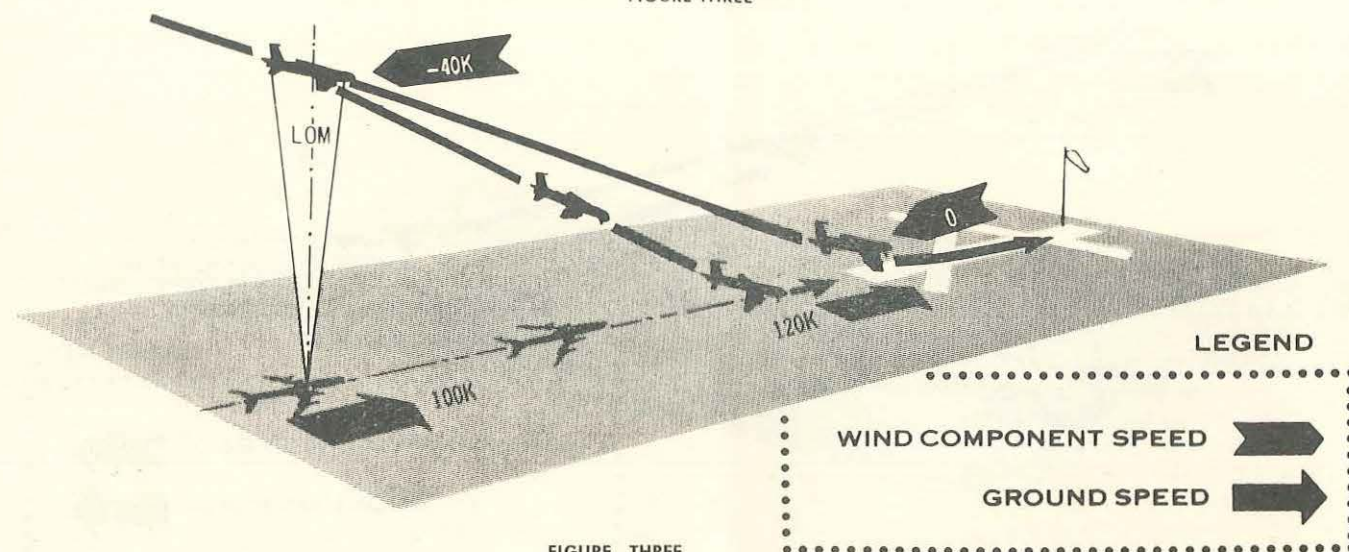
FIGURE THREE

In Figure 3 we take up the strong headwind aloft condition. In this case we have a 40 knot headwind over the outer marker and a zero component on the ground. In this case we find that the average ground speed from the outer marker to touchdown is 110 knots, which results in an elapsed time of 1.7 minutes and an average rate of descent of 580 feet per minute for a precisely executed approach. In comparing this situation with the normal profile approach depicted in Figure 1, we see that in the headwind shear approach the aircraft ground speed must be accelerated by 20 knots during the final approach instead of the normal 10

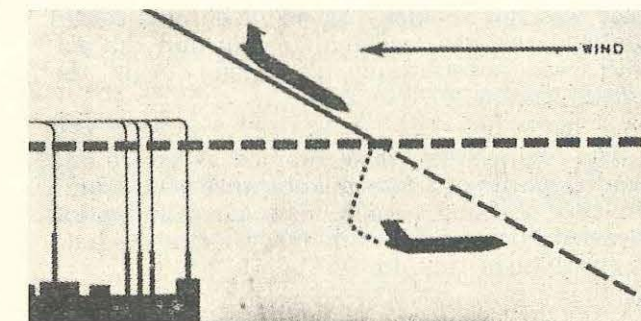
FIGURE FIVE

Shear can be anticipated whenever there is an inversion (Fig. 5). Shear is also a hazard potentiation with frontal passage and in and near thunderstorms. Severe down drafts associated with thunderstorms warrant delaying take-off or landing when such storms are over or adjacent to the airfield. Shear should be anticipated when taking off or landing over cliffs, water, in hilly terrain and with large buildings or trees adjacent to the runway. Normally, the severity of such low altitude wind shear bears a direct relationship to the surface wind speed. Don't overlook the help you can obtain from the weather forecaster. Check with him before take-off and, when you suspect shear, call him before making your final approach.
