# AVIATION SAFETY DIGEST

DEPARTMENT OF  
CIVIL AVIATION

No. 37      MARCH, 1964

Prepared in the Air Safety Investigation Branch,  
Department of Civil Aviation, Commonwealth of Australia

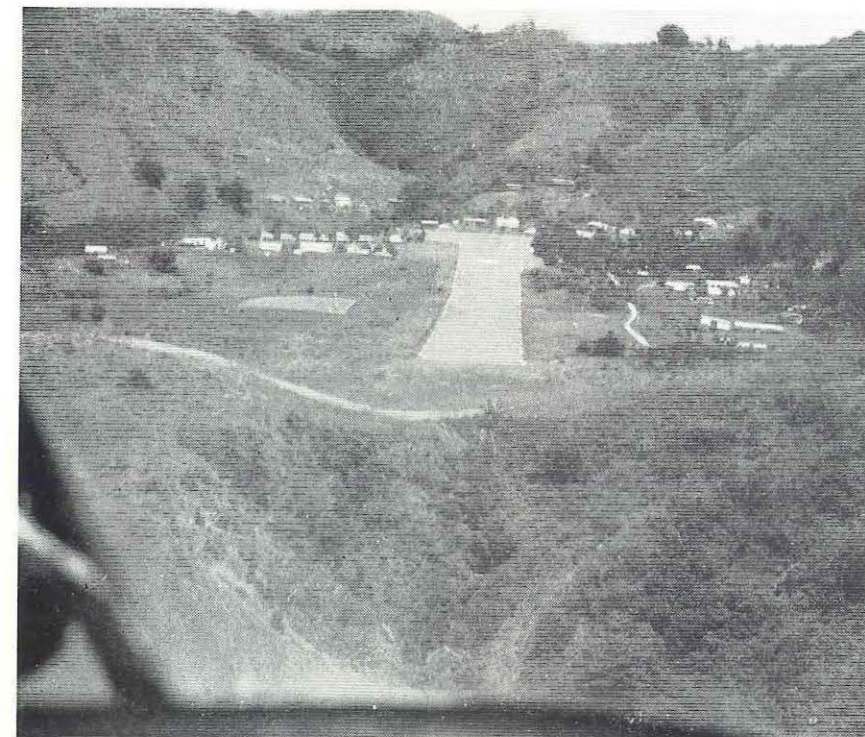
Fig. 3

7. **Runway slope:** Some runways slope from one end to the other and this can produce illusions. Suppose a pilot habitually makes his approach at a glide slope angle of three degrees and a rate of descent of 5/600 F.P.M. Putting it another way, he is used to seeing a 177-degree relationship between runways and his eye. However, consider a runway sloping upward at, say, two degrees from the threshold, as in Fig. 3. If the pilot manoeuvres himself to a point in space from which to commence his final approach, at which he achieves his customary 177-degree relationship to the runway, he will of course need to make good a glide slope of one degree (with the greatly increased power requirements that implies) to reach the threshold.

Tapini airstrip in New Guinea illustrates the effect of runway slope.
