AVIATION SAFETY

DIGEST

No. 40, DECEMBER, 1964

DEPARTMENT OF CIVIL AVIATION

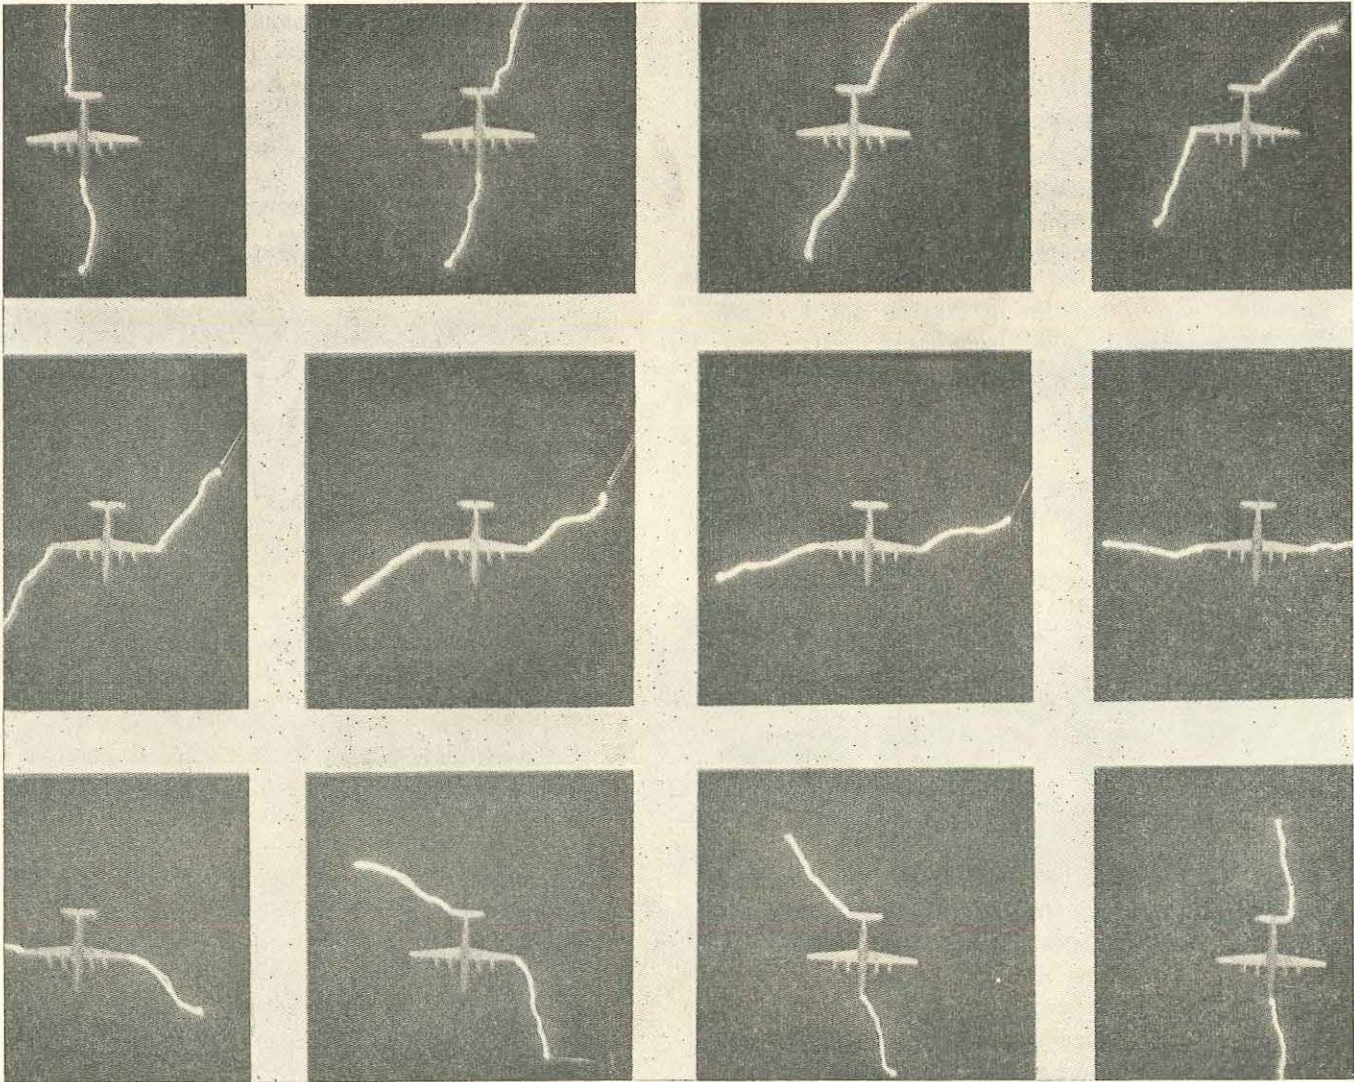
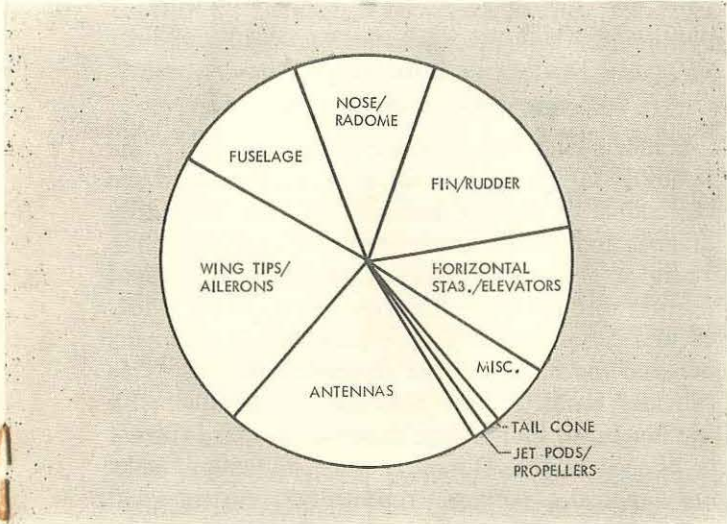
Figure 7
Approximate Distribution of Points on Aircraft Struck by Lightning. Estimated from various military and commercial strike reports

their extreme location, and their bearing attachments to the shell. As might be expected, these are the components most often damaged by lightning strikes (see Figure 7).

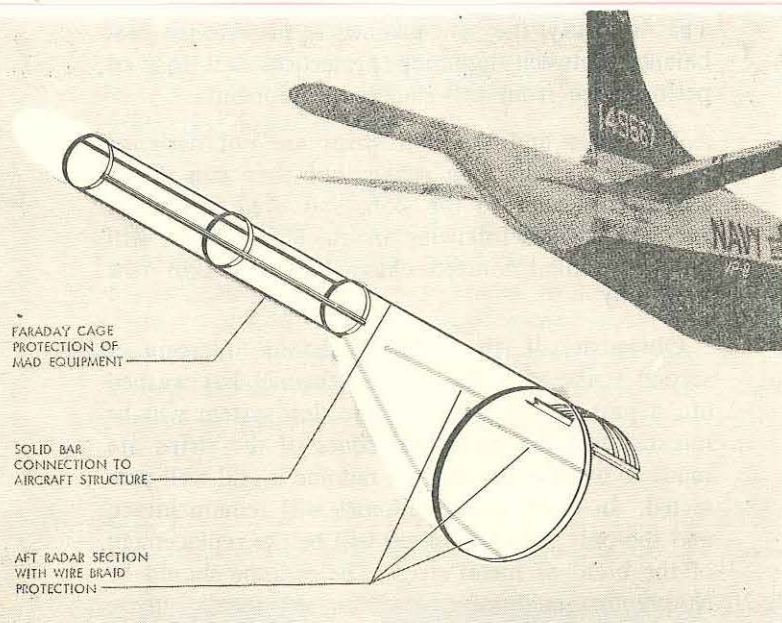
Figure 9
Faraday Cage Type Protection of P-3A MAD Boom

An extensive protection system of the permanent type is shown in Figure 9. This long housing will be recognized by some readers as the MAD boom of the P-3 anti-submarine aircraft. The rods, which

extend almost full length on all four sides, are interconnected at intervals, providing a Faraday cage intended to spread the current so that the tendency of one rod to induce secondary currents in internal components is largely offset by an opposing tendency in the opposite rod.

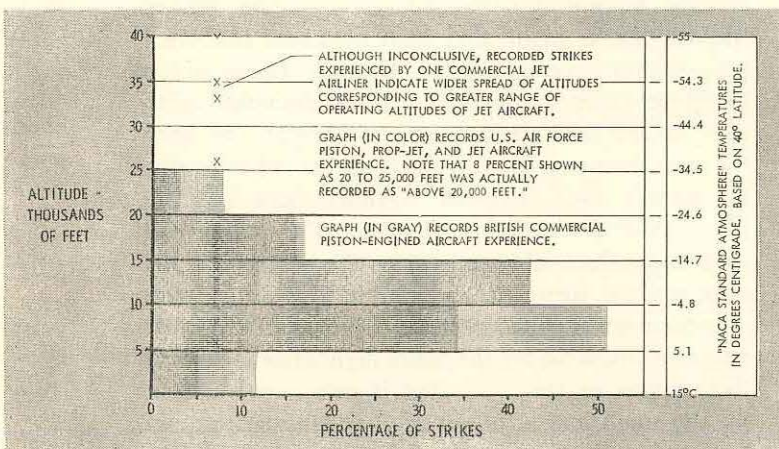
Figure 13
Lightning Strikes to Aircraft as a Function of Altitude
— Two Superimposed Graphs

Statistics on lightning strikes to aircraft seem to show that altitude plays a minor role, in a practical sense, as far as determining the likelihood of being struck. Reports show that most strikes to aircraft occur below 20,000 feet with a certain emphasis on the 5 to 10,000-foot level but these figures also appear to reflect the altitudes where most flying occurs—even jet aircraft spend a large proportion of their average flight time climbing or descending at low operational levels. Figure 13 superimposes two graphs from two entirely different sources and locales. As stated above, about the only conclusion that can be made is that strike probability drops sharply above 20,000 feet. Incidentally, this statement is further supported by Air Force statistics which show that 9 of 11 strikes reported on B-52's were below 20,000 feet, but is somewhat repudiated by another record of 14 jet aircraft strikes (indicated by x's on Figure 13) which shows a wider spread of altitudes corresponding more closely with the greater range of operating altitudes of the pure jet. However, strike probability almost certainly coincides with the altitude range of the cumulo nimbus which, in general terms and depending upon world location, is commonly found between 3 and 30,000 feet, is somewhat less frequent up to 50,000 feet, but can even extend to higher levels than this.

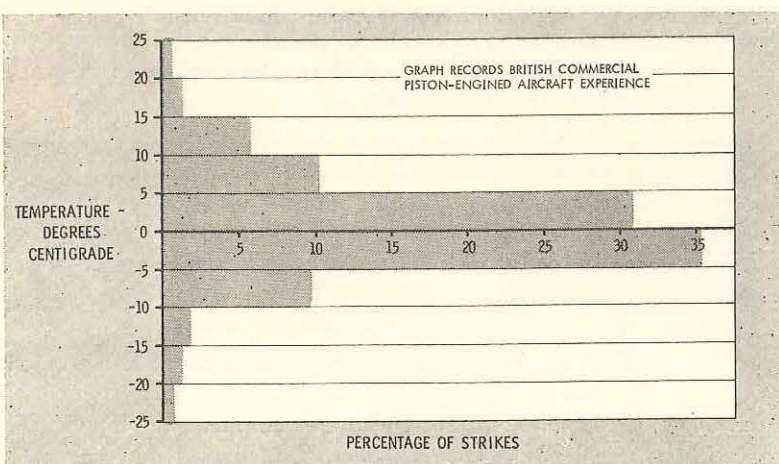
Figure 14
Lightning Strikes to Aircraft as a Function of Ambient Temperature

Perhaps a more satisfactory method of avoiding strikes near thunderstorms is to keep a watchful eye on the ambient temperature. As indicated in Figure 14, the majority of lightning strikes (about 80 percent) occur in the temperature range -10°C to $+10^{\circ}\text{C}$. Thus it appears that a good precaution to flight crews would be to select a flight level where the temperature is not near freezing, although it should be noted (see the right-hand side of Figure 13) that -10°C to $+10^{\circ}\text{C}$ corresponds to a considerable range of altitude (2,500 feet to 12,500 feet on the graph.) It should also be noted that temperatures inside and outside of clouds can vary a great deal. Incidentally, the fact that most strikes occur near 0°C correlates quite well with thunderstorm electrification theories that charge separation occurs at about the freezing level. However, it is to be expected that positive charge centers at the tops of tall clouds are at much lower temperatures than this.

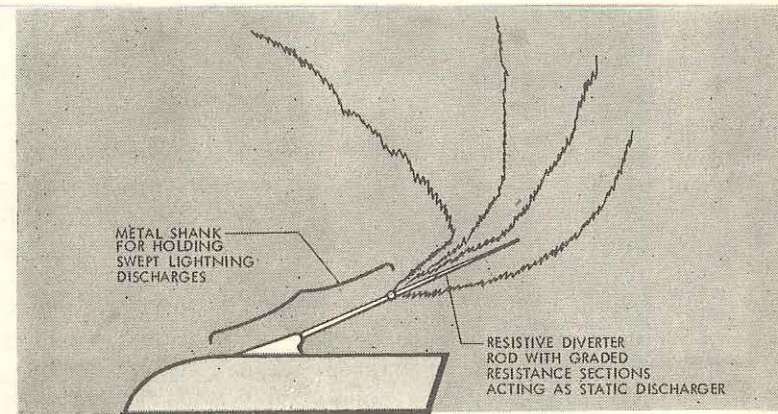
Figure 15
Combined Static-Discharger/Lightning-Diverter Rod for
Empennage or Wing Tip Installation

localized point at which lightning might strike (see Figure 15). The diverter rod base is designed to carry the stroke currents without damage to the skin or airframe at the attachment point.
