AVIATION SAFETY DIGEST

DEPARTMENT OF CIVIL AVIATION

No. 42, JUNE, 1965

Prepared in the Air Safety Investigation Branch,
Department of Civil Aviation, Commonwealth of Australia.

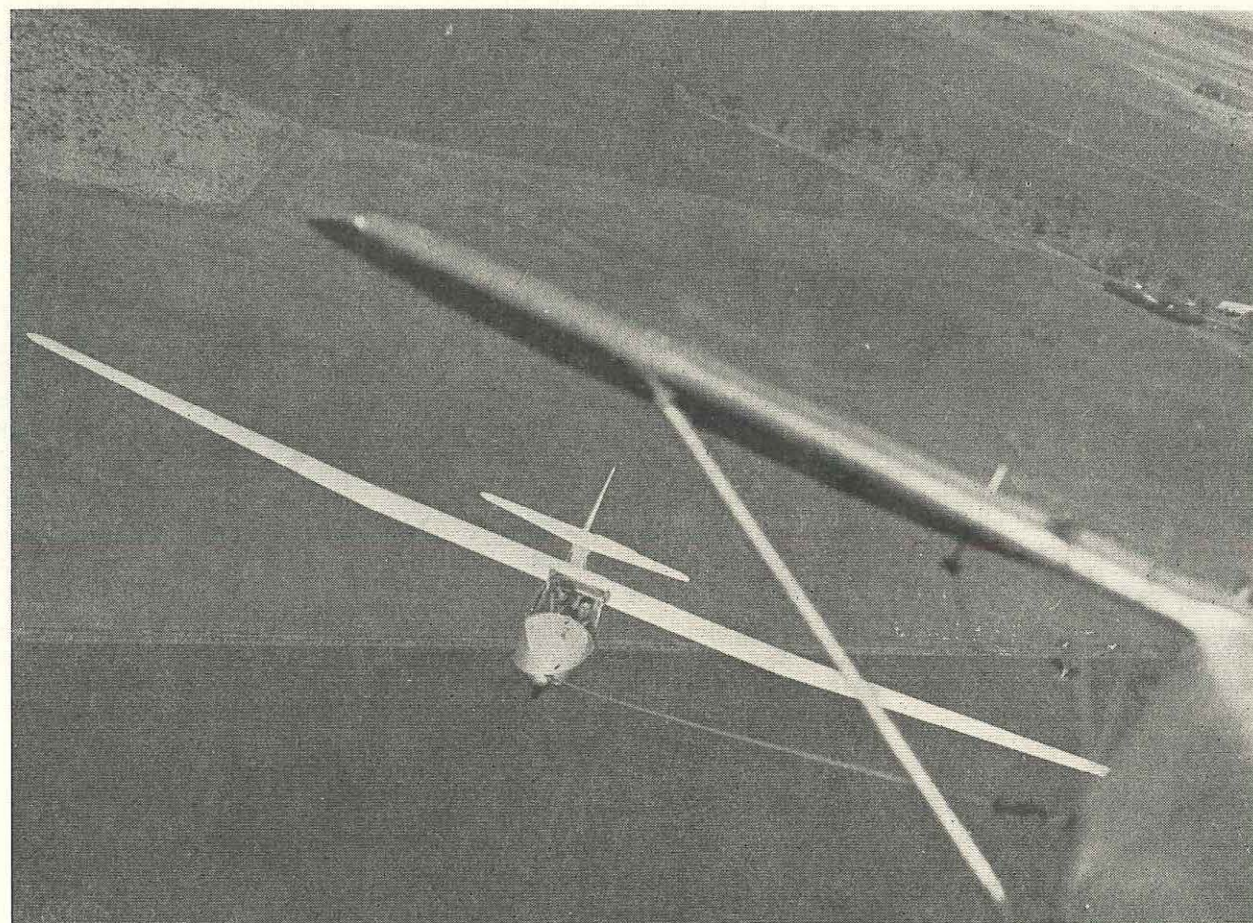
DH.82 tug as seen from glider in low tow position.

Kookaburra glider in low tow position as seen from tug aircraft.

There is little doubt that control of the tug aircraft was lost when the glider pilot blinded by the sun, allowed the glider to climb into an abnormally high position. It is probable that both pilots failed to appreciate how quickly a dangerous situation was developing, and delayed too long in releasing the tow.

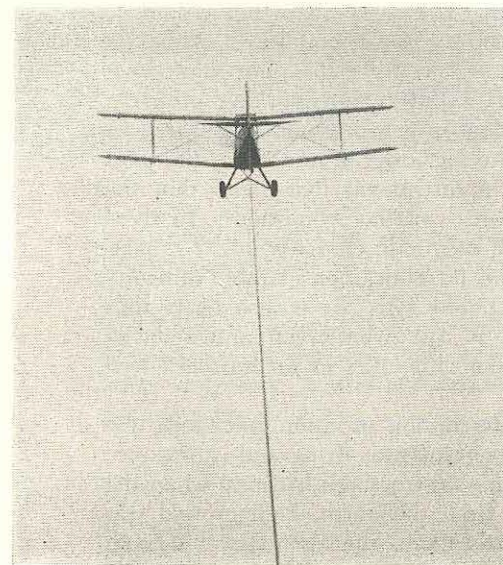
This accident is strikingly similar to one which occurred to a DH.82 engaged in glider towing at Alice Springs in September, 1960.

On that occasion, the aircraft had taken off and climbed to about 200 feet when the glider pilot unintentionally let the glider sink into the tug's slip-stream. In attempting to regain the normal high tow position, the glider climbed abruptly. The tail of the DH.82 was pulled up almost vertically, the tow rope broke, and the DH.82 dived into the ground before the pilot could recover. The pilot was killed and the aircraft completely destroyed by impact and fire. Despite the hilly nature of the terrain below, the glider pilot was able to make a safe landing near-

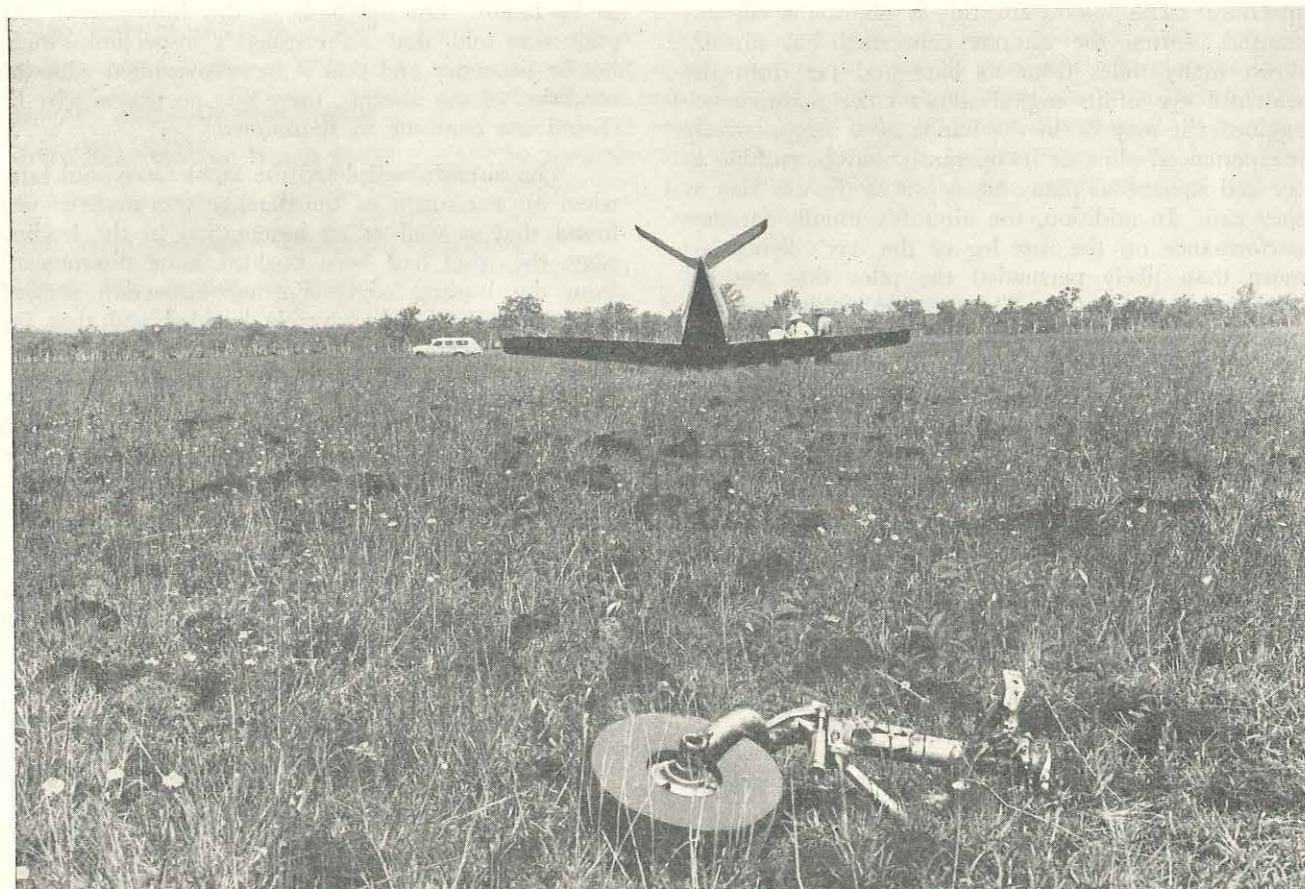
In some of these cases, the pilots concerned had made what might have seemed adequate enquiries about the suitability and serviceability of their intended landing ground. In the light of subsequent events however, it is clear that the pilots' specification of minimum requirements on their informants' assessment of the area, or even the process of communication between the two, must have been totally inadequate.

Over the years many, many capable pilots have learned to their cost that merely accepting a layman's

land on doubtful surfaces—the risk far more than outweighs what you could possibly stand to gain. Make it a rule not to land on an unrecognized landing area without first inspecting it from the ground yourself or obtaining reliable advice from a *knowledgeable person* familiar with aircraft operations!
