AVIATION SAFETY DIGEST

DEPARTMENT OF CIVIL AVIATION

No. 46

JUNE, 1966

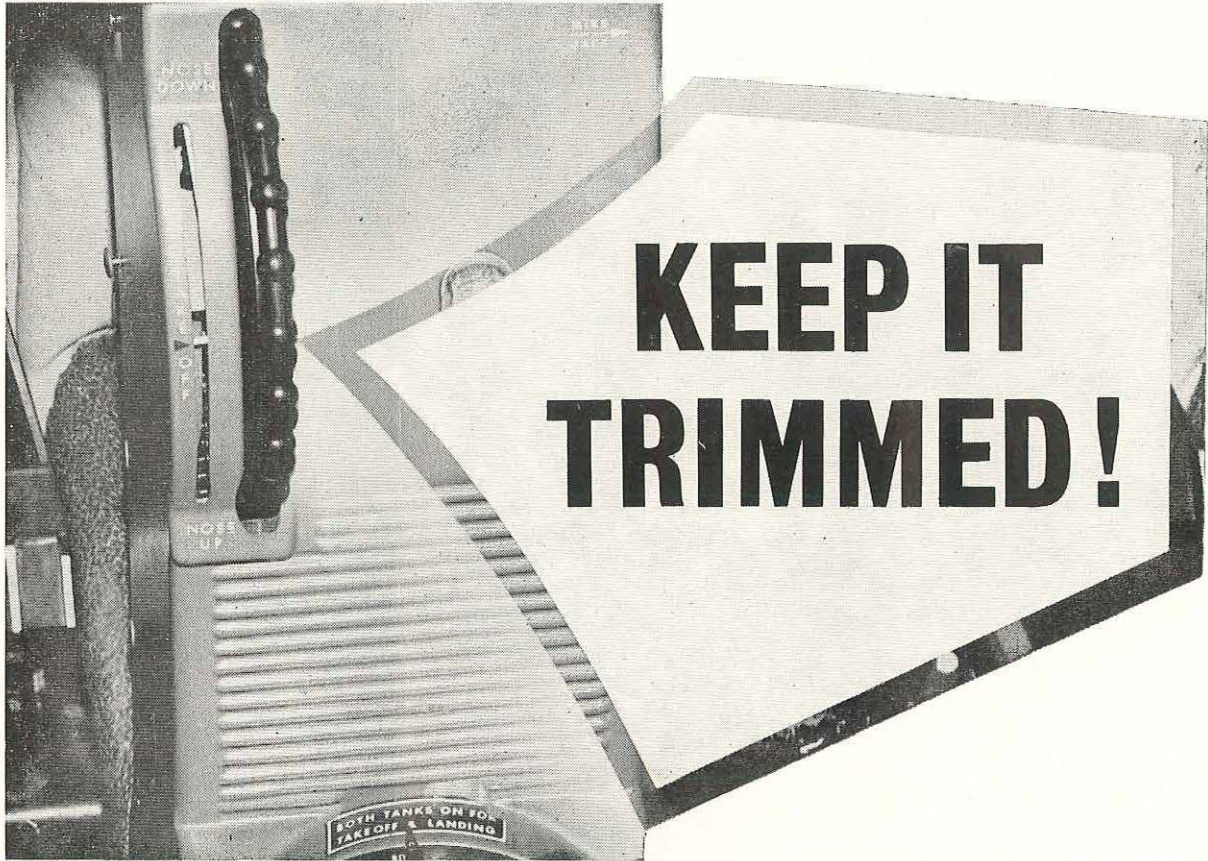
Examination of the wreckage showed that at the time of the crash, the elevator trim was almost in the full nose-down position. Flight tests carried out in another Cessna 172 confirmed that this type of aircraft, in common with many others, will become nose heavy if it is not re-trimmed after the flaps are raised. The test aircraft was loaded to establish a centre of gravity position similar to that of the crashed Cessna and, with the aircraft trimmed to climb with 20 deg. of flap selected, the elevator trim indicator position was found to correspond with that found in the wreckage. Immediately the flaps were raised with the elevator trim left in this position, the aircraft developed a strong

Above right: The tail assembly as it came to rest, showing the elevator trim tab set almost fully nose down.

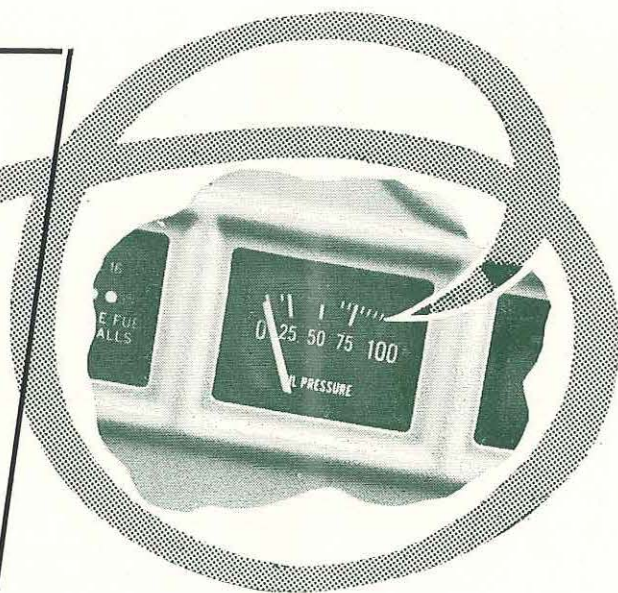
**DON'T
LET IT
HAPPEN
TO YOU**

A Cessna 172 belonging to a country aero club was due for a 100 hourly inspection. Arrangements were made for the inspection to be carried out at an authorized workshop some 70 nautical miles away, and the ferry flight to and from the workshop was planned as a solo cross-country training flight for a club member holding a restricted private licence. He was to fly the aeroplane from its home base to the workshop early in the morning, allow ample time to have the inspection carried out, and make the return flight home late in the afternoon.

The events leading to the seizure of the engine and the consequent forced landing provide a classic illustration of the fact that an accident is seldom caused by a single isolated event, but rather by a chain of small, seemingly unimportant omissions, and unfortunate associations of circumstances.

Apparently in too much of a hurry even to make a normal check that the oil pressure was registering after each of his engine starts, the pilot then failed to notice there was no oil pressure during his run-up. So the stage was finally set. He took off, the engine seized, and a serious accident was averted only by the narrowest of margins.
