AVIATION SAFETY DIGEST

Department of Civil
Aviation . . Australia

No. 47

SEPTEMBER, 1966

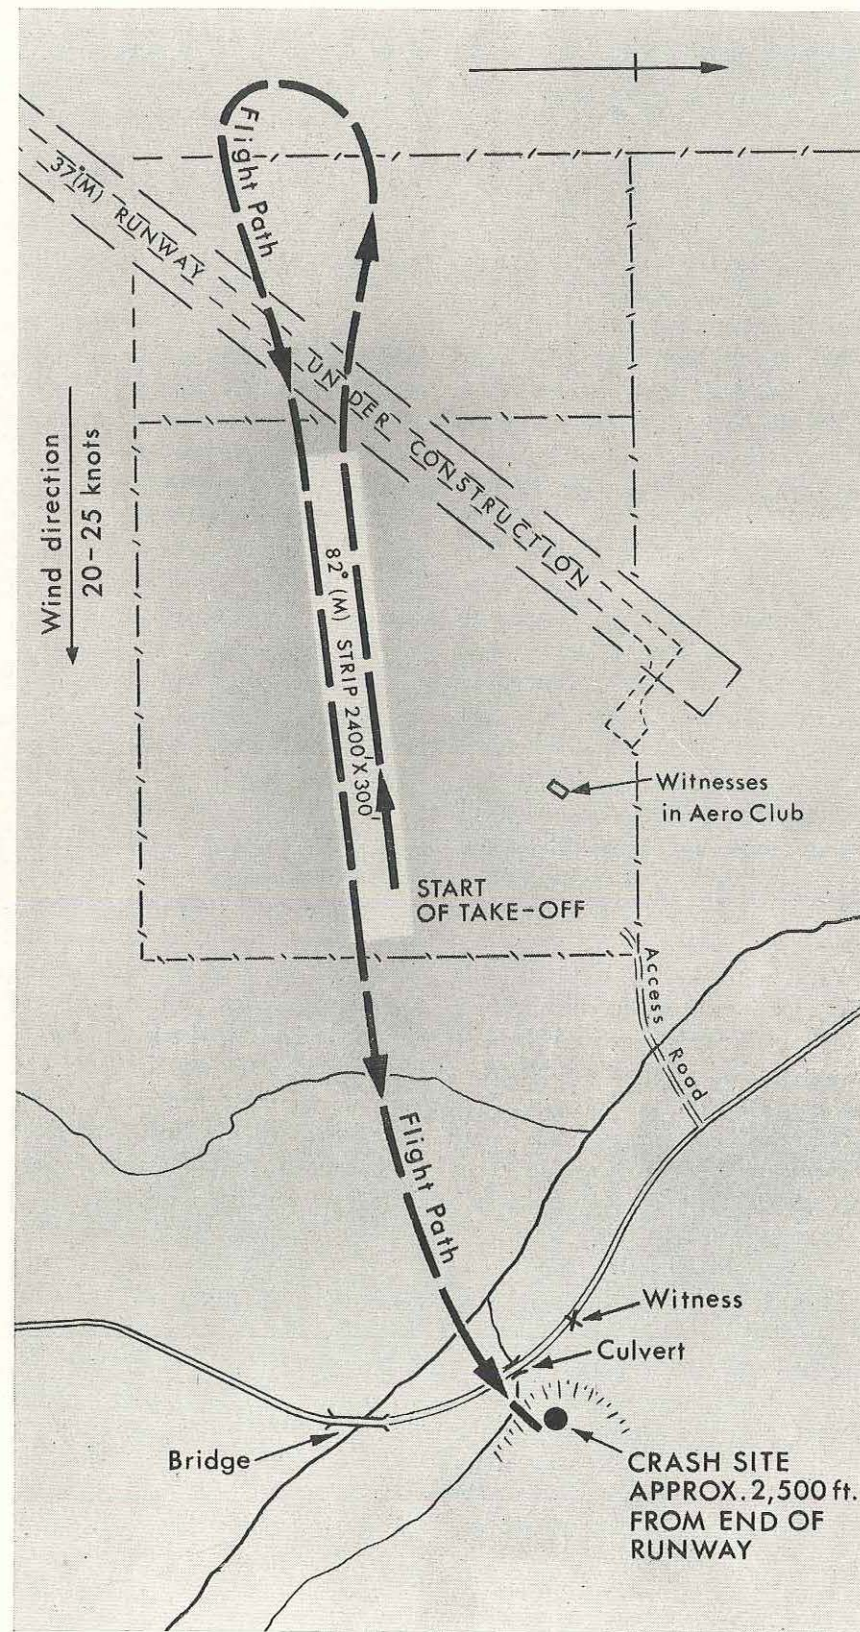
applied opposite aileron to level the wings as they dived almost vertically, then eased the aircraft out of the dive and landed straight ahead on the strip. The pilot had given the passengers no warning of his intention to perform these manoeuvres.

There is little doubt that when the accident occurred, the pilot was attempting to emulate this earlier performance. The reason why he didn't get away with it the second time is probably twofold; firstly, the pilot had begun the manoeuvres from climbing speed at only 500 feet, as against cruising speed at some 1500 feet on his earlier attempt, and secondly, the increased wind strength and the pronounced downdraught on the lee side of the aerodrome would have had the effect of increasing the amount of height required to recover level flight.

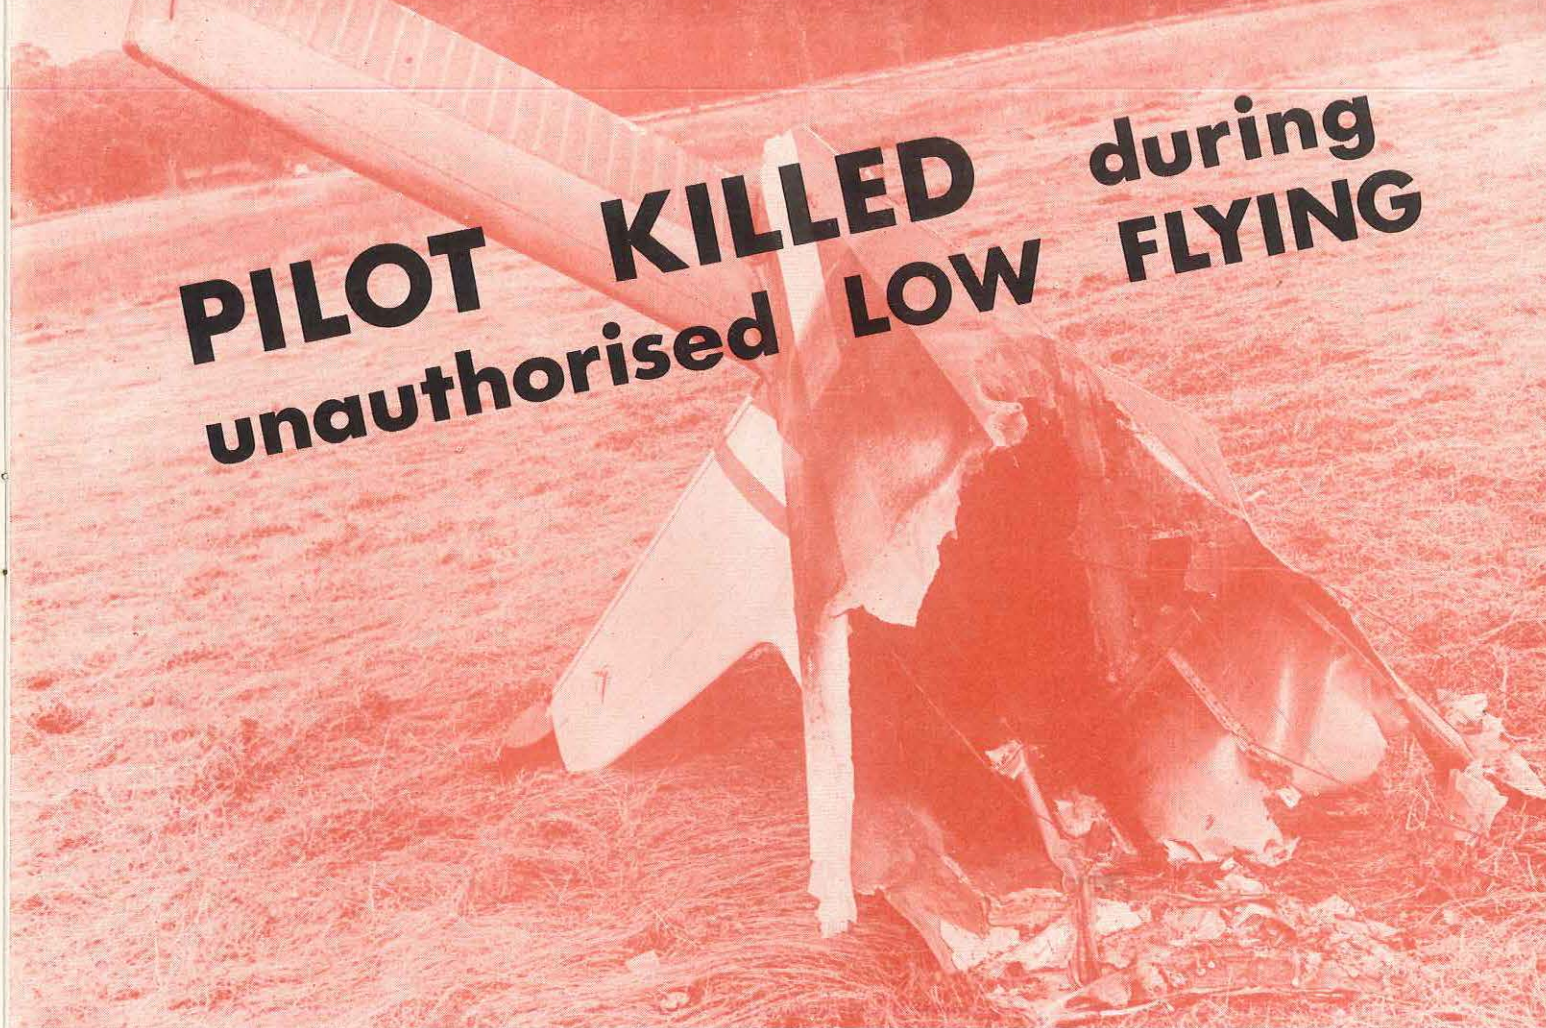
Examination of the wreckage, and impact marks on the ground, showed that the aircraft had struck the ground first with the starboard wing, while in a steep nose-down attitude. The first point of impact was 210 feet beyond the broken power line. The wreckage had then bounced and slid for 30 feet before coming to rest. The tail section and the outer port wing, which had been pulled away from the fire in the attempt to save the pilot, had sustained relatively little damage, but the remainder of the aircraft had burned to destruction. There was, however, no evidence to suggest that a loss of engine power or any defect in the airframe had contributed to the accident.

Although there were no impact marks on the virtually intact port wing and tailplane, or on the propeller, some 12 feet of the broken power line was smeared with paint matching the colour on the wing and tailplane. The destruction of the starboard wing by fire was too complete for any impact

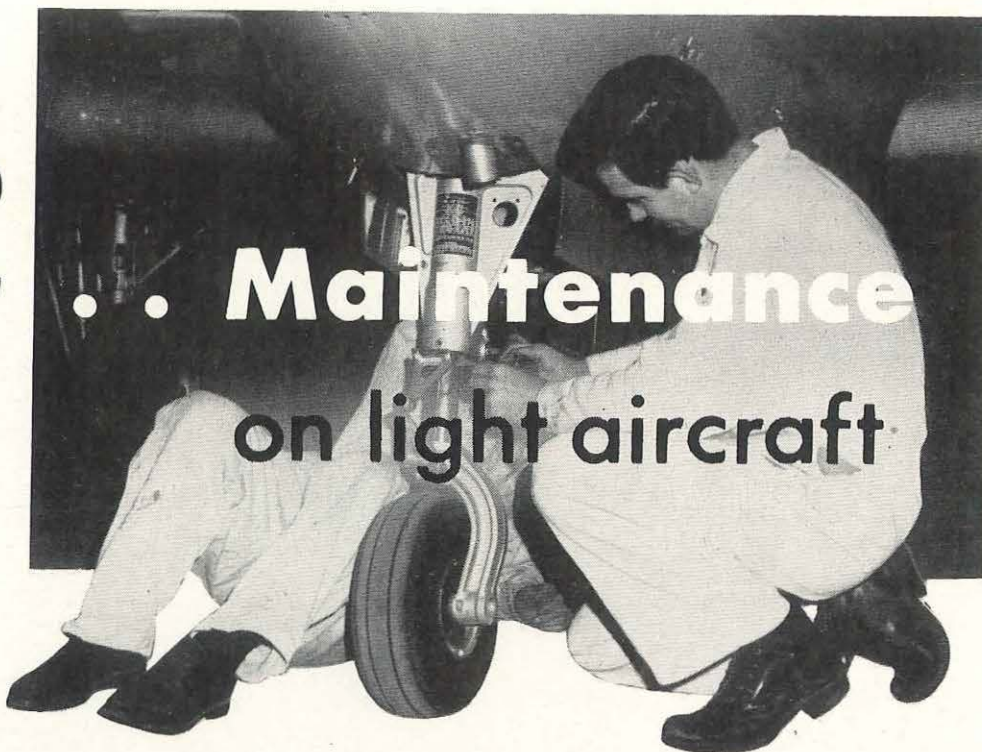
Analysis of a number of accidents to aircraft that have involved the failure of oleo shock absorber undercarriages, indicates that incorrect maintenance is frequently a contributory cause. The most common fault has been lack of oil in the strut, leading maintenance staff to over-inflate the strut to restore it to its correct inflated length as measured on the exposed portion of the piston tube. The purpose of this article is to explain, in general terms, the basic principles of the oleo shock absorber strut and to emphasise the necessity for maintaining the oil level and air pressure within the proper limits. The article is not intended to describe any particular strut, since there are several types in common use today and the same general principles apply to them all. Rather, it is concerned with correct day to day maintenance by pilots and maintenance engineers, many of whom may have gained the bulk of their experience on aircraft with undercarriages employing rubber shock cord, coil spring, or spring steel, shock absorber equipment.

Torque links as fitted to some types of light aircraft oleo legs. The sequence shows how the links can be fractured in over-extension, as is likely to occur if the return stroke of the oleo leg piston is not adequately dampened. The torque links are fully extended in the photograph at left. Fracture of one of the links is inevitable as they are forced beyond this fully extended position.

With a properly filled and inflated strut, the stroke of the piston is such that it will accept landing shocks before it reaches the full extent of its inward travel, or "bottoming" as it is more colloquially known, and there will be sufficient oil for the metering mechanism to control the strut during the return to its normal position. If the oil level is permitted to fall below the specified level, the recovery stroke will not be properly controlled and the conditions leading to the failures already described will be initiated. It naturally follows that the lower the oil level, the sooner the failure will occur.

Neglecting oleo strut maintenance has been responsible for at least three very expensive accidents, two of which could easily have inflicted serious injuries to the occupants of the aircraft. It would be hard to say how many cases of minor damage, such as bent propeller tips, have resulted directly and indirectly from this same cause.

When the strut has been correctly filled, the air valve plug is replaced and the torque links where fitted are re-connected. Then, with the aircraft standing on its

Once the strut has been properly filled, it is usually sufficient to deflate it periodically and check that with the strut fully compressed, the oil level is as recommended by the makers. This check can be conveniently carried out during 100 hourly inspections, but should be made more frequently if there is reason to suspect oil is leaking from the strut. Any leakage will most probably take place on the piston tube and since leaks develop fairly rapidly once they reach this stage, it is advisable to have the strut inspected and, if necessary, overhauled whenever leakage is evident.
