# AVIATION SAFETY DIGEST

DEPARTMENT OF CIVIL AVIATION

No. 48

DECEMBER, 1966

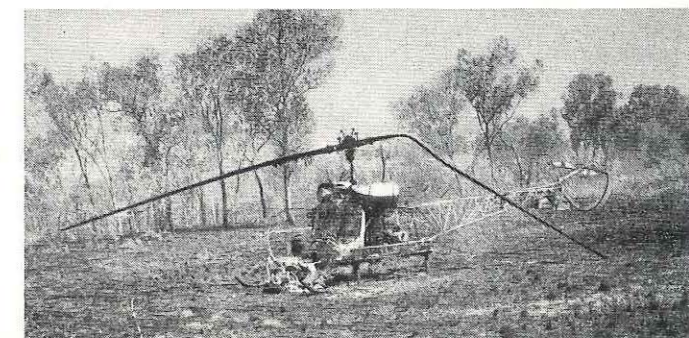
These photographs show what happened to two helicopters when they landed in dry grass in the Northern Territory and in Queensland. In both instances the engine exhausts set fire to the surrounding grass. In the case of the Hughes (above and inset) the pilot climbed out to find the grass on fire beneath his aircraft. He immediately scrambled back into the cockpit to fly the helicopter to safety, but although he was unable to start the engine, probably because of the heat generated, the fire burnt itself out without spreading to the aircraft's fuel system. Damage was confined to the cockpit bubble, engine wiring and other plastic components such as the air cleaner and the engine fan shroud.

The pilot of the Bell (below) wasn't so fortunate. After landing in a clearing in the course of a gravity survey flight, the engine stopped before the pilot had time to shut it down. He climbed out to investigate and found that the long grass under the engine area was burning and had set the aircraft on fire behind the fire wall. Almost immediately afterwards, and before he could take any preventative action, flames engulfed the aircraft and it was completely burnt out.

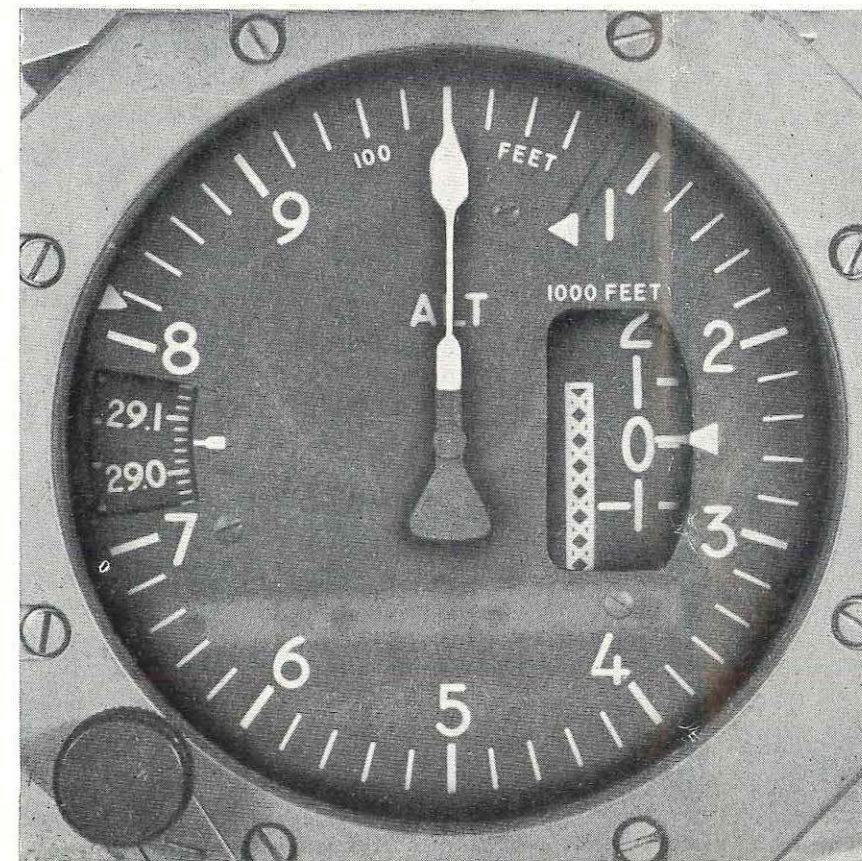
Kollsman altimeter as fitted to Boeing 727's.

The Kollsman drum-pointer type of altimeter installed in the aircraft has a range of from plus 50,000 feet to minus 1,500 feet. Hundreds of feet are indicated by a radial pointer; thousands of feet are indicated on a rotating drum. To increase the conspicuity of the thousands of feet readings, a cross-hatched marking is printed on the drum adjacent to the figures. A conventional barometric scale calibrated in inches of mercury is provided for setting the altimeter, and the adjusting knob also positions an index on the periphery of the in-

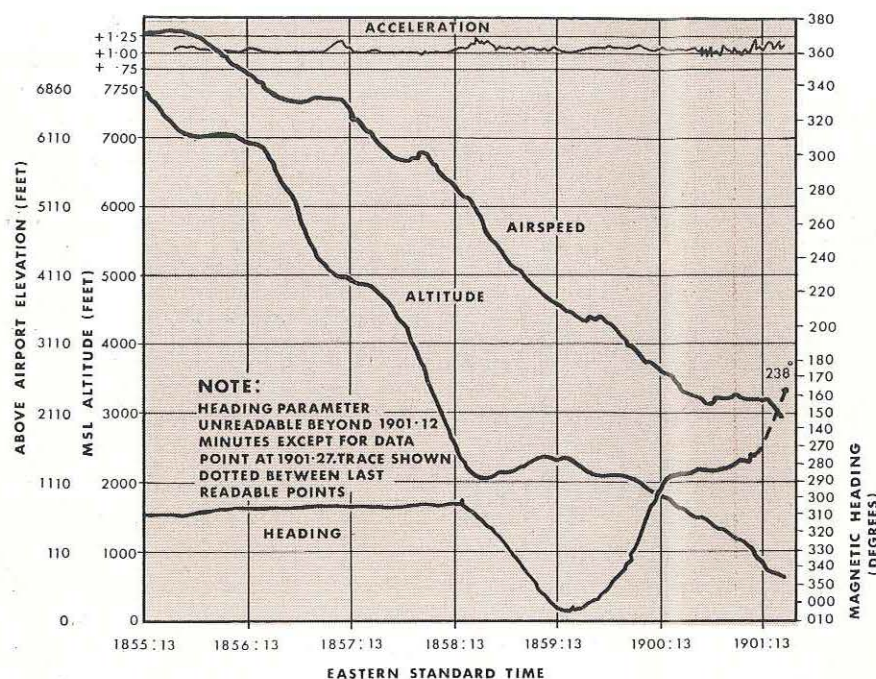
Read-out obtained from Flight Recorder Traces.

The aircraft's flight recorder was recovered from the wreckage and examination of the tape covering the portion of the flight from LaGuardia to the initial descent into Cincinatti revealed nothing unusual. A detailed read-out of the flight recorder traces for the final six minutes of the flight produced a ground track and profile which corresponded in all essentials with the evidence of air traffic controllers and witnesses on the ground. It showed a continuous descent from 7,000 to 2,000 feet on a heading of 305 degrees, during which the airspeed was reduced from 350 knots with a descent rate of about 3,000 feet per minute. The aircraft levelled off at 2,000 feet (1,110 feet above airport level)

and remained at this altitude for 1 minute 20 seconds while the airspeed decreased to 190 knots. While still maintaining this altitude the aircraft turned to a northerly down-wind leg and subsequently began a left turn on to base leg. At 1859:57 (1859 hours, 57 seconds) the aircraft began descending again, and a relatively steady descent of about 800 feet per minute was maintained for 70 seconds and the airspeed was reduced to 160 knots. At this point the aircraft was still holding a west-north-westerly heading on base leg. At 1900:53 another left turn was initiated on to final approach and at 1901:07, 20 seconds before impact, at an altitude of 1,100 feet or 210 feet above airport level, the descent rate increased to approximately 2,100 feet per minute, for 10 seconds. During this time, the aircraft descended into the valley, formed by the Ohio River, below the elevation of the airport. In the final 10 seconds of flight before impact, the descent
