# AVIATION SAFETY DIGEST

Department of Civil  
Aviation . . Australia

No. 49

MARCH, 1967

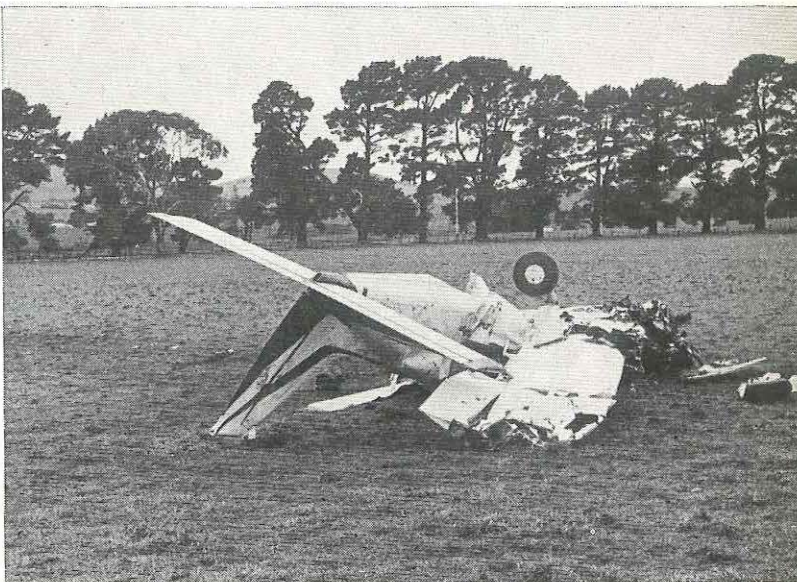
**Forty minutes after departure from a private aerodrome in the Geelong district of Victoria, a Beechcraft Musketeer crashed at Kingston, 12 miles north of Ballarat, in conditions of low cloud and poor visibility. The pilot and his three passengers were killed and the aircraft destroyed.**

and propeller. The occupants had been hurled from the cabin and the aircraft had come to rest on its back with the fuselage grossly distorted and completely broken in two places. The port fuel tank had burst open when the wing had broken off, spilling the contents on to the ground, but the aircraft did not catch fire. The starboard fuel tank was undamaged and still full of fuel. The flying control cables were still connected to their respective surfaces and there was no evidence that the flying controls were anything but serviceable up to the moment of impact. The magneto switches were both on and the fuel selector was positioned to the port tank. The flaps were in the up position. The propeller, which was badly distorted from striking the ground under power, had snapped off from the crankshaft, complete with its mounting flange. This condition had clearly been brought about by a sudden, violent stoppage of the engine, from high RPM. Spark plugs taken from the engine showed that it had been operating satisfactorily before the crash.

The cause of this accident was that the pilot proceeded, at a low height, into weather conditions in which visual flight could not be maintained, and being not qualified for instrument flight, he did not maintain effective control of the aircraft.

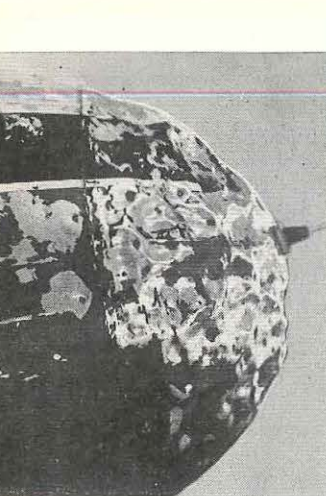
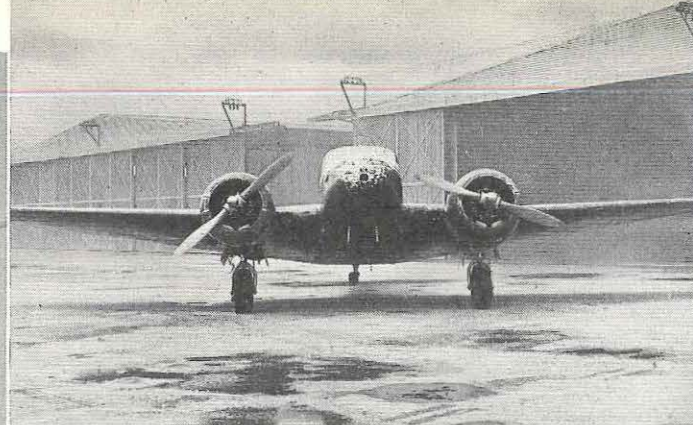
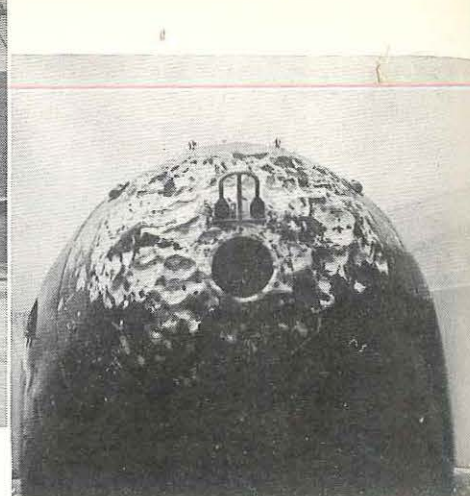
While making an IFR flight from Moorabbin to Warracknabeal, Victoria, in mid-October, a Beech 18 aircraft encountered a severe updraught and extremely heavy hail. The hail damaged the aircraft to the extent that it became necessary to divert to Ballarat.

The aircraft had been considerably damaged by the hail. The nose dome was a mass of large indentations and there were smaller dents along the fuselage back as far as the rear cabin door. The rotating beacon was completely destroyed, all the windscreen panels had been broken and two of the panels of the cockpit's side windows were cracked. On the tail assembly, the entire leading edge of the tail plane was dented and the leading edges of the fins were literally flattened.

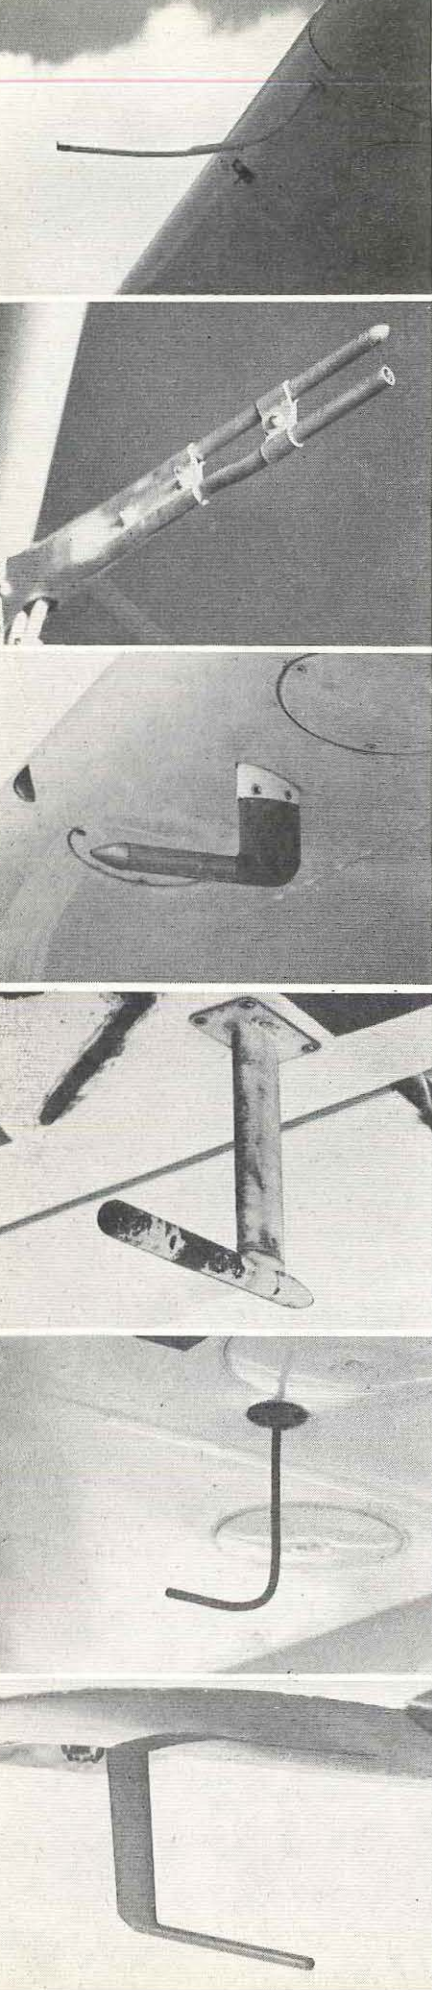
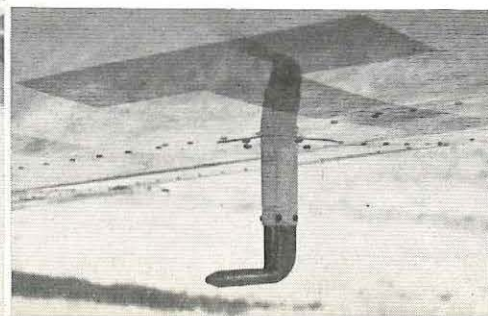
Automatically opening mechanical pitot cover as fitted to Mooney aircraft.  
Left: Cover closed.  
Right: Cover open as in flight.  
Note the flat plate exposed to the airflow, deflection of which lifts the cover off the front of the pitot tube.

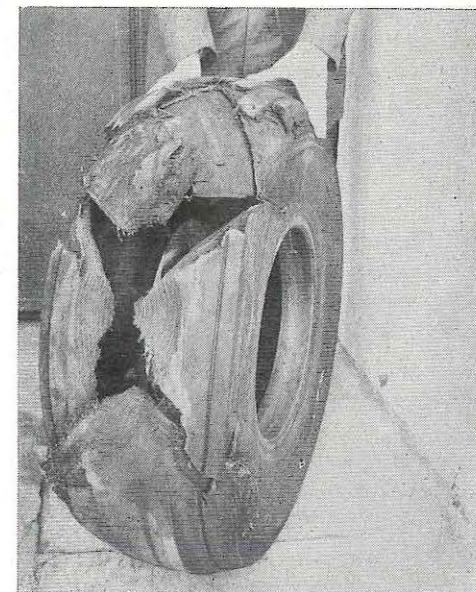
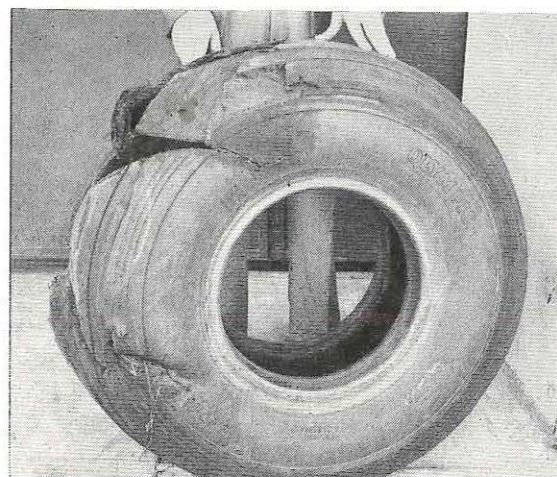
During the take-off, the vibration increased so much that it became obvious to the captain that the tyre was very severely damaged, and on inspecting it himself from the cabin after the aircraft was airborne, the captain saw that it was almost shredded. The aircraft continued to Melbourne and made an uneventful landing, and after the blown tyre had been replaced and minor damage to one of the port undercarriage doors, repaired, the aircraft was returned to service.

The captain's decision to return from Mangalore to Melbourne without first having the damage to the tyre properly assessed and the adjacent airframe components inspected by an engineer, was viewed most seriously by both his company and the Department. Indeed, it almost borders on foolhardiness. Not only was there a risk of blowing the other port tyre on take-off or during the subsequent landing, with a potential for very serious consequences; there was also the possibility that the blown-out tyre could have thrown off large pieces of tread and caused damage to the airframe itself, especially if pieces had been flung into a whirling propeller. As it was, the port outer undercarriage door had sustained minor damage, and the captain was not to know that this damage was not more serious.
