AVIATION SAFETY DIGEST

DEPARTMENT OF CIVIL AVIATION

No. 50

MAY, 1967

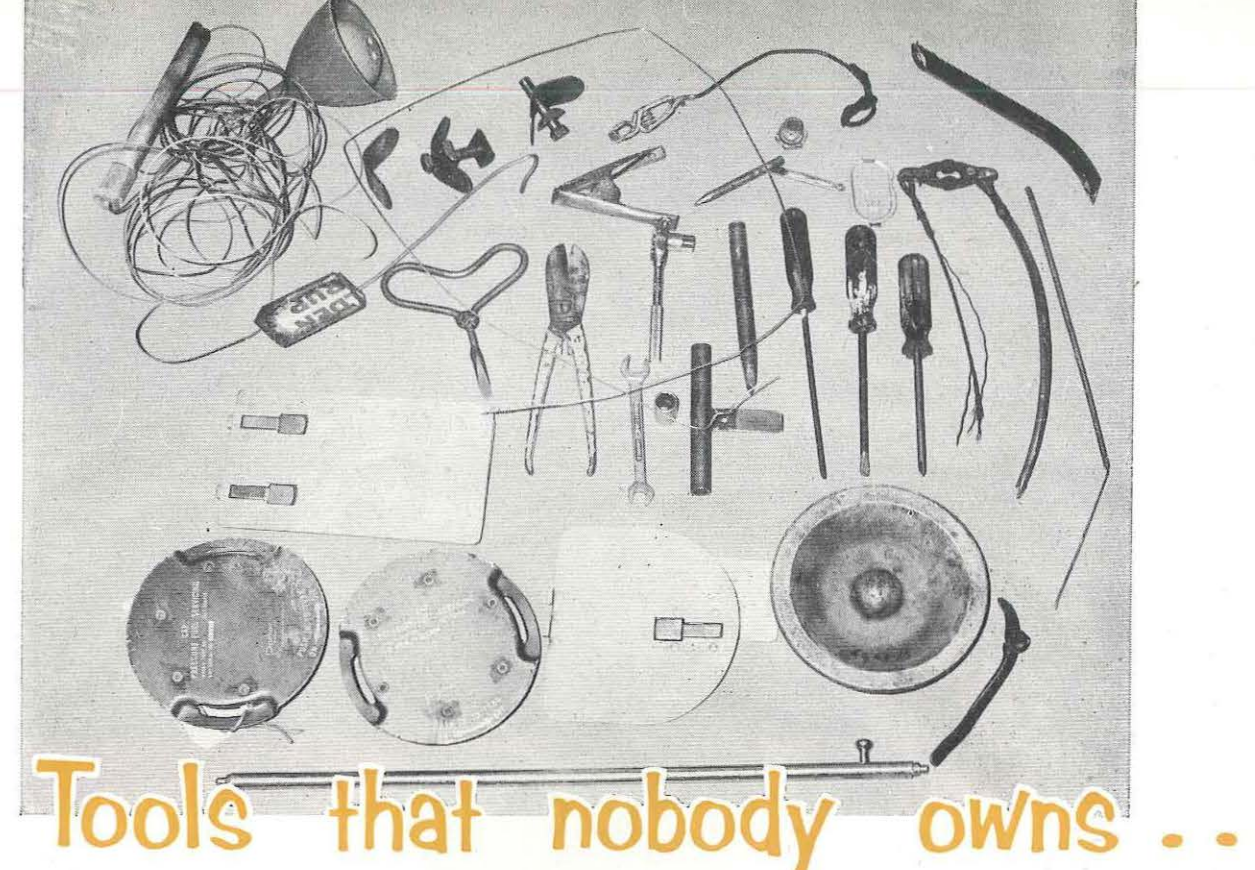
A Digest article "Lost and Found" early last year (see Aviation Safety Digest No. 45, March 1966) listed a number of tools and other items of equipment that had been found on the movement areas of major airports, over several preceding months. Maintenance staff had obviously left the equipment at various times in the engine bays and wheel wells of aircraft they were working on, and the items had subsequently fallen from the aircraft while manoeuvring on the airport concerned. The article went on to discuss the potential dangers that forgotten equipment of this sort can pose, particularly if a piece drops from an aircraft after it has taken off.

The accompanying photograph of tools and other equipment collected over a period at one major airport in Australia, shows that the problem is still far from beaten, and that maintenance personnel need to exercise a good deal more care in "cleaning up" when they finish working on an aircraft. Although some of the articles shown in the photograph are quite costly, it is remarkable that, with the exception of the trail-

When this type of incident first became prominent, the type of equipment found was, in the main, of the kind usually employed in major repair workshops. But more recently, the trend has been towards the sort of tools used in day-to-day maintenance, as the brief article at the foot of page 13 will confirm. We are concerned at this, since such work should be performed by either Licenced Aircraft Maintenance Engineers or by persons working directly under their supervision. To judge by results, it would seem that, in some cases, standards of supervision and final inspection before certification are simply not as good as might be expected.

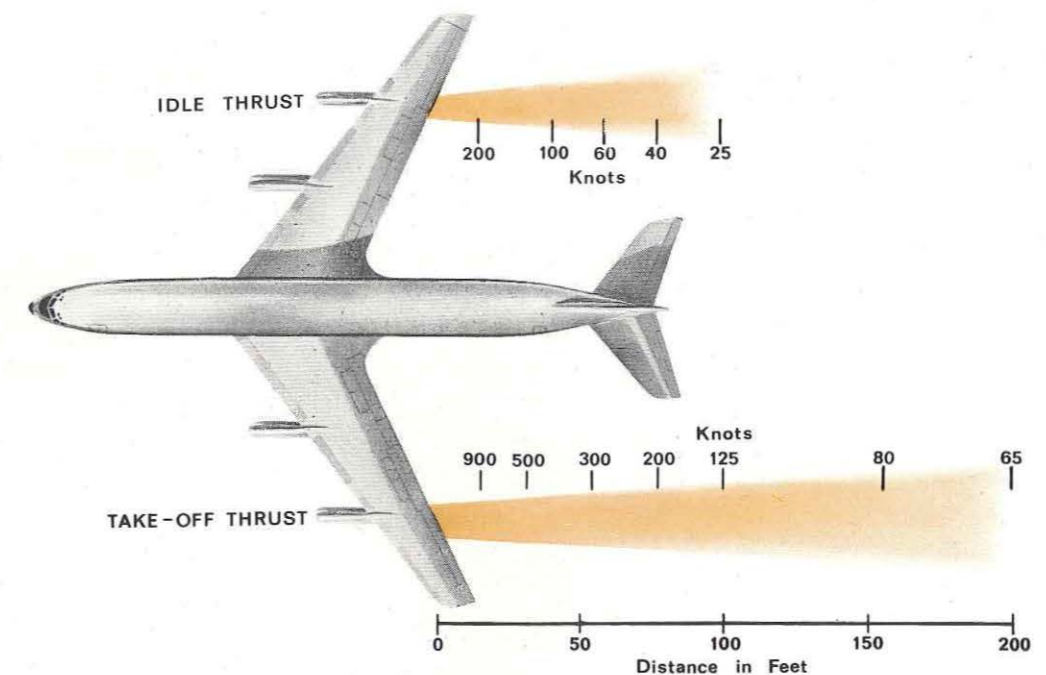
Fig. 5. Diagram showing efflux velocities that may be expected behind large jet aircraft at idle and take-off power settings.

The diagram at Fig 5 shows jet efflux velocities that may be expected in the wake of a large jet aircraft on the ground. In the light of the accidents already described, however, it is clear that these values cannot be accepted as absolute, but as a guide only. It is estimated that in the case at Adelaide Airport, the tail of the DC-3 was at no time closer to the Boeing's jet pipes than 90 feet. If the Boeing's engines were at the idle thrust, as would seem to be the case since the aircraft's forward stairs were still in position, an efflux velocity of less than 30 knots is all that might have been expected. This figure is certainly much less than the velocity that would have been required to inflict the damage sustained by the DC-3. Why then the large discrepancy between the "theoretical" and actual velocities? The answer appears to lie, at least partly, in the wind that was blowing at the time. The Boeing was facing almost directly into a 12 knot westerly wind, gusting to 16 knots, and it is apparent that

WARNING: Wind conditions can have a marked effect on jet effluxes. These figures for still air conditions, should not be regarded as absolute, but as a guide only.

closely as possible to ensure that designed blast clearances are maintained. Airline despatching engineers should also ensure that the blast area behind a jet is clear of other aircraft, personnel, and equipment, before giving the jet aircraft captain a clearance to start his engines. Pilots of jet aircraft, for their part, should use the least possible thrust when taxi-ing on aprons, especially in close proximity to other aircraft, refuelling equipment, and buildings. Probably the most critical taxi-ing phase is when the throttles are opened to "break away" thrust to get the aircraft moving, especially if, at the same time, the aircraft has to turn sharply or if its path is slightly uphill. In these circumstances, quite large amounts of thrust are required for a short period. For example, efflux velocities of over 70 knots have been measured 150 feet behind the jet pipe of a typical large jet at its minimum break away thrust. The intensity of such a blast, and the area it affects, is sometimes very difficult for a pilot to appreciate from the cockpit.

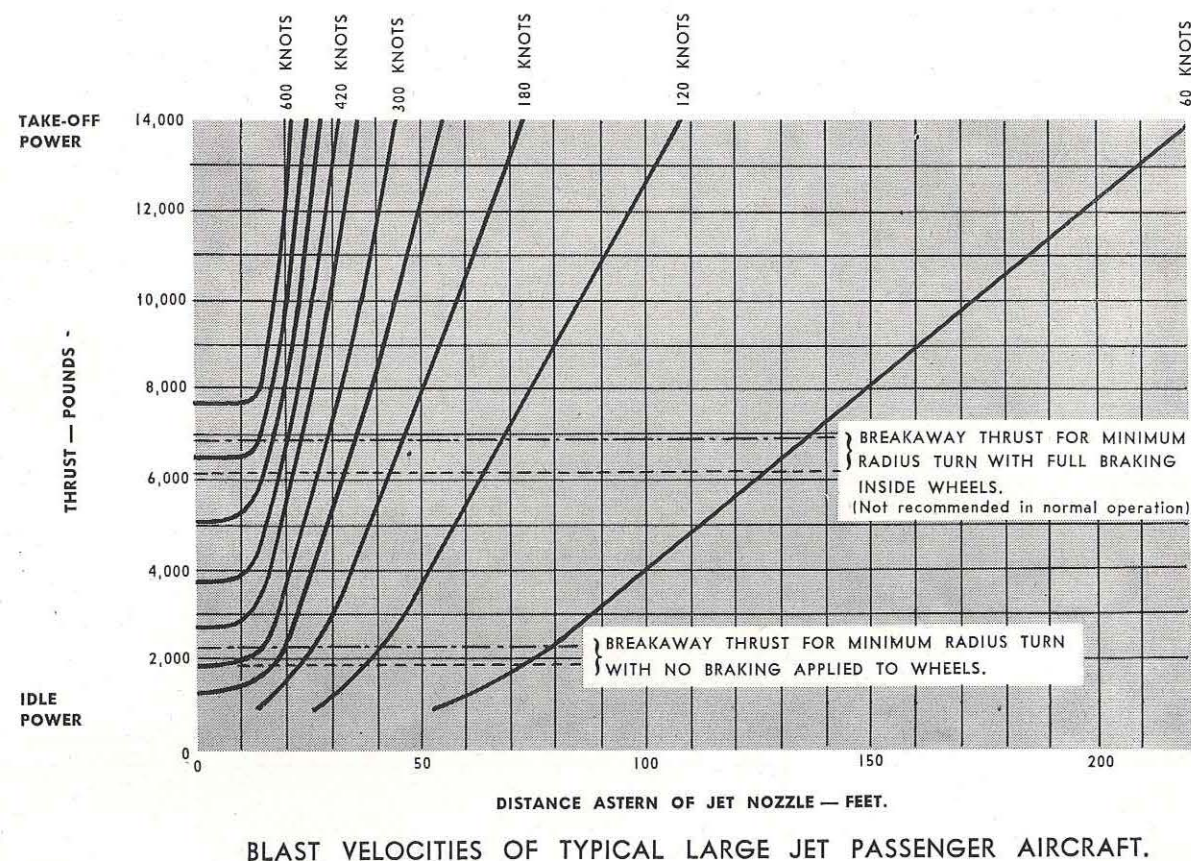
Fig. 6 Graph showing efflux velocities to be expected at varying power settings and distances from jet pipes. Note how rapidly the efflux velocity increases as distance from the jet pipe decreases, particularly at high power settings.

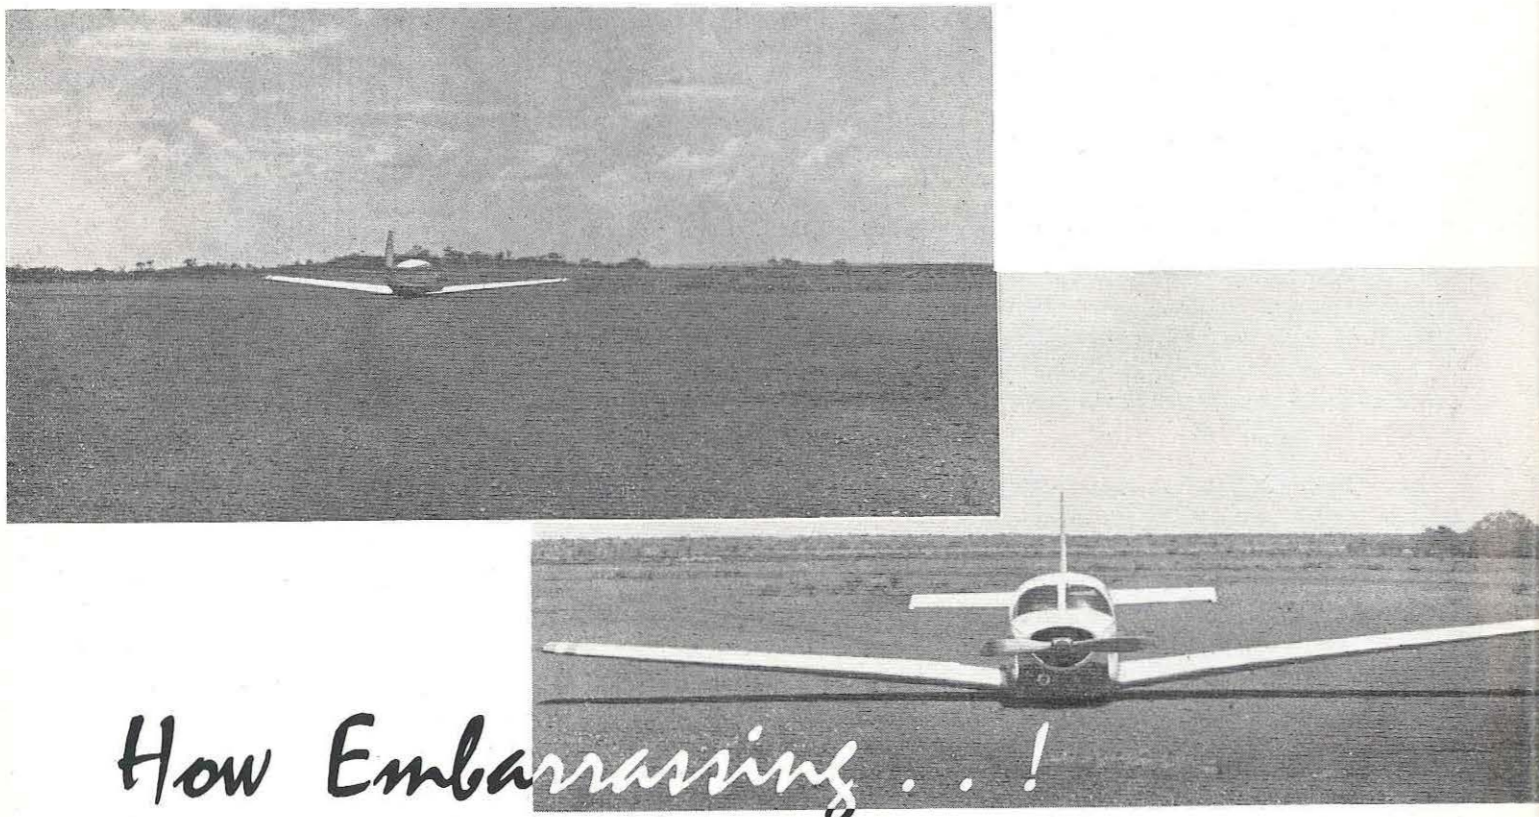
How Embarrassing...!

The pilot of this Mooney didn't forget to lower his undercarriage—he remembered it just once too often!

Only as the aircraft settled and the propeller struck the ground and stopped, did the pilot realize what he had done. He had mistaken the stall warning for the undercarriage horn, and in the heat of the moment, had reacted by moving the undercarriage lever to its opposite position, actually raising the undercarriage.

The pilot said that the two warning horns had similar tones and apparently, because of the considerable amount of power the pilot was using right down to touch-down, the undercarriage horn itself did not sound when the pilot unintentionally retracted the wheels just before the aircraft settled.
