# AVIATION SAFETY DIGEST

DEPARTMENT OF CIVIL AVIATION

No. 51

JULY, 1967

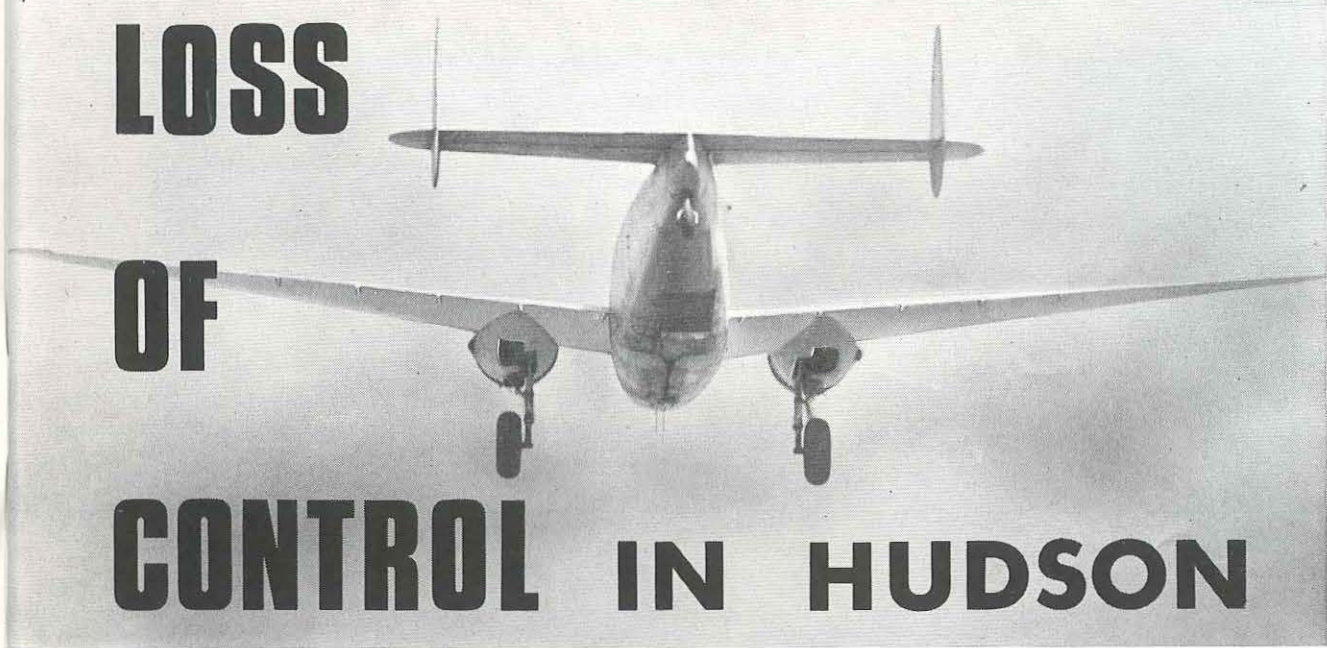
At the conclusion of a survey flight in the Northern Territory, a Lockheed Hudson called the Tennant Creek Flight Service Unit and reported that it was in the circuit area. The aircraft did not land as expected and no further communications were received from it. A search was subsequently carried out, and the wreckage of the aircraft was found two miles west of the aerodrome. All six occupants had been killed and the aircraft destroyed.

The most significant finding to emerge from the examination of the wreckage was that one of the duplicated aileron control chains in the pilot's control column was broken in the region of the control wheel sprocket. The breakage had occurred when a link pin of the chain had failed, and there was evidence that the broken link pin could have subsequently jammed the assembly as the control wheel was being rotated. Following further extensive examination and laboratory testing, it was concluded that the failure of the chain and the associated damage to the control column assembly, were not consistent with impact damage, but the investigation could not positively establish

Firstly, it was found that one of the duplicated aileron control chains in the pilot's control column assembly had broken and there was evidence that it had temporarily jammed. The damage was believed to be inconsistent with impact damage and consideration was therefore given to the effect of such a situation occurring in flight. Flight and ground tests conducted to simulate such sudden jamming, showed that although the pilot would be temporarily deprived of aileron control, the aircraft could still be controlled to maintain level flight with the elevator and rudder controls alone. The tests could not however, simulate the element of surprise. Similarly, it was not possible to test the reaction of a pilot to circumstances in which he would not only be required to control the aircraft, while it was turning to the left, probably at low airspeed, but would also be required to try and overcome the restriction by exerting considerable force on the control wheel. It was found that the physical force required to free the aileron controls in such a situation, would be well within the capacity of one person. While it could not be conclusively established what overall effect the total situation would have on the control of the aircraft, the test results showed that the very least effect would be a gross distraction of the pilot from his task.

The cause of this accident was a loss of control of the aircraft, and although the evidence available does not permit the reason for the loss of control to be determined, the possibility cannot be eliminated that the pilot suffered an impairment of ability and, coincidentally, was deprived temporarily of aileron control.

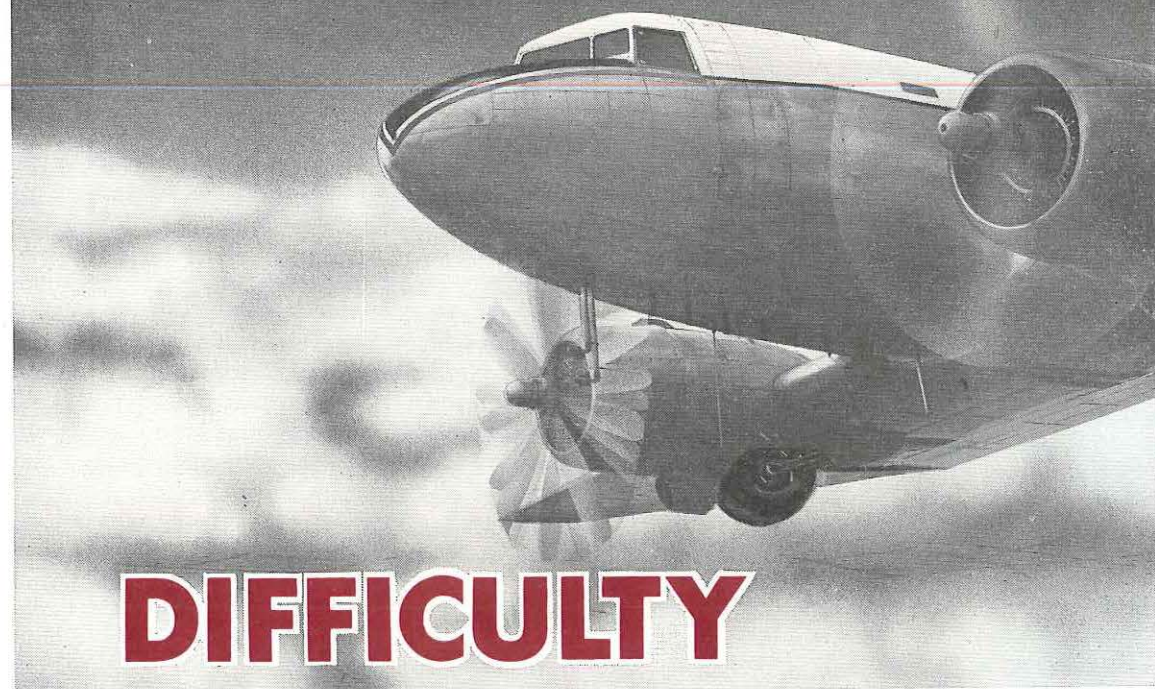
A DC-3 was making a night flight from Launceston to Melbourne carrying freight. The aircraft was cruising at 9,000 feet in clear air and the outside air temperature was minus 20 degrees C. Thirty minutes after reaching the top of climb, the crew felt a slight thump in the cockpit. There was no indication of any malfunction and the engine instruments continued to indicate normally, but a short time later a smell of burning came from the heating system. The first officer then saw a shower of sparks coming from the lower section of the starboard engine and the captain immediately began the shut down procedure for that engine. The shower of sparks ceased when the captain closed the throttle, but when he pressed the propeller feathering button, the engine RPM only decreased to about 500. At this speed the feathering button popped out and the RPM increased again to about 1,200. The captain tried several times more to feather the propeller, but on each occasion the result was the same.

When the starboard engine was inspected after the aircraft had arrived at Melbourne, the No. 7 cylinder was found to be cracked in the vicinity of the cylinder shrinkage band. The indications of fire seen by the crew had evidently been caused by combustion gases escaping through the crack and "torching". There was no evidence of any sustained fire having developed in flight. It was apparent that age and fatigue had contributed to the cylinder failure.

The test thus supported the belief that the difficulty in feathering the starboard propeller when the engine trouble was encountered, was caused by oil wax which had formed in the propeller dome, and that when the feathering

The real lesson of the incident is that it is good practice for crews to cycle the propeller pitch controls during pre-take-off checks, after even short stop-over periods at intermediate ports, whenever low outside air temperature conditions are to be expected in flight.

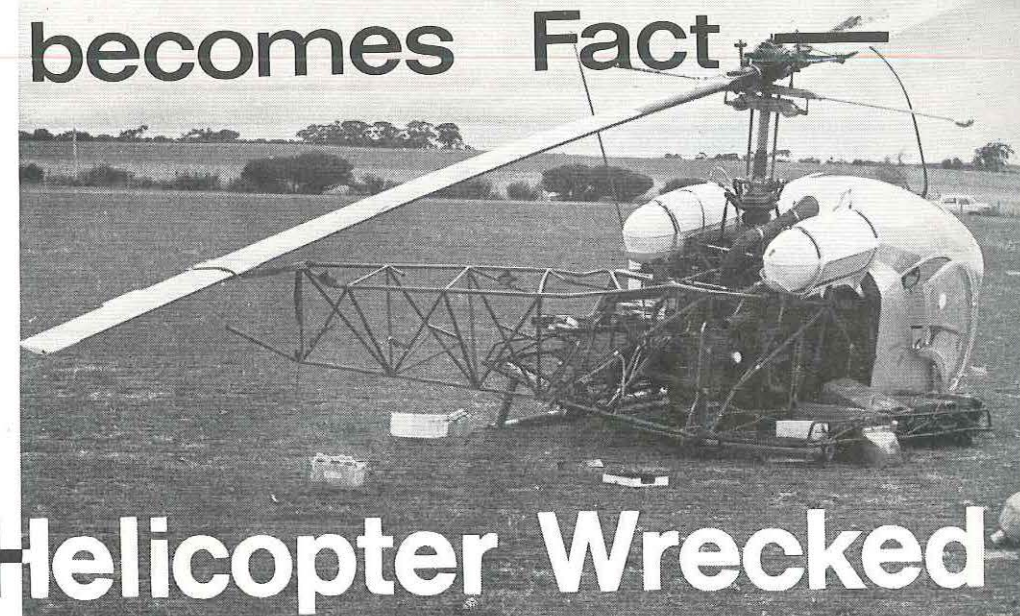
While making a climbing turn in translational flight, shortly after taking off from a paddock in the Konnongorring district of Western Australia, a Bell 47-G2 suddenly began to lose height. The pilot saw that both engine and main rotor RPM were decreasing, but despite some attempt at remedial action, he was unable to prevent the helicopter striking the ground heavily. The helicopter was extensively damaged, although both pilot and passenger escaped without injury.

As the helicopter passed over the wires, the engine and rotor RPM began to decay and the aircraft lost height. The respective RPM needles remained synchronised on the instrument, indicating that there was no clutch slippage, and with the throttle fully open, the pilot decreased collective pitch to try and regain engine and rotor speed. The engine did not seem to respond however, and the aircraft lost height more rapidly.

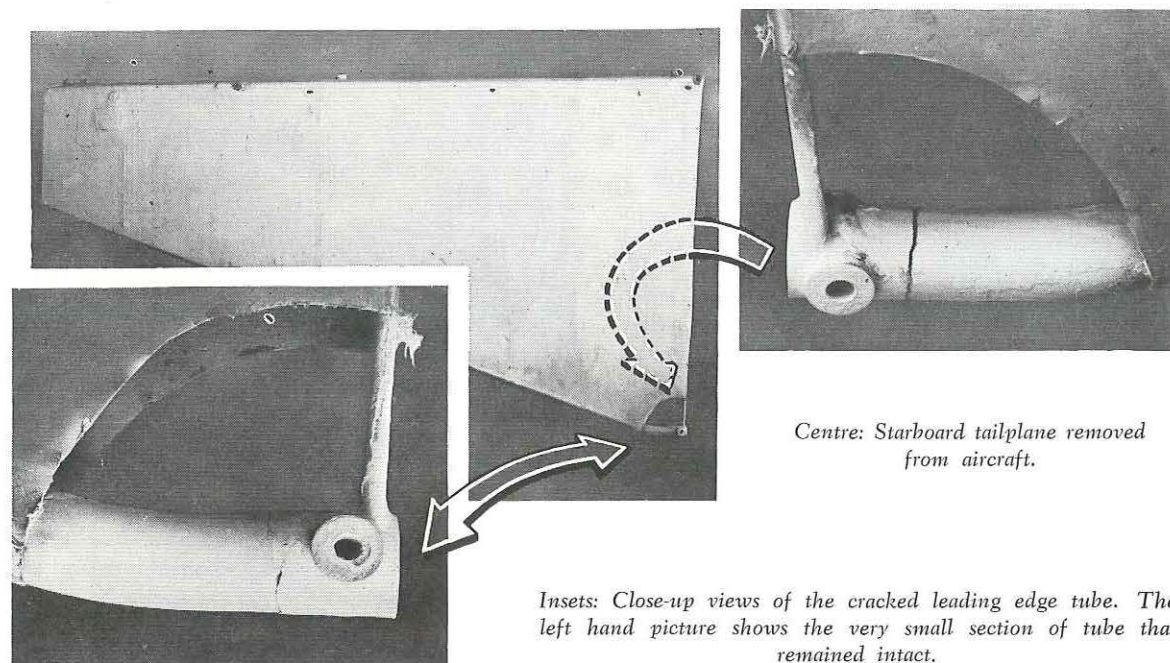
During a 100 hourly maintenance inspection being carried out on an Auster J5F, the tube which forms the main structural member and leading edge of the starboard tailplane, was found badly cracked. The crack was one inch outboard of the attachment bolt hole and had propagated almost completely around the tube, leaving only a very small section of the tube holding the tailplane in place.
