No. 54

AVIATION SAFETY DIGEST

DEPARTMENT OF CIVIL AVIATION AUSTRALIA

No. 54 JANUARY 1968
DEPARTMENT OF CIVIL AVIATION, AUSTRALIA

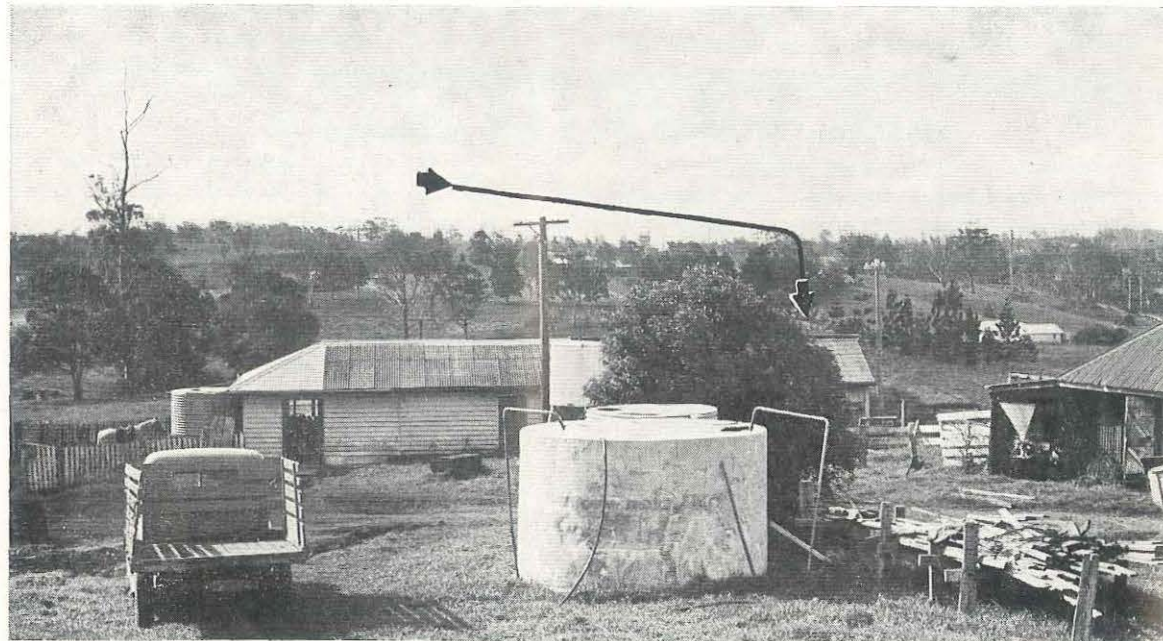
Final flight path of aircraft as seen by eyewitness 300 yards south of accident site.

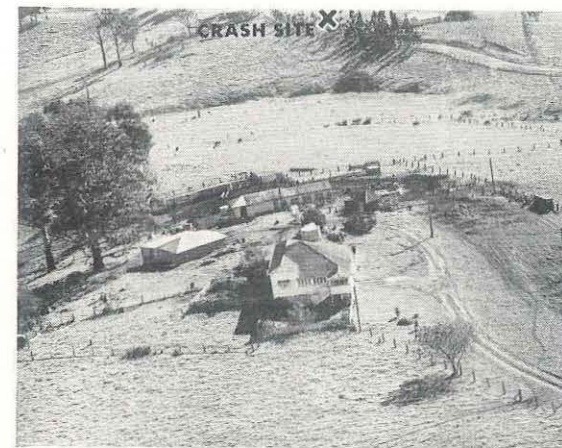
The last photograph taken during the ill-fated flight. The camera was recovered from the aircraft wreckage. The low level from which the picture was taken is especially evident when compared with the photograph on the opposite page.

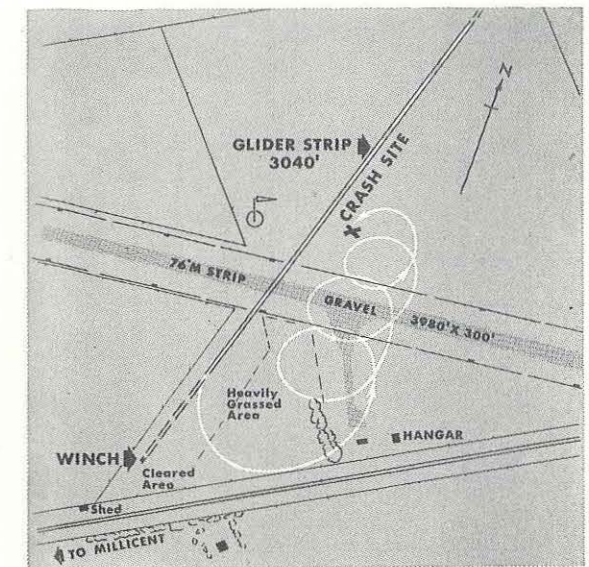
Diagram showing take-off direction and final flight path of glider.

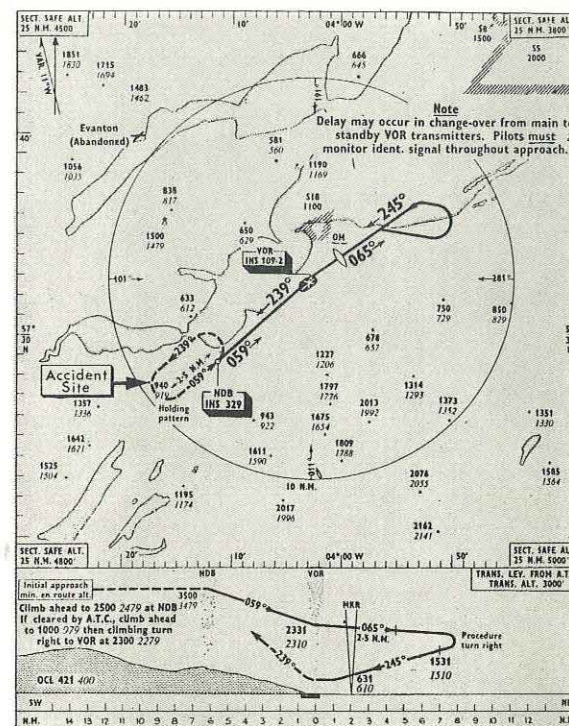
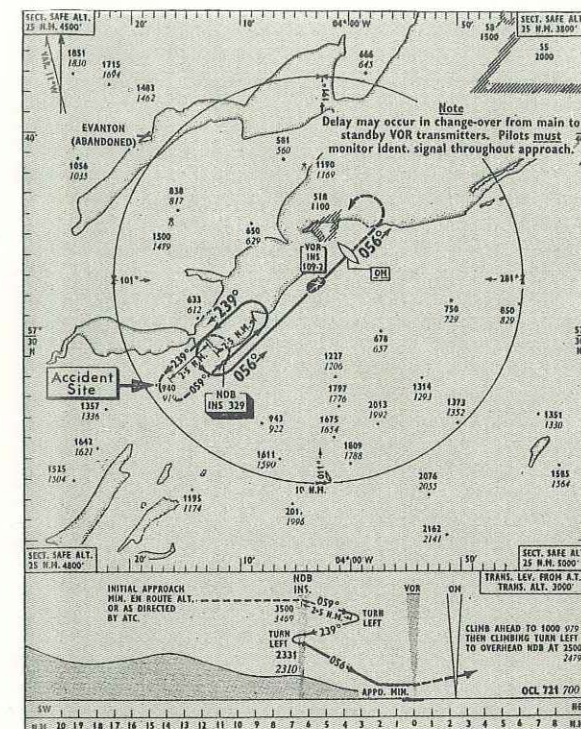
Dalcross VOR/Marker Instrument Approach Chart for runway 24.

Dalcross NDB/VOR Instrument Approach Chart for runway 06.

Current approach procedure charts for Dalcross were found in the wreckage of the aircraft. The profile section for the runway 24 procedure, shows an altitude of 3,500 feet over the NDB and a subsequent descent to an altitude of 2,331 feet at the VOR; i.e., when the aircraft is to the south-west of the NDB, it should not descend below 3,500 feet.
