DEPARTMENT OF CIVIL AVIATION AUSTRALIA

AVIATION SAFETY DIGEST

No. 55

MARCH 1968

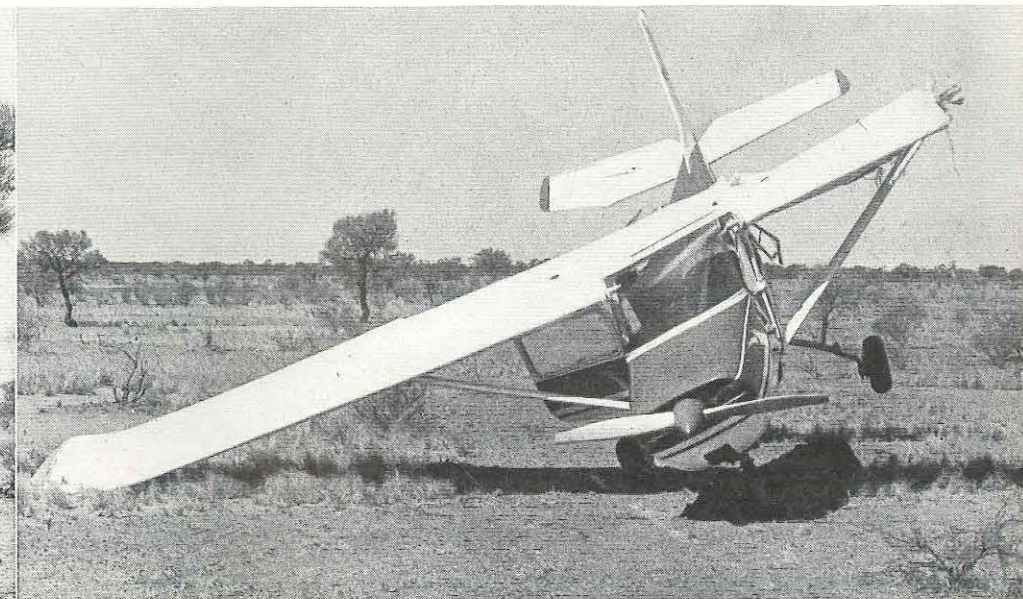
A Tree Gets in the Way

A pilot who had recently gained his commercial licence but was totally inexperienced in bush flying, was engaged by a charter company to take part in aerial mustering operations at a station property in Western Australia.
