No. 56

MAY 1968

AVIATION SAFETY DIGEST

DEPARTMENT OF CIVIL AVIATION AUSTRALIA

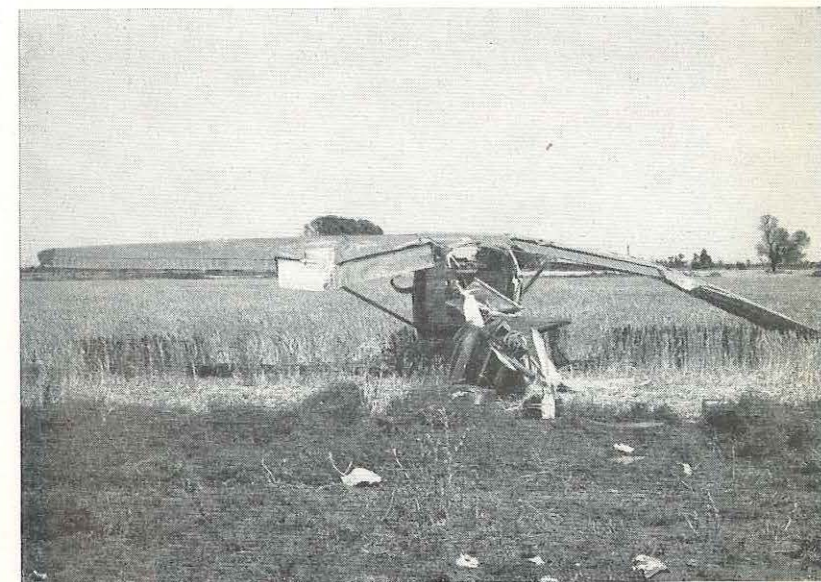
This was a hired Cessna 172, in which a private pilot was making a local flight in Queensland, with three friends as passengers, when he decided to inspect a dam he had built on a nearby farm.

The aircraft flew around the property at a very low level, then climbed to about 150 feet over a power line. The engine was then throttled back abruptly and the aircraft descended again. At a height of 30 feet it collided with another power line on the boundary of a paddock, and dived into the ground in a near vertical attitude and somersaulted. The engine and rear fuselage broke off and the aircraft came to rest in an upright position. The pilot later died of the injuries he received and his three passengers suffered serious injuries.

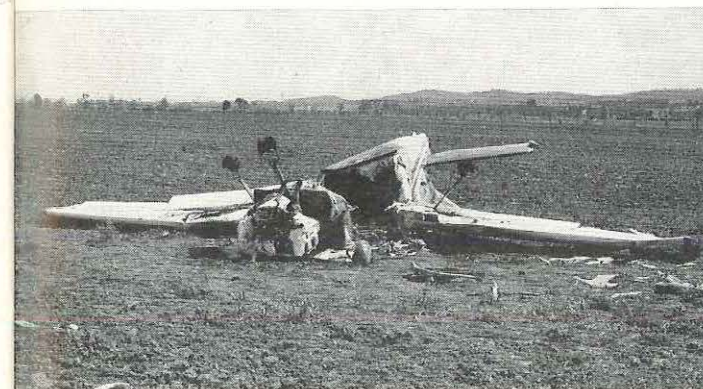
Towards the end of a training flight in Queensland, this Victa, with a young "C" rated instructor and a pupil on board, was seen returning towards the aerodrome from the training area, at low level. The weather was fine and the aircraft was functioning normally. After flying for some distance at an average height of about 15 feet, which varied only enough to avoid obstacles, the aircraft flew into a power line. Taking one wire with it, the aircraft then climbed steeply into a near vertical attitude, fell over on its back, and crashed to the ground inverted. Both occupants were killed and the aircraft was burnt out.

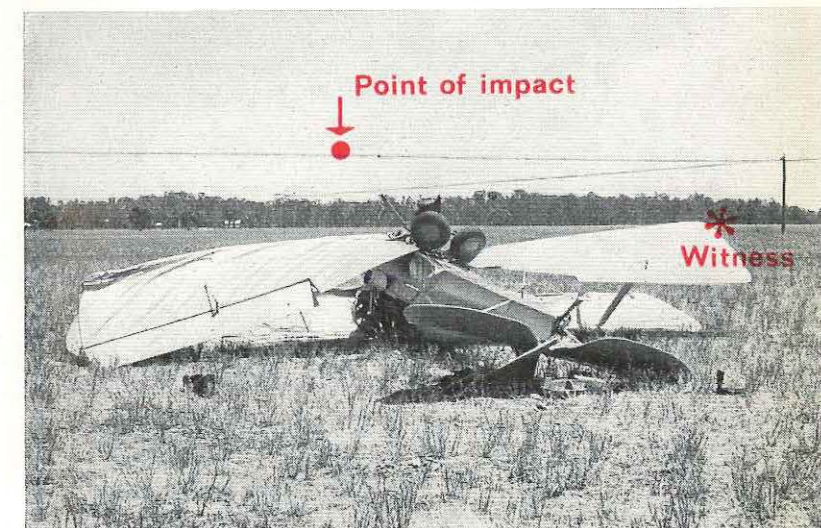
In N.S.W. a private pilot and a friend had flown to a property in this Tiger Moth to visit some friends. When it was time to go the two men boarded the aircraft in the paddock where it was parked and took off.

The aircraft flew around the homestead then turned back towards the party of friends who had gathered in the paddock to farewell the men. The aircraft descended as it approached the group, passing in front of them about 20 feet above the ground. It then began to climb, but the undercarriage struck a single wire pole line and the aircraft dived steeply into the ground and overturned. The passenger was killed and the pilot seriously injured.

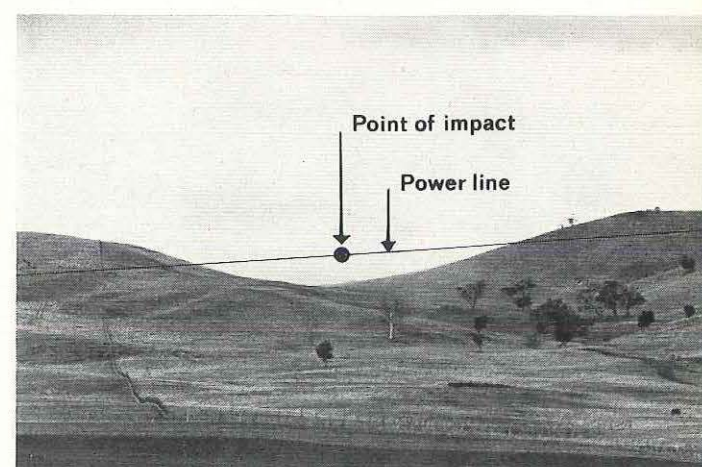
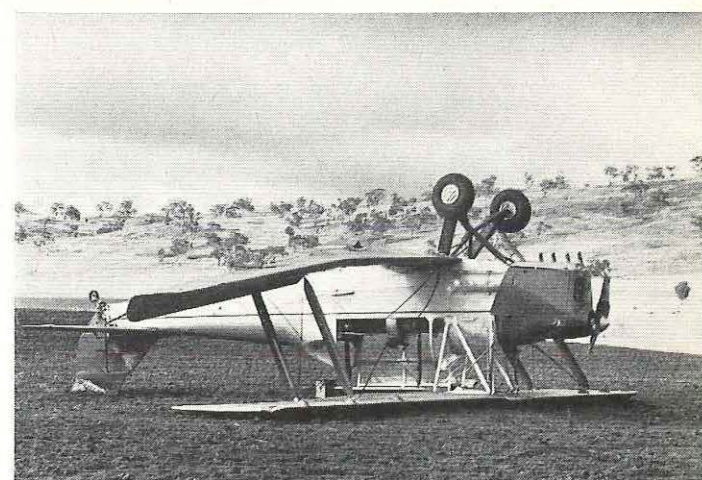
Ferrying a Musketeer, with a student pilot as a passenger, to a country centre in Queensland, a "C" class instructor followed the course of a dry river at 500 feet to point out suitable forced landing areas to the student. In answer to a question by the student, the instructor set out to demonstrate a forced landing approach to a sand bar in the river bed, allowing the aircraft to descend below the level of the trees flanking either side of the river. As he was about to climb out of the river course, the occupants heard a loud "TWANG", and saw that the H/F aerial had been severed. The aircraft continued to fly normally however, and thinking the aircraft had struck a bird, the pilot continued to his destination where he made a straight-in approach.

Unknown to the pilot until after he landed, the aircraft had struck and broken two telephone lines strung across the river and these were trailing for 600 feet behind the aircraft. As the aircraft approached to land, the wires dragged across a power line, shorting it out and breaking several wires. Fortunately, no great damage was done and no-one was injured, but it is easy to imagine similar circumstances creating an extreme hazard for persons or property in the vicinity of the power line.

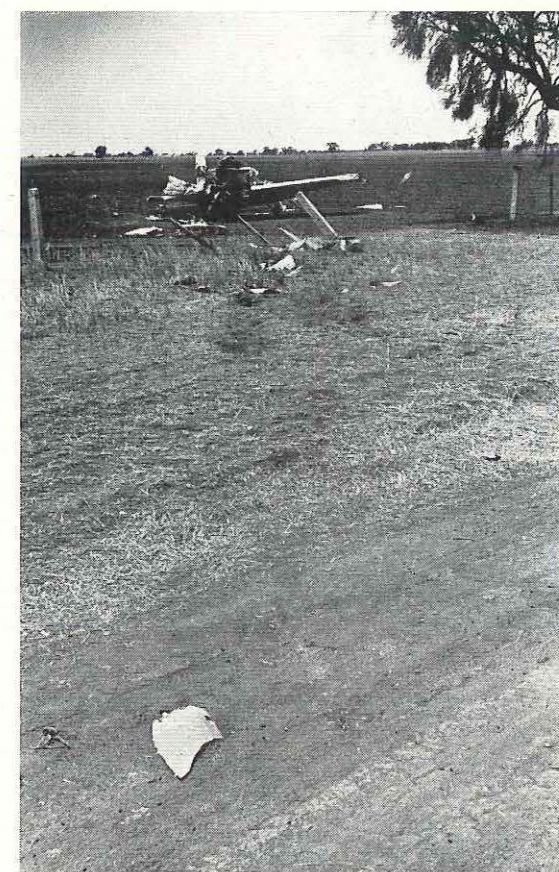
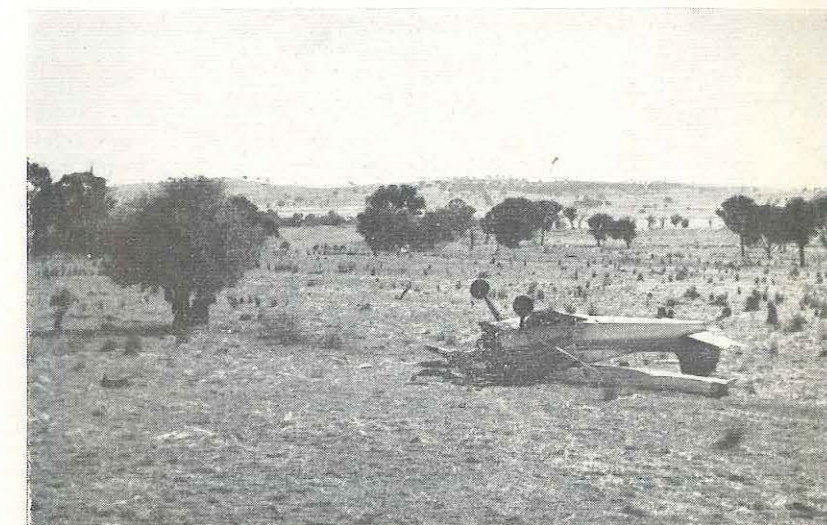
When this accident occurred a private pilot was taking a friend for a flight in a Victa from a country aerodrome in Victoria. Sighting a farm house where

a friend of the passenger lived, the pilot descended, as he said later, "to allow the passenger to have a good look at his friend's property". The aircraft approached the house at low level, converging at an acute angle with an unseen single wire power line which supplied the property. The aircraft's undercarriage caught on the power line and the aircraft skidded along the wire, lifting it clear of the supporting poles. The pilot attempted to land in a field beyond the house, but the aircraft, still restrained by the power line struck the ground heavily, cartwheeled through a fence and came to rest facing the direction of the flight. As the photograph shows, the aircraft was destroyed. Both occupants were severely injured.

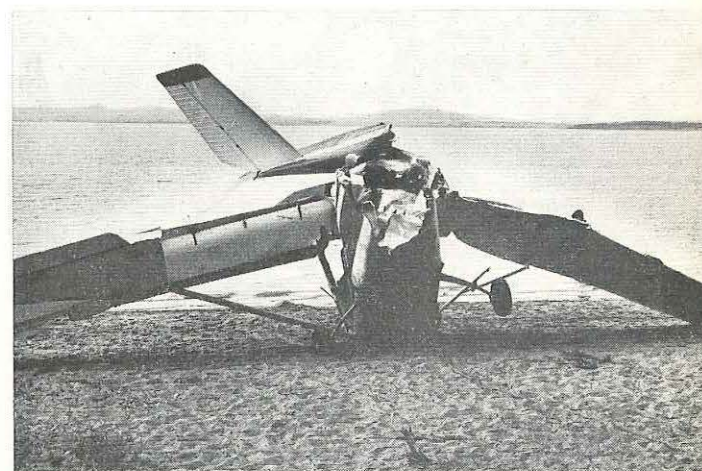
Late in the afternoon, a private pilot was taking some friends on a sight-seeing flight from Ballarat, Victoria. After flying around the city, the aircraft flew to nearby Lake Burrumbeet and began a low run across the lake from south to north, the aircraft crossing a southern shore at about 100 feet and descending further as it flew out over the water.

The sun was just setting at the time, and the visibility was hazy. There was no wind and the surface of the lake was mirror-like and almost translucent in appearance. A quarter of a mile out from the shore, the aircraft levelled out and flew very low above the water. It continued at this height for a short time, but then about a mile out from the shore the undercarriage touched the surface of the lake and without further warning the aircraft plunged into the water. The pilot and one passenger escaped from the submerged cabin and were later rescued by a motor boat, but the two other passengers were drowned.

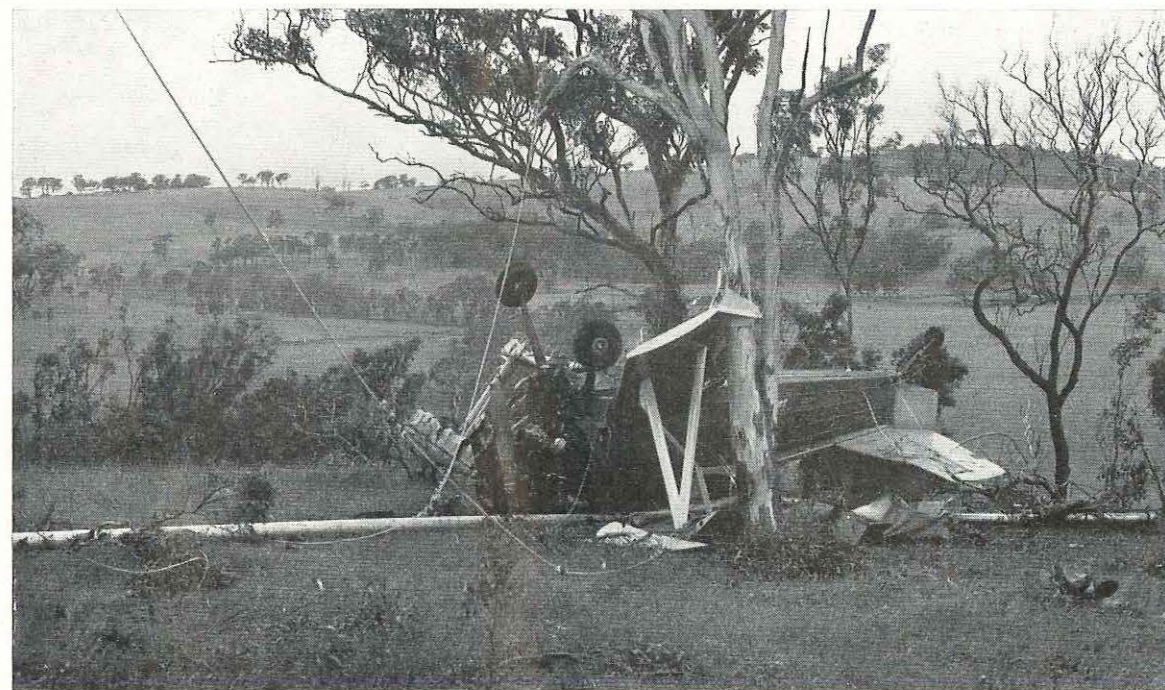
During a ferry flight in deteriorating weather, to Toowoomba, Queensland, the pilot of a Grumman Agcat descended to a low altitude to try and remain below the lowering cloud base. But when only four miles from his destination, he saw it would be impossible to continue the flight visually because of even lower cloud and reduced visibility on the hills ahead, and he began a turn back on to a reciprocal heading. In

the course of the turn, the pilot unintentionally entered a patch of cloud, and while still turning, the aircraft collided with the upper section of a 220 feet high radio mast belonging to a local broadcasting station. The mast collapsed, taking the aircraft with it, which then struck the ground in a steep nose down attitude. Miraculously the pilot, though seriously injured survived the crash and was able to extricate himself from the wreckage.

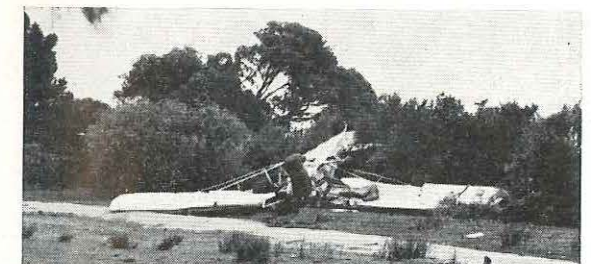
At Flinders Island, Bass Strait, the owner-pilot of an Auster was asked to deliver a part for a lighting plant to the settlement on Cape Barren Island, 20 miles to the south. The pilot offered to air-drop the part instead of landing on the island and this arrangement was accepted.

circuit and then began a run-in over the settlement at about 40 feet. Just before reaching the dropping point in front of the island's store, the pilot leant out the side window, holding the article to be dropped. As he did so, the aircraft turned to the left towards a 50 feet high pine tree, a little over 200 feet away. The pilot released the package but continued looking back towards where it fell. The aircraft then straightened up, but it did not climb, nor was there any change in the engine note, and it flew straight into the pine tree, 37 feet above the ground. The top of the tree was lopped off at the trunk and the aircraft dived to the ground 150 feet further on, coming to rest upside down. The pilot, who was the only occupant was fatally injured.

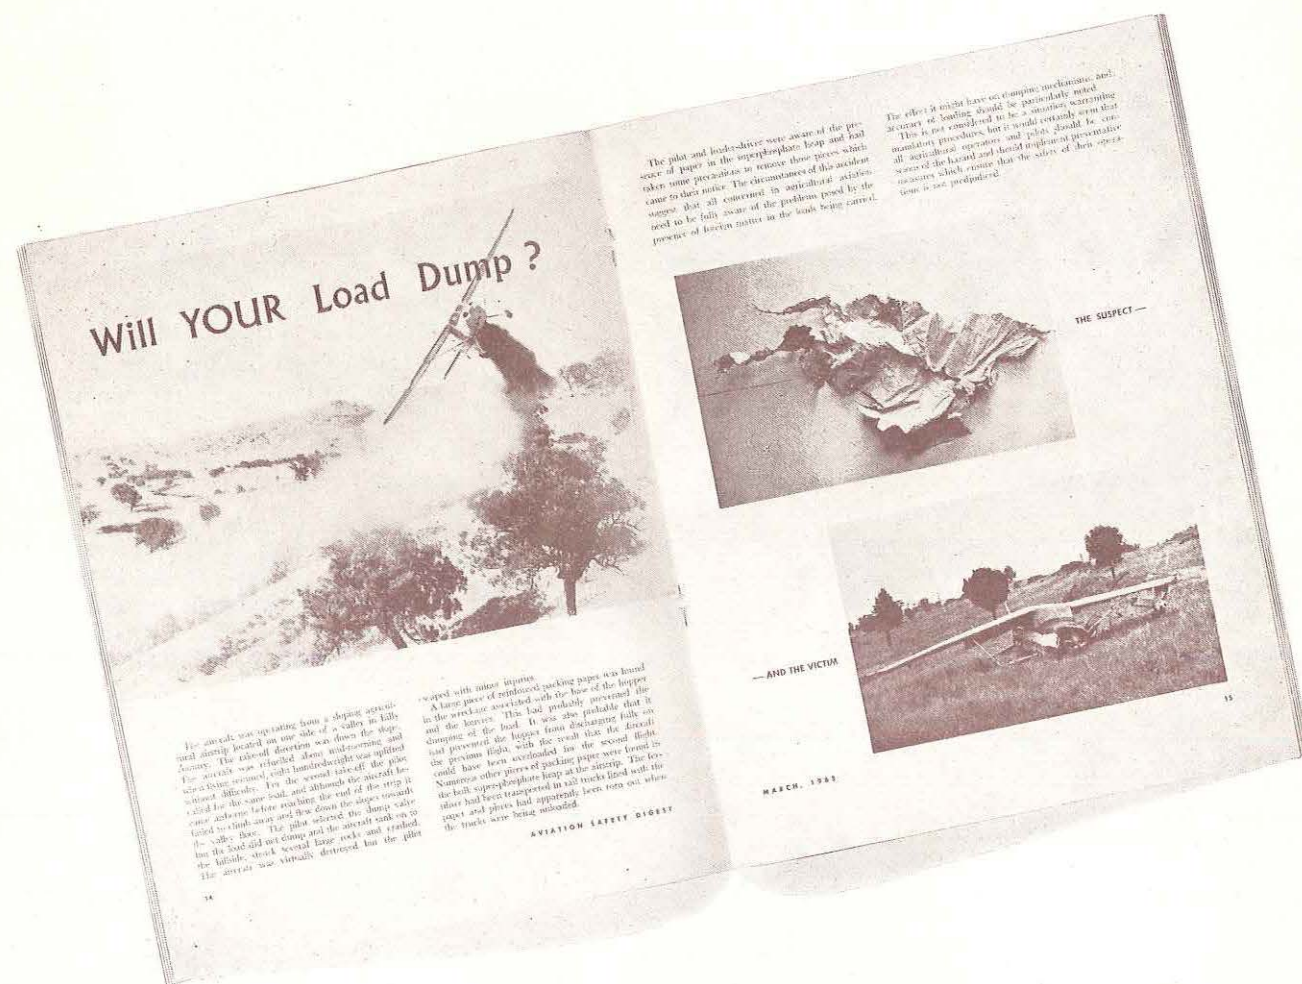
The pilot however, took this as a signal that the loading had been completed, and before the driver could warn him that the aircraft was overloaded, opened the throttle and began to take-off. The aircraft became airborne but failed to climb normally and the pilot tried to dump the load. There was no response and the aircraft sank into trees and scrub and crashed. As is evident from the picture, the aircraft was virtually destroyed. The pilot sustained serious injuries.

The aircraft's hopper was found to be blocked with several pieces of tree root, up to eight inches in length. Further investigation revealed that, before the operation began, the bulk superphosphate had been heaped on the natural surface of the ground beside the airstrip, and not on a prepared area. The pieces of tree root were obviously shovelled into the loader bucket while the driver and the farmer were clearing up the remains of the heap.

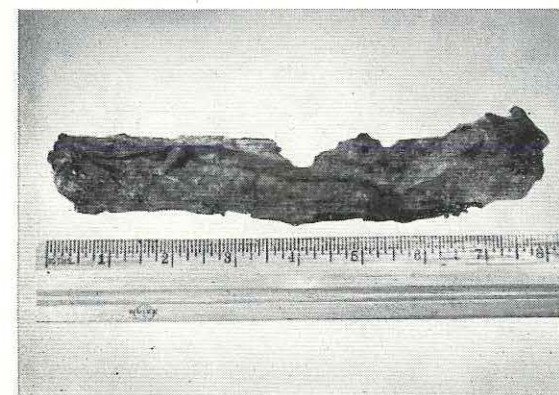
One of the pieces of tree root found blocking the aircraft's hopper after the accident.

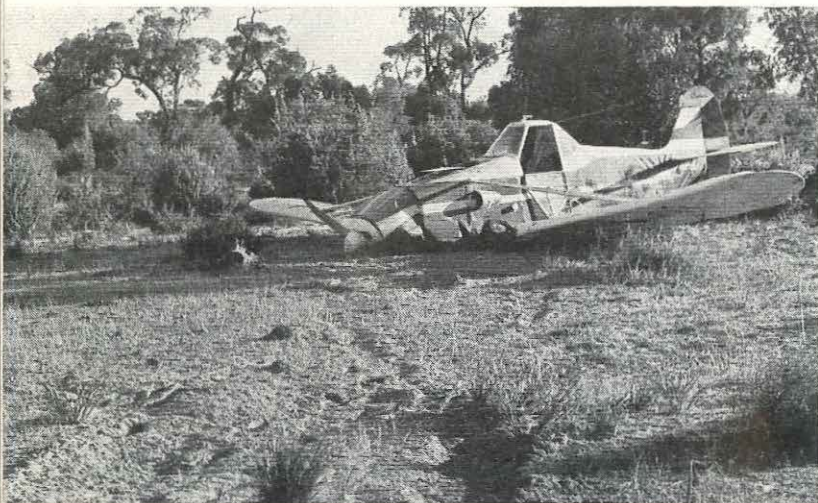
Before it struck the ground as shown, the Pawnee illustrated on the next page was also engaged on a super-spreading operation in Western Australia, in company with another aircraft of the same type.

The bulk superphosphate being used was freshly manufactured ("green" as it is known in the industry), and was of a fine powdery texture with a high moisture content. Superphosphate in this state tends to compact easily and does not flow as freely as more "matured", granulated superphosphate.

Unknown to the pilot, nearly half his aircraft's load on the preceding sortie had compacted in the aircraft's hopper and had failed to spread. In accordance with his normal practice, the pilot had landed with the hopper dump flap open, but because the landing was a smooth one, the superphosphate that had "hung up" in the hopper, was still not dislodged. The aircraft was then re-loaded again for the next sortie, and this load, on top of the remaining portion of the previous load, resulted in the aircraft being substantially overloaded.

During the ensuing take-off, the pilot realised the aircraft was overloaded and attempted to dump the contents of the hopper, but without success. It was too late to discontinue the take-off and the aircraft became airborne just above stalling speed. The pilot continued his efforts to dump the load by working the dump lever to and fro, and at the same time tried to climb the aircraft to avoid trees ahead. The aircraft would not climb however, and the pilot had to weave his way between the trees. He then decided to try and land in a clear area to the left of his flight path, but as he turned the aircraft, it stalled at a height of about 15 feet. The aircraft fell heavily to the ground, slid 55 feet, and came to rest facing the direction of flight.

The aircraft was damaged beyond economical repair but the pilot escaped with minor injuries. Investigation showed that the "green" superphosphate had packed down in the throat of the hopper, preventing the load from discharging.
