DEPARTMENT OF CIVIL AVIATION AUSTRALIA

**AVIATION
SAFETY
DIGEST**

No. 58 SEPTEMBER 1968

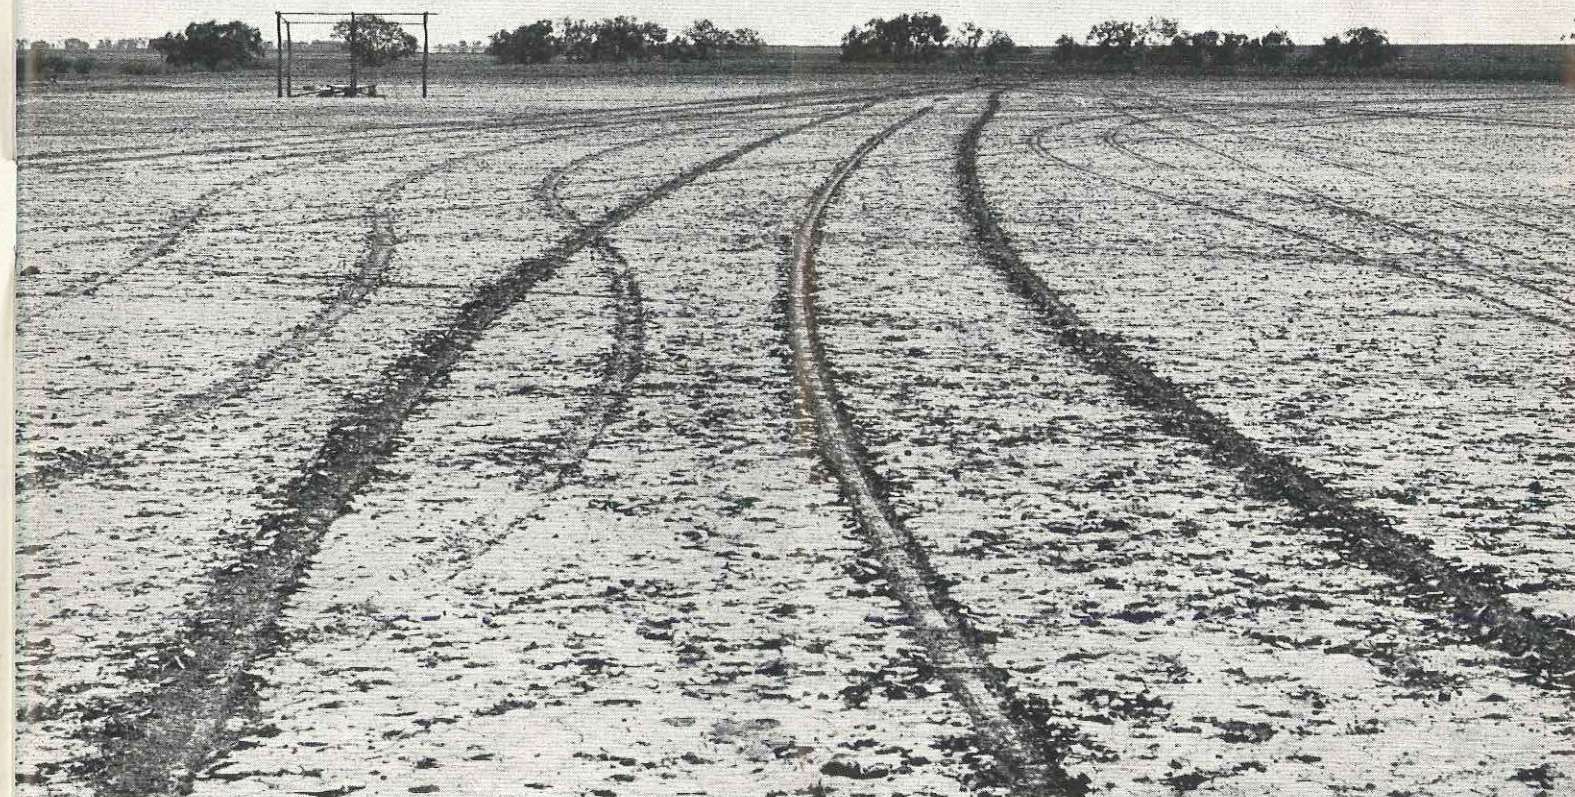
Musketeer destroyed on take-off

While attempting to take-off from a claypan on a station property in north-western Queensland, a Beech Musketeer failed to become airborne. After using all the available run the aircraft struck a tree, and still under power, crashed into a dry creek. The aircraft was destroyed by fire and all four occupants were killed.

Examination of the wreckage produced no evidence that the aircraft performance was other than normal up to the moment of impact. A propeller slash on the tree struck by the aircraft indicated that the engine had been under full power at the time and a subsequent stripping of the engine did not disclose any defects. The wreckage examination also confirmed that the flaps were fully extended at the time of the accident.

When measured, the length of claypan available for the take-off was found to be 1,174 feet. The low telephone line nine feet above the ground, which the property owner had pointed out to the pilot, was found to be just far enough beyond the north-eastern edge of the claypan not to affect the available operational length of the claypan itself.

The cause of the accident was that the pilot attempted to take-off on a strip which was of insufficient length under the existing conditions.

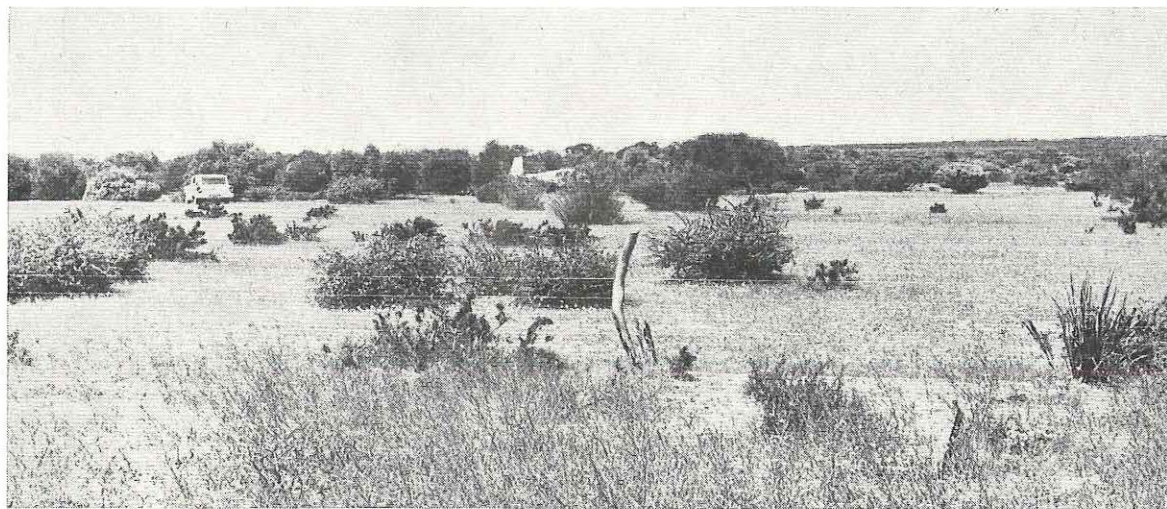
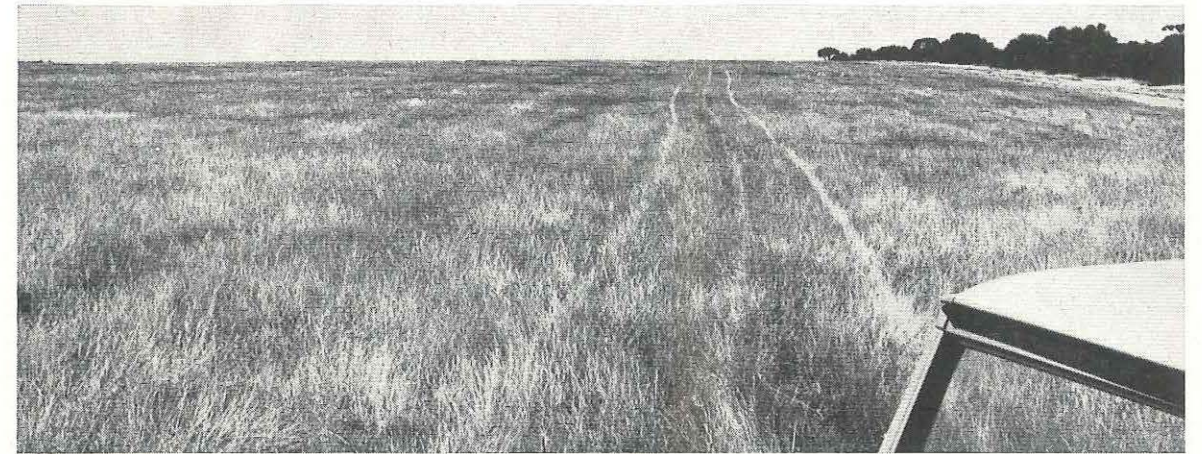
The pilot of this Mooney M20 attempted to take off fully loaded from a paddock in which the effective operational length of the run he had chosen was 1,800 feet. After using the length of the paddock without becoming airborne, the pilot attempted to lift the aircraft over the fence at the up-wind end of the paddock. The aircraft struck the fence with the undercarriage, the port wing dropped, then the starboard wing struck a bush and the aircraft slewed

to a stop badly damaged. The occupants escaped without injury. The pilot had not consulted the take-off performance chart in the aircraft's Flight Manual, which would have shown him that in the prevailing conditions an effective operational length of 2,200 feet on short, dry grass was required. In any case, because the paddock was covered in long weeds, it is very doubtful whether the area would have met the requirements of an authorised landing area.

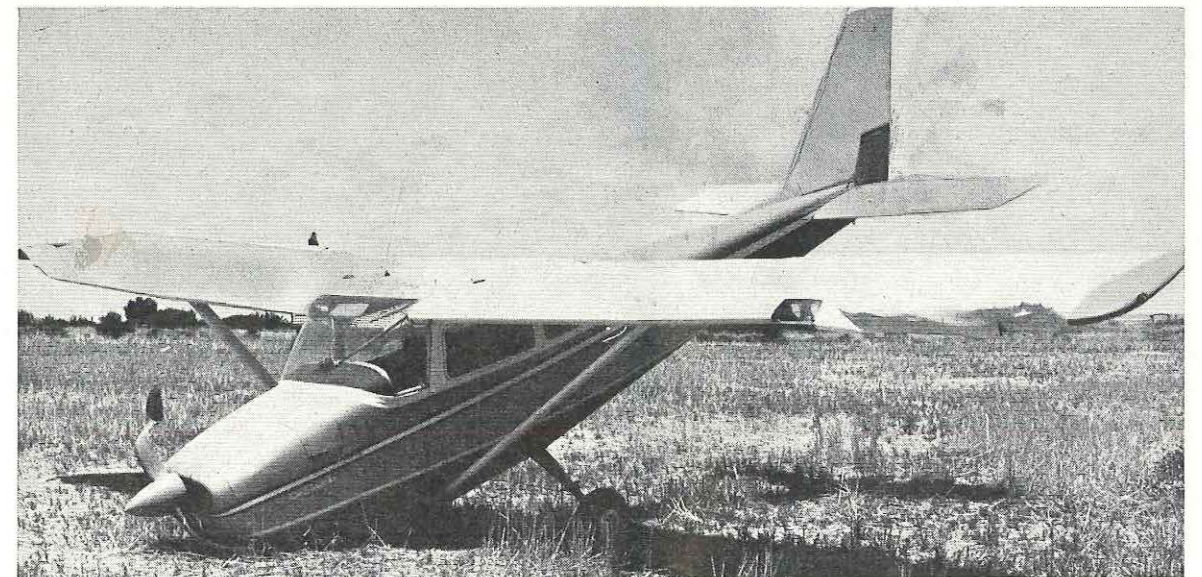
In Western Australia the pilot of a Cessna 172 had flown from Jandakot Airport to visit some country friends and had landed his aircraft in a suitable paddock on their property. When he was ready to depart again the next day the wind was blowing from a different direction and it was necessary for him to select another take-off path. Just as the pilot was ready to leave, a neighbouring farmer asked the pilot if he would take his children for a short local flight. The pilot agreed, and after calculating the all-up weight of the aircraft, estimated that he would require at least 2,000 feet of take-off run. However, as the property owner had driven his vehicle over the paddock in the proposed direction of take-off and determined that half a mile of run was available, the pilot was satisfied that the length was adequate. After the passengers were on board the aircraft the pilot started the engine and taxied down-wind preparatory to beginning the take-off run. Because there was an undulation in the paddock he lost sight of the up-wind fence of the paddock, and

The aircraft accelerated normally, but when it reached the top of the rise the pilot saw the boundary fence not far in front of the aircraft and realised that the distance he had allowed was not enough. The airspeed at this time was a little above 50 knots. However, the pilot believed he could clear the boundary fence. The aircraft became airborne, but then sank back on to the ground again and struck the fence. The nose leg collapsed and the aircraft skidded to a halt badly damaged. One of the child passengers suffered minor injuries.

Measurements made later showed that from the point at which the pilot had begun the take-off run, the effective operational length was only 1,450 feet, whereas if he had utilised the full length of the paddock the distance available would have been in excess of 2,500 feet.

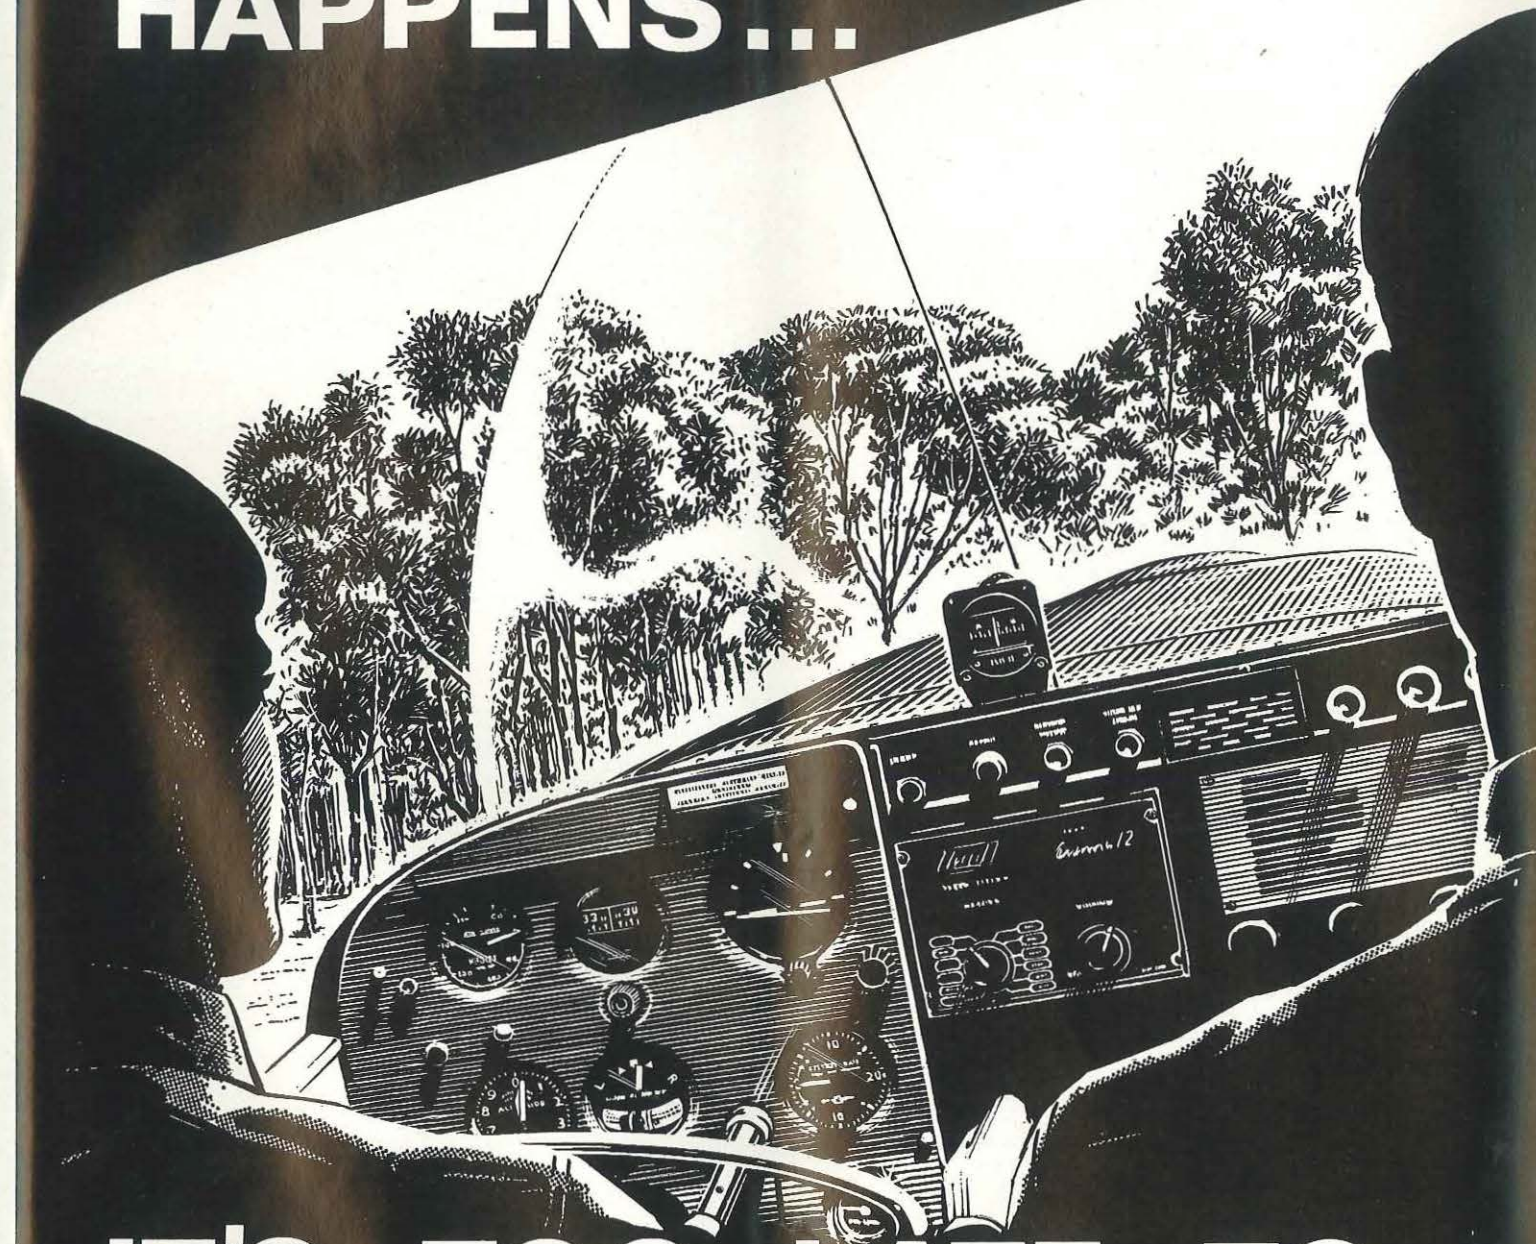
WHEN THIS HAPPENS...

IT'S TOO LATE TO -

- Measure the length of the field.
- Check it against the requirements for authorised landing areas in the V.F.G. and A.I.P.
- Compute the distance required from the performance charts in the aircraft's flight manual.
