DEPARTMENT OF CIVIL AVIATION AUSTRALIA

AVIATION SAFETY DIGEST

No. 59 NOVEMBER 1968

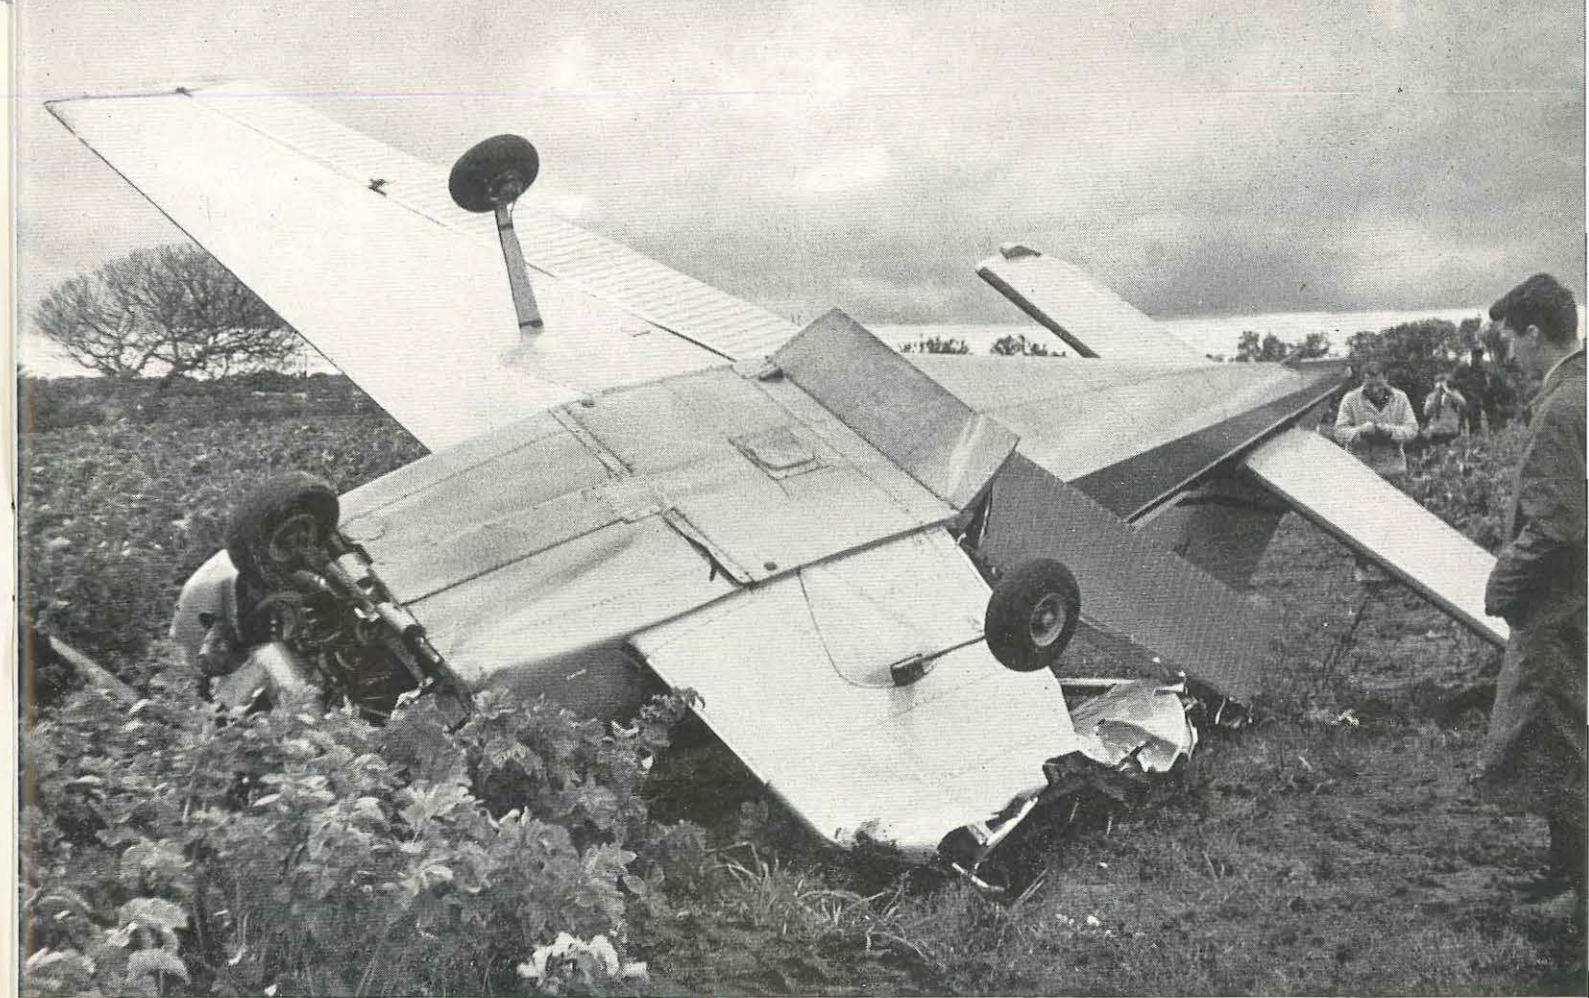
LUCKY ESCAPE IN
MISJUDGED FORCED LANDING

the port wing struck an upper branch and almost immediately the aircraft stalled. As the nose dropped, the aircraft rolled to the right on to its back, then fell upside down into a market garden adjoining the paddock which the pilot had chosen for the forced landing. The main impact was taken on the starboard wing and nose and, although these sections of the aircraft sustained severe damage, much of the impact force was cushioned by the very soft ground of the market garden. As a result the pilot escaped with only minor abrasions.

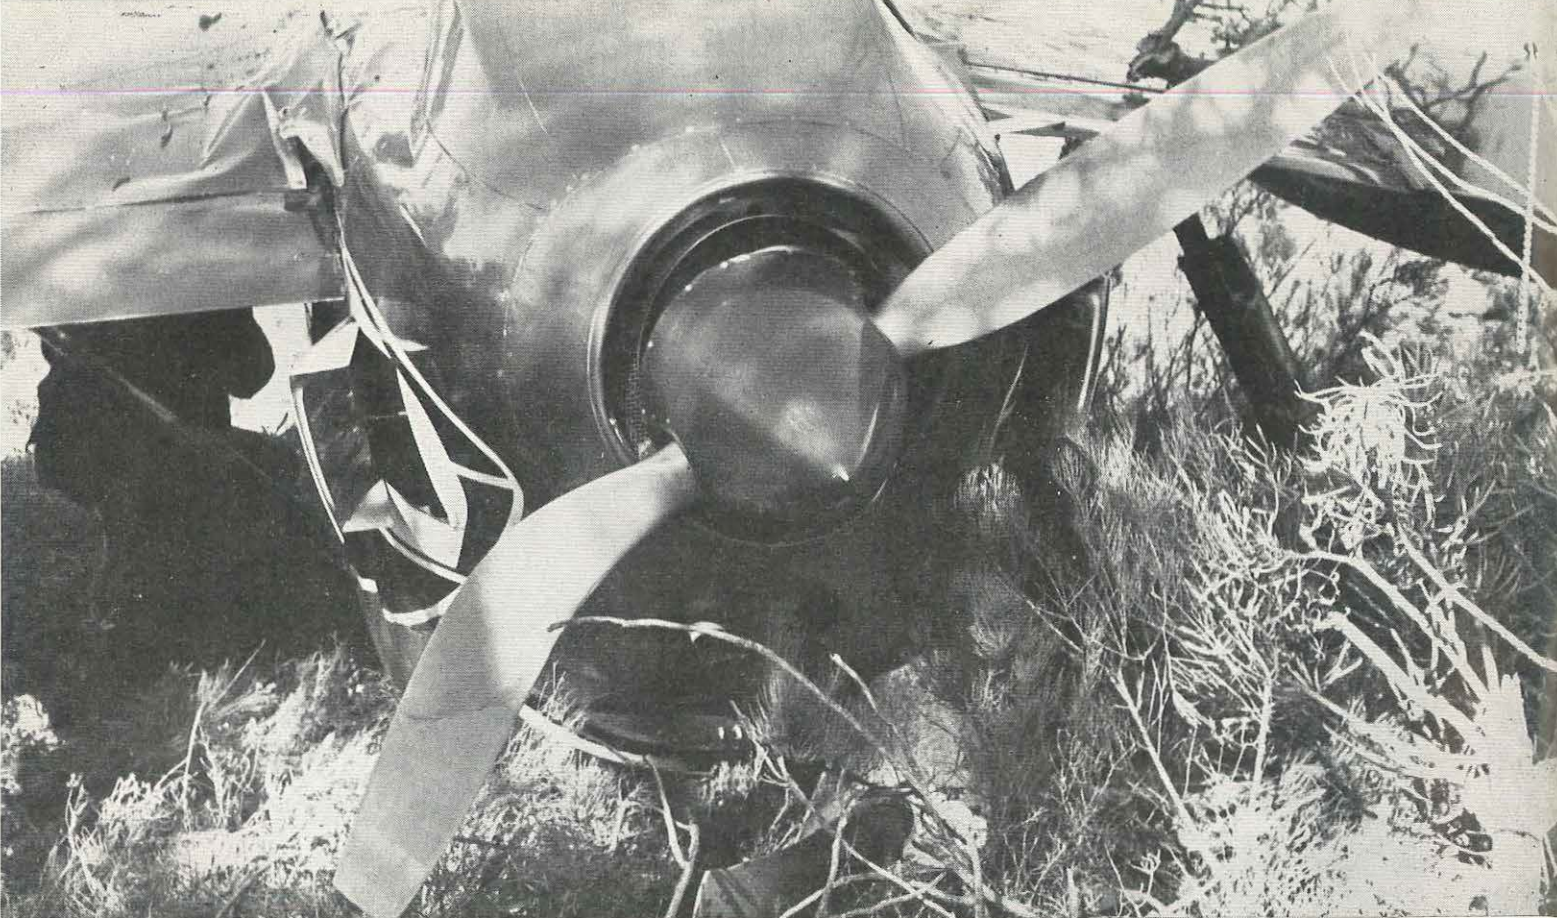
ENGINE FAILURE UNRECOGNISED

the aircraft still losing height, it continued turning until it was over a timbered area adjacent to the aerodrome and heading in a direction almost the reciprocal of take-off. Finally, flying slowly in a pronounced nose-up attitude, with the front engine still developing full power, the aircraft struck the tops of the trees and descended into a scrub-covered, timbered area alongside the aerodrome. The aircraft was damaged beyond repair but the pilot received only minor injuries.

Although the stuck condition of the starboard tank vent valve was not the cause of this accident, the emergency from which it developed would not have occurred if the valve had been functioning properly. The case therefore provides a warning to operators of all aircraft to ensure that vent lines and valves are thoroughly checked for operation and freedom from obstructions at the prescribed inspection intervals.

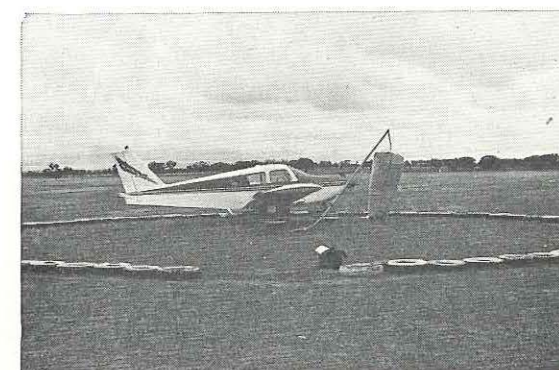
Damage to the leading edge of the wing resulting from the collision with the windsock pole.

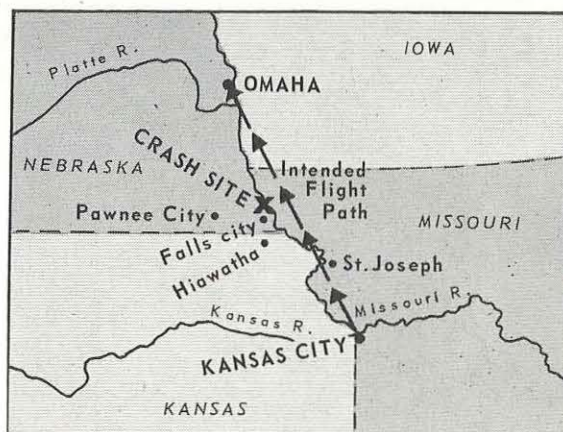
Sketch map showing flight planned route and crash site.

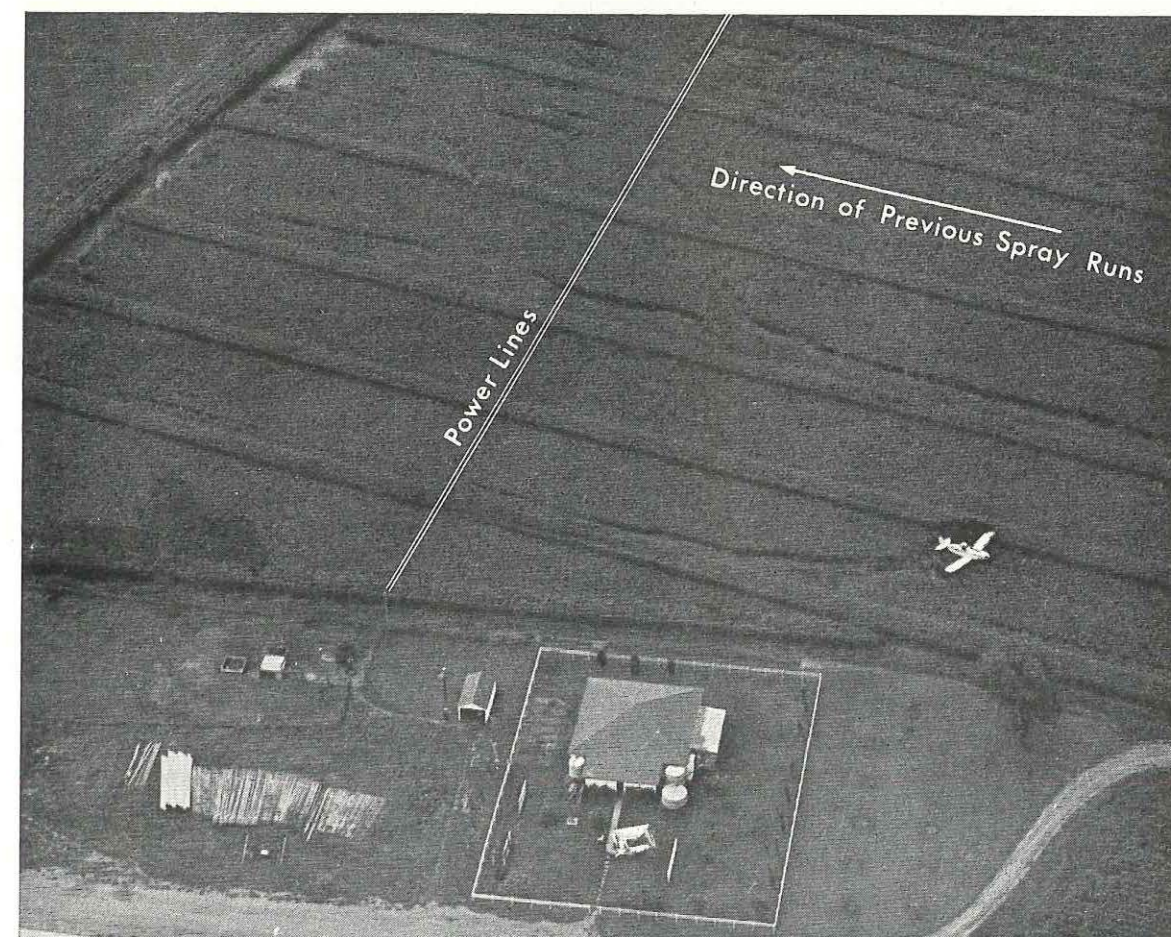
Aerial view of area showing relationship of power lines and sudan grass rows, and the way in which previous runs were flown.
