JANUARY, 1969

SOME PEOPLE NEVER LEARN (and what a way to treat a Tiger!)

Inadequate Undercarriage Maintenance

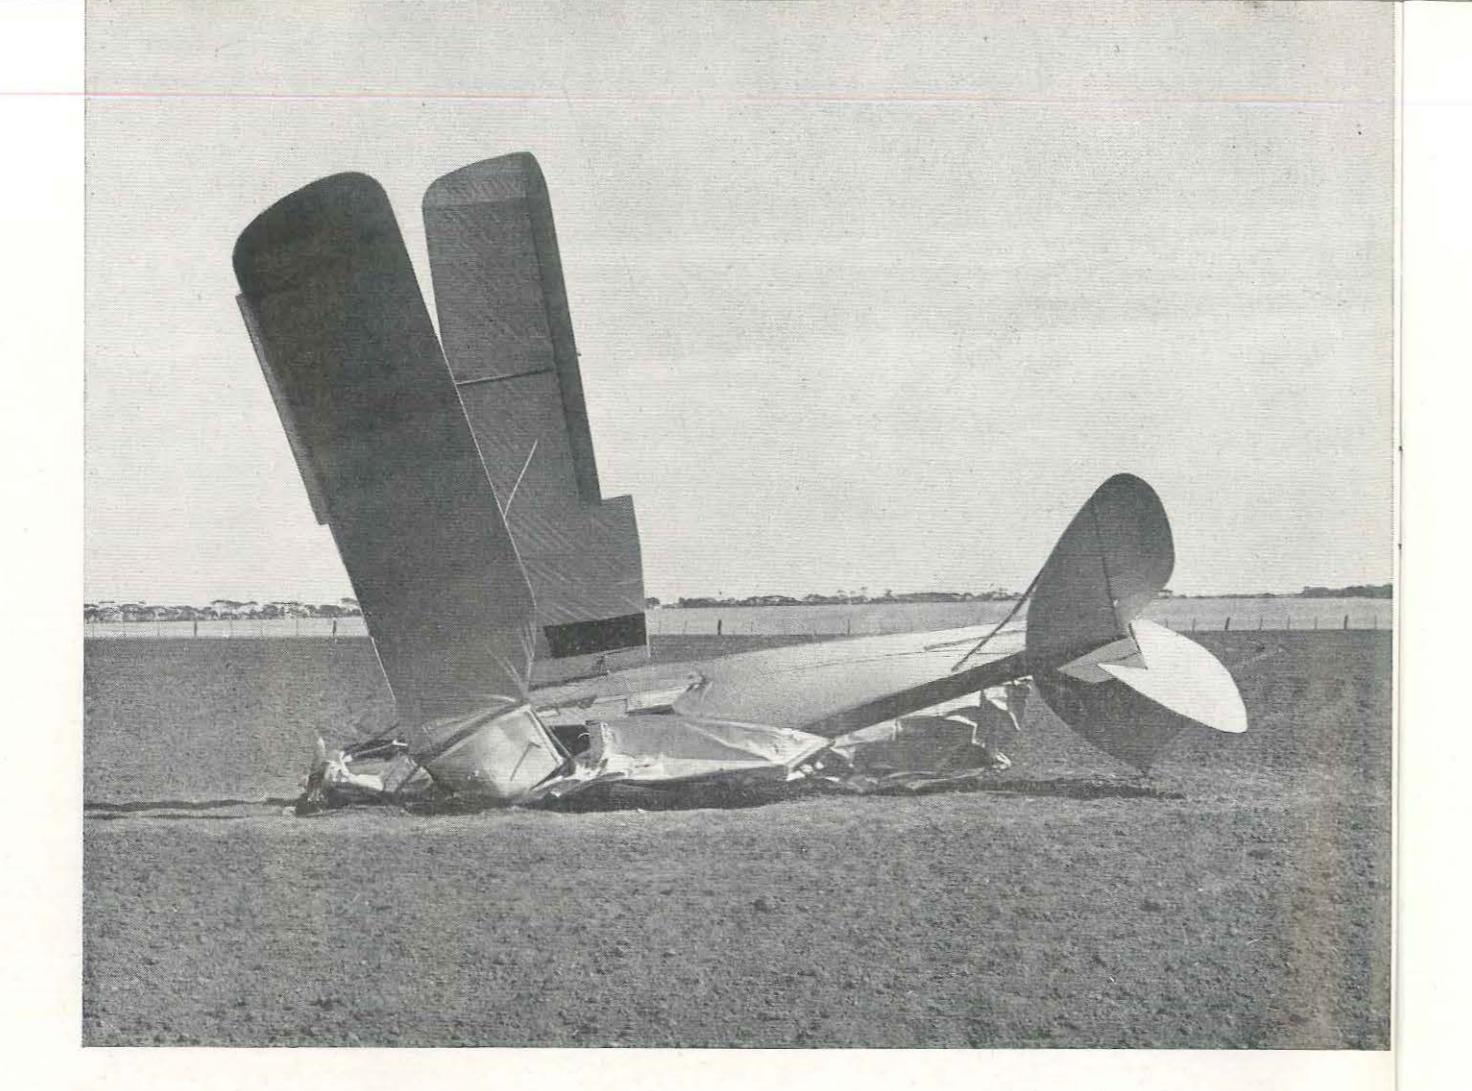
THE pilot of this Tiger Moth, flying solo, was ferrying the aircraft from a town in northern Victoria to a relative's farming property in the same district, a distance of about 12 miles. At the property the pilot planned to clean the aircraft before flying it on to an authorised workshop for a 100-hourly inspection.

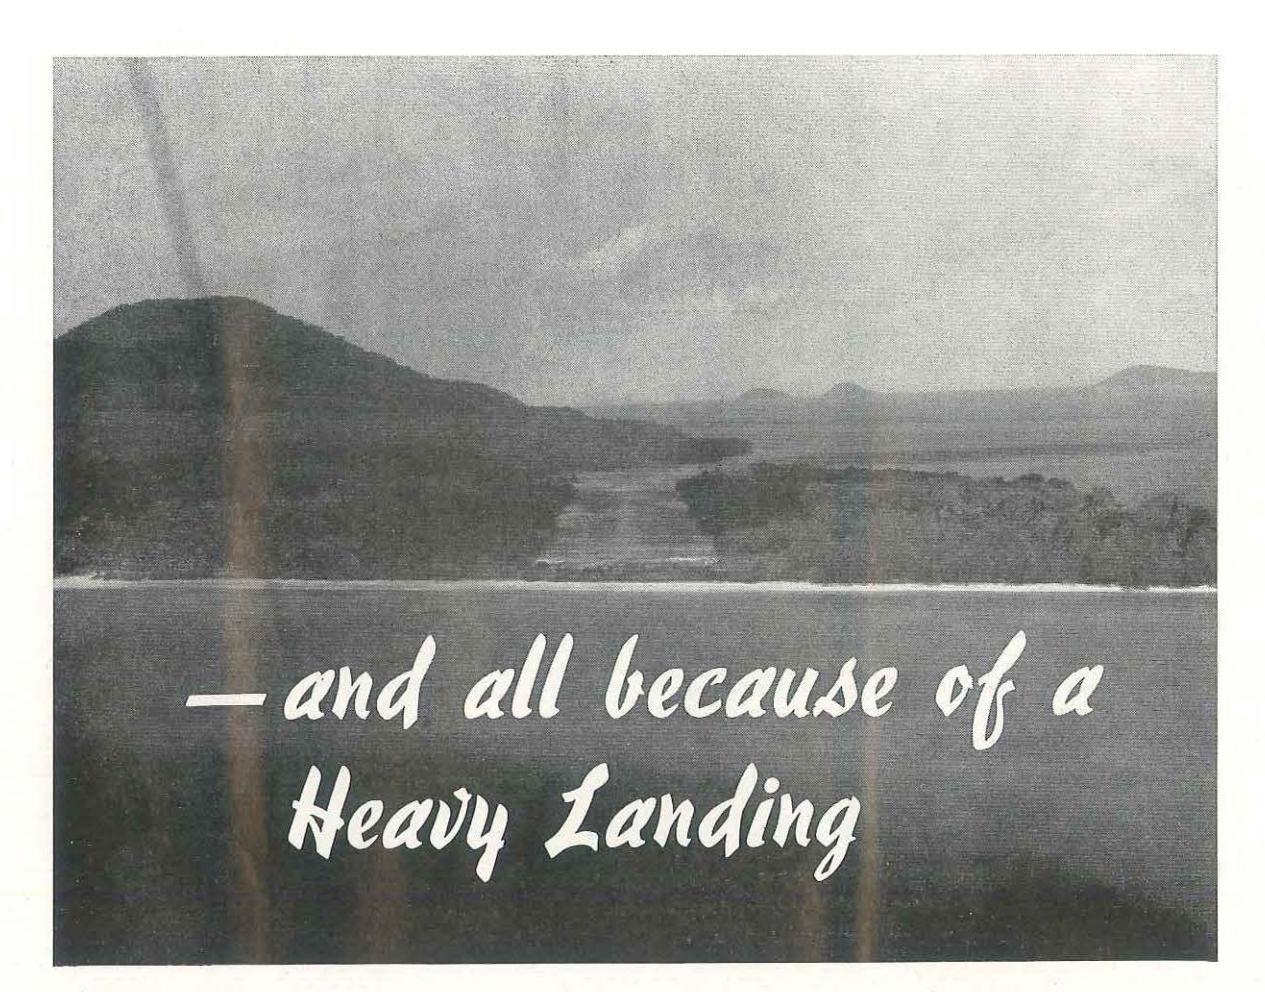
PRIVATE pilot with two friends as passen-A gers, all of whom were from Sydney, New South Wales, were making a holiday tour of the Oueensland coast in a hired Cessna 182.

As the aircraft approached the upwind end of the strip the pilot turned right away from the hills to carry out a circuit over the sea (see aerial photograph). Soon afterwards, while the pilot was still flying directly away from the island, the aircraft suddenly entered a diving turn to the left. The pilot recovered with some difficulty, but then experienced further trouble in maintaining control because of the aircraft's tendency to keep diving to the left. Concluding that one of the ailerons was damaged, and thinking that at any moment he might lose control altogether, the pilot transmitted a MAYDAY call, advising that the aircraft had a damaged aileron, was out of control and was going into the sea five miles north of Dunk Island.

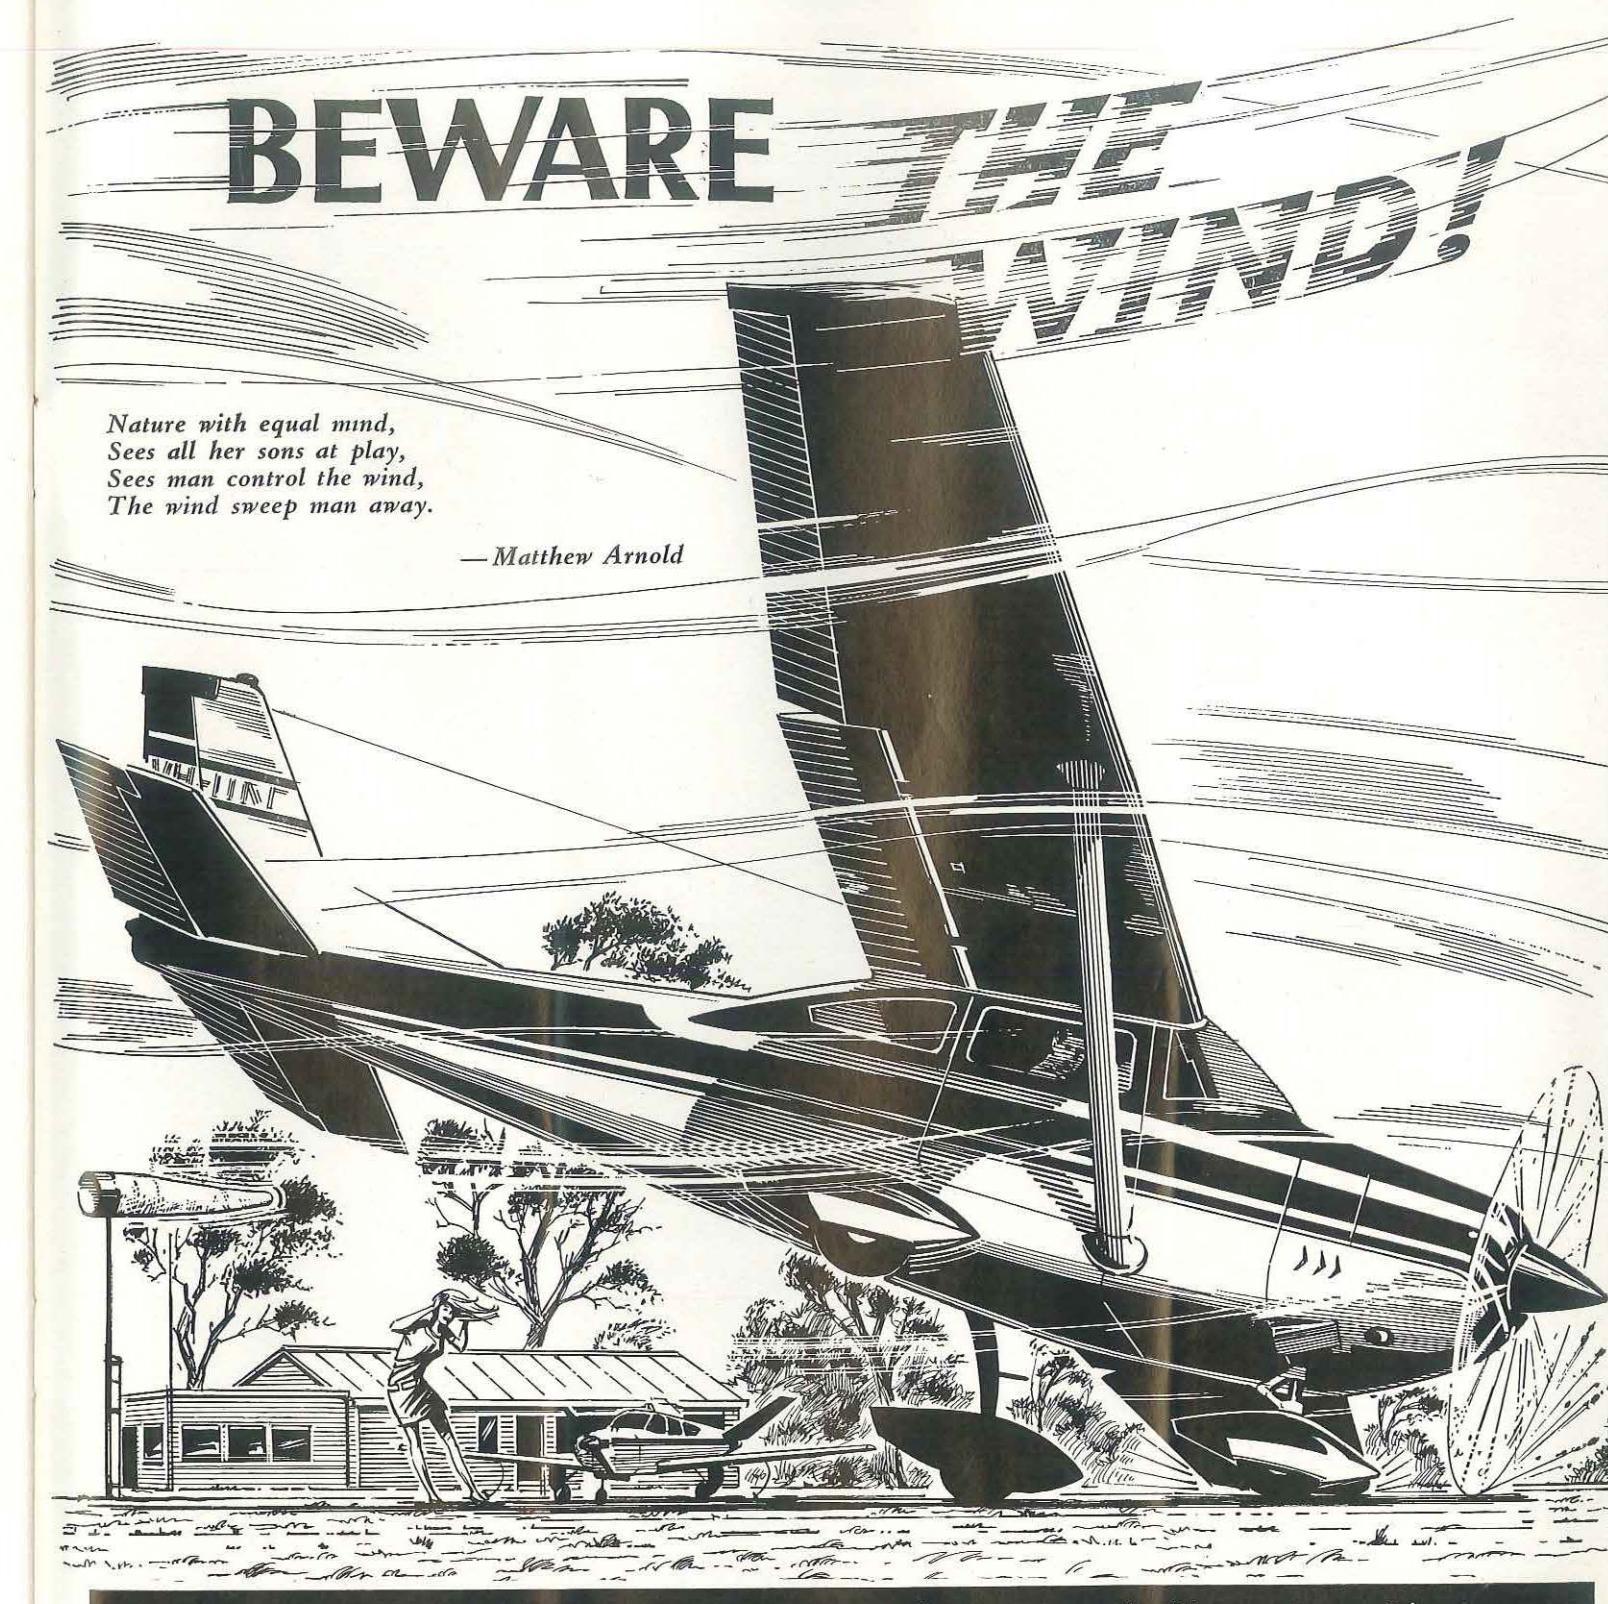
Next time strong winds are forecast, some aircraft are going to be blown over — at least that's what we can expect if statistics are any guide. Within a 10-day period recently, no less than six aircraft were upset by wind while manoeuvring on the ground — all of them incurring damage of varying degrees.

If you HAVE to fly in high wind conditions, make it as easy for yourself as possible. As well as using ailerons and elevators to the best possible advantage while taxi-ing, employ ground handling assistance, especially when turning or taxi-ing crosswind. There are no prizes for doing it all by yourself — particularly if you finish up with your aircraft over on its back!
