# AVIATION SAFETY DIGEST

No. 61 MARCH, 1969  
DEPARTMENT OF CIVIL AVIATION, AUSTRALIA

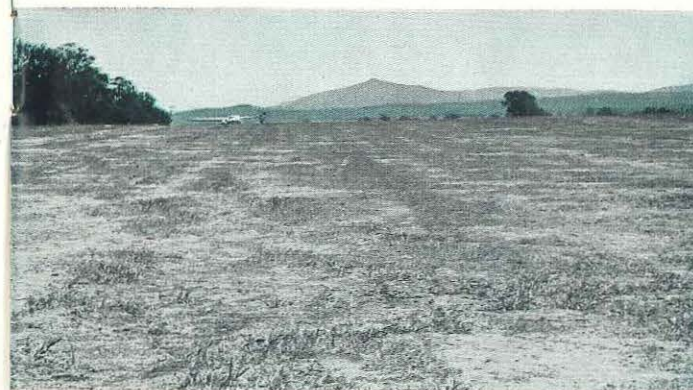
View looking west from the eastern end of the strip. Note the distant background of hills and the way in which the western portion of the strip is hidden by the "hump".

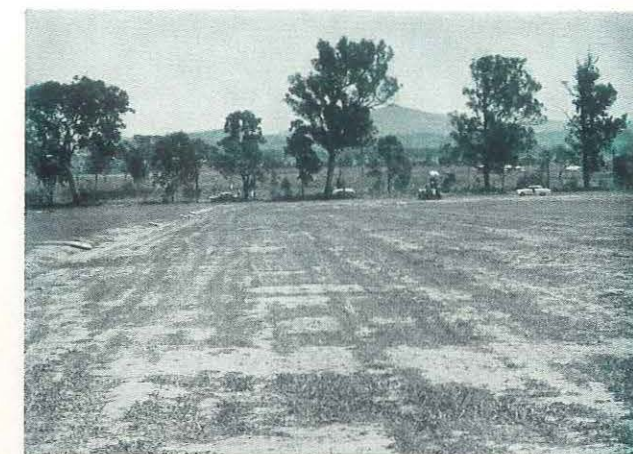
The tall timber at the western end of the strip. The glider launching winch can be seen in the centre of the picture.

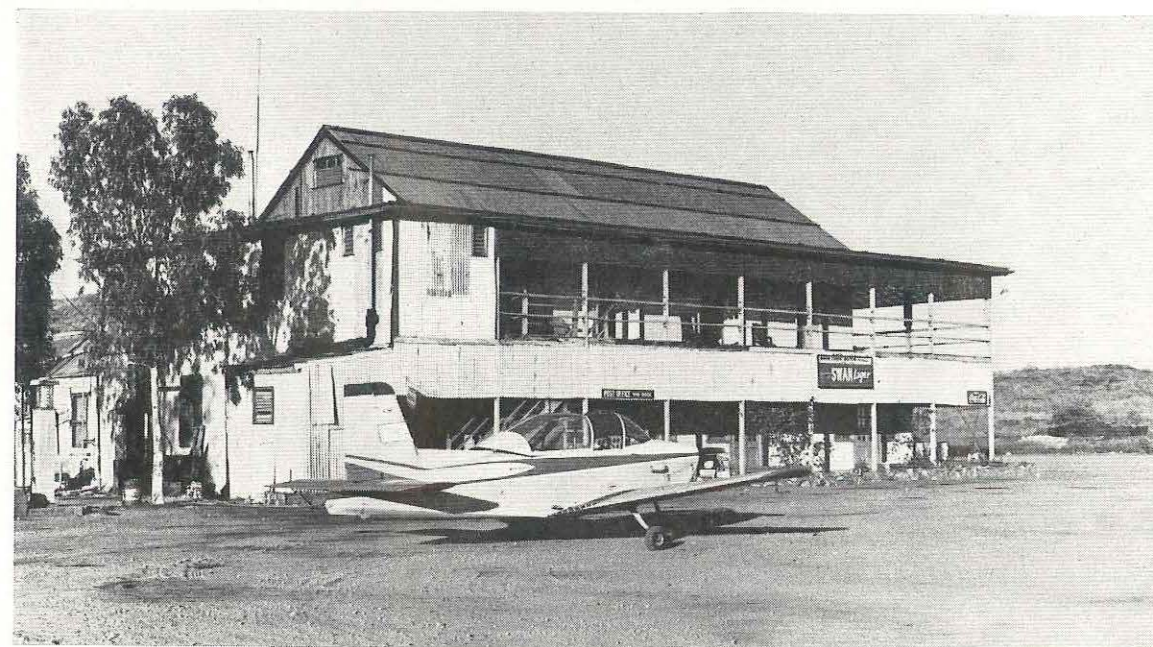
*The other Victa parked in front of the hotel. It was the position of this aircraft that inspired the pilot involved in the accident to attempt his landing on the road.*

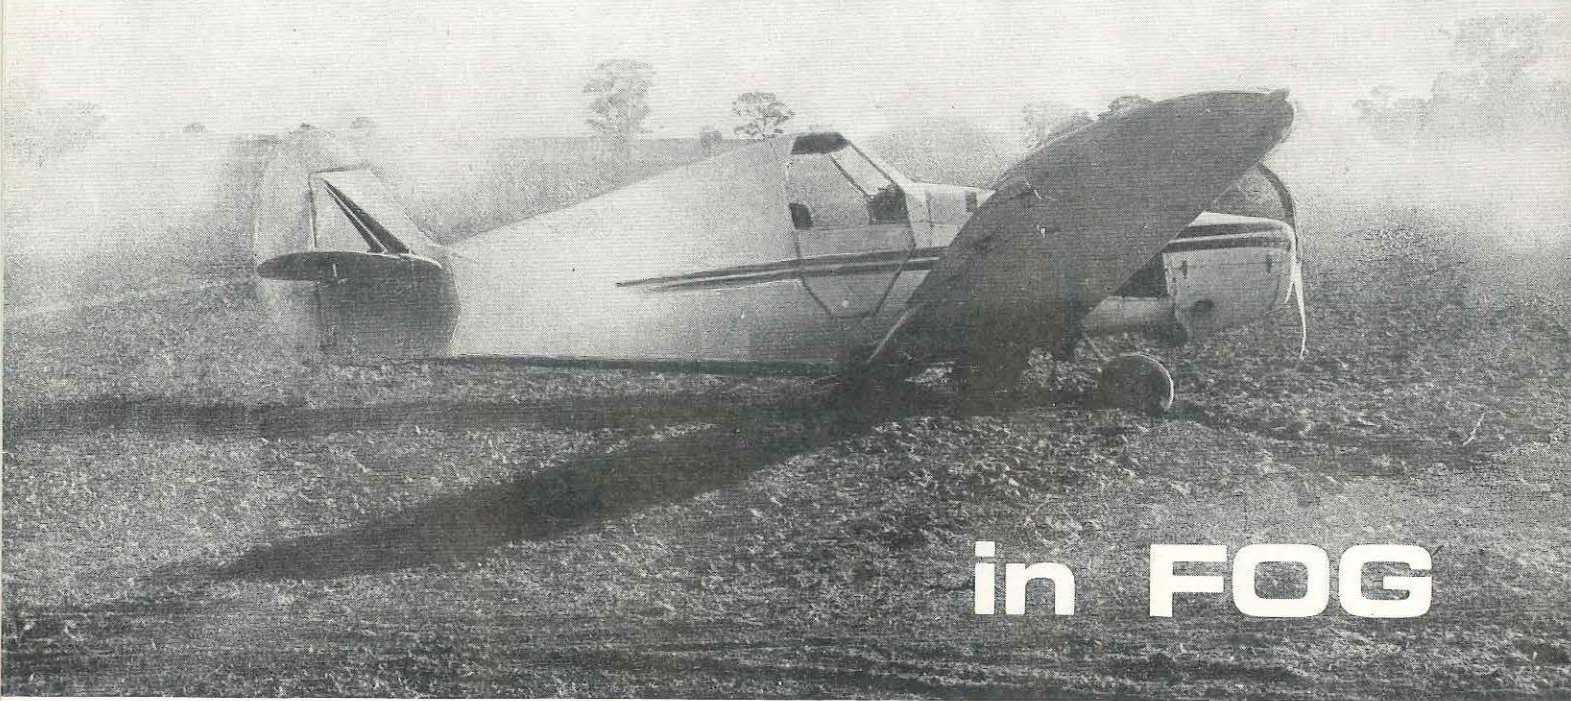
**. . . Unless of course you happen to be the captain of a Hawker Siddeley Trident fitted with the Autoland system!**

This may seem a fairly obvious sort of statement—especially considering the time, money and effort that has been spent overseas developing a system for landing aeroplanes in zero visibility conditions! And so it is. But it is all the more reason for incredulity that an experienced agricultural pilot should not only consider himself capable of landing in fog, but actually try to do it! Needless to say, his attempt was not exactly crowned with success, as the pictures of the Pawnee show.

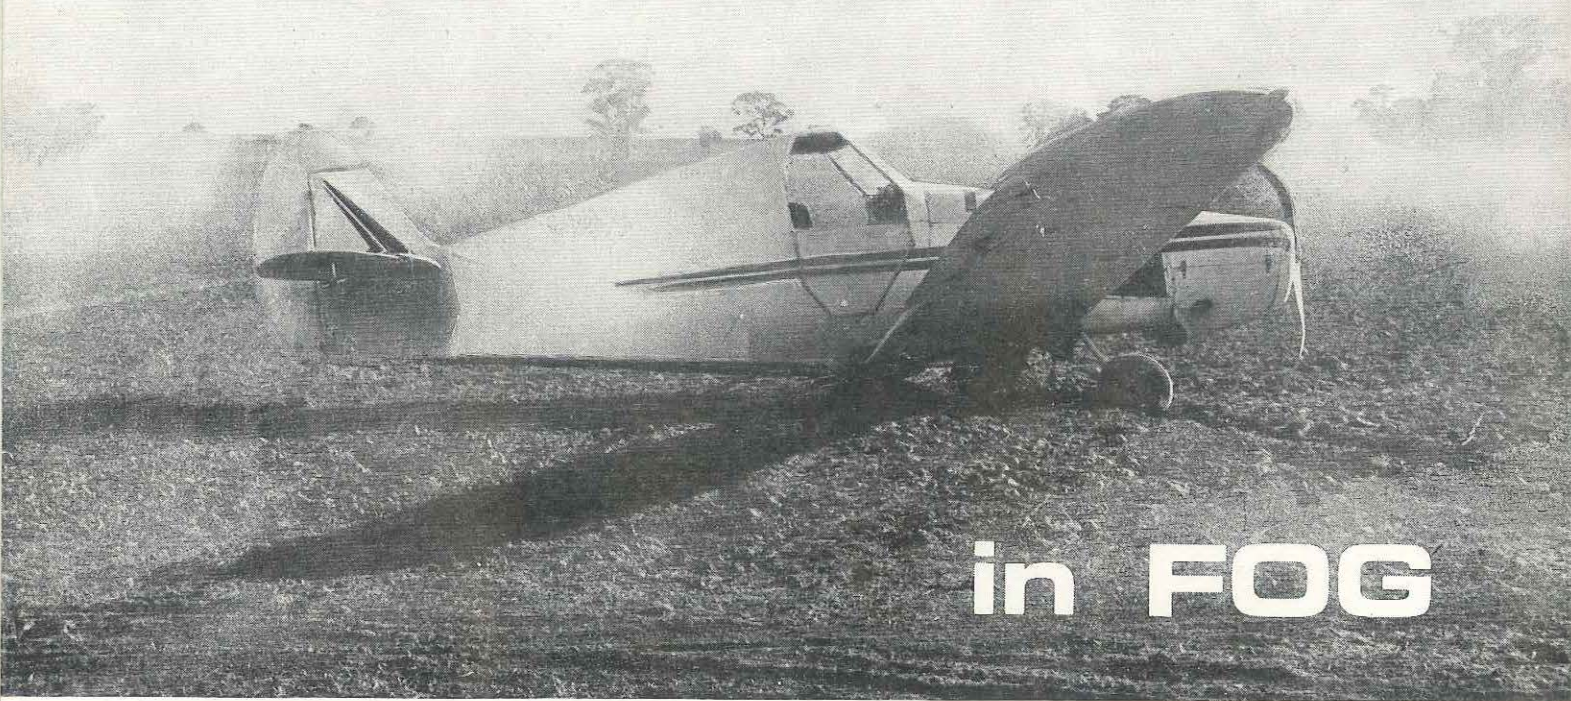
**. . . Unless of course you happen to be the captain of a Hawker Siddeley Trident fitted with the Autoland system!**

This may seem a fairly obvious sort of statement—especially considering the time, money and effort that has been spent overseas developing a system for landing aeroplanes in zero visibility conditions! And so it is. But it is all the more reason for incredulity that an experienced agricultural pilot should not only consider himself capable of landing in fog, but actually try to do it! Needless to say, his attempt was not exactly crowned with success, as the pictures of the Pawnee show.

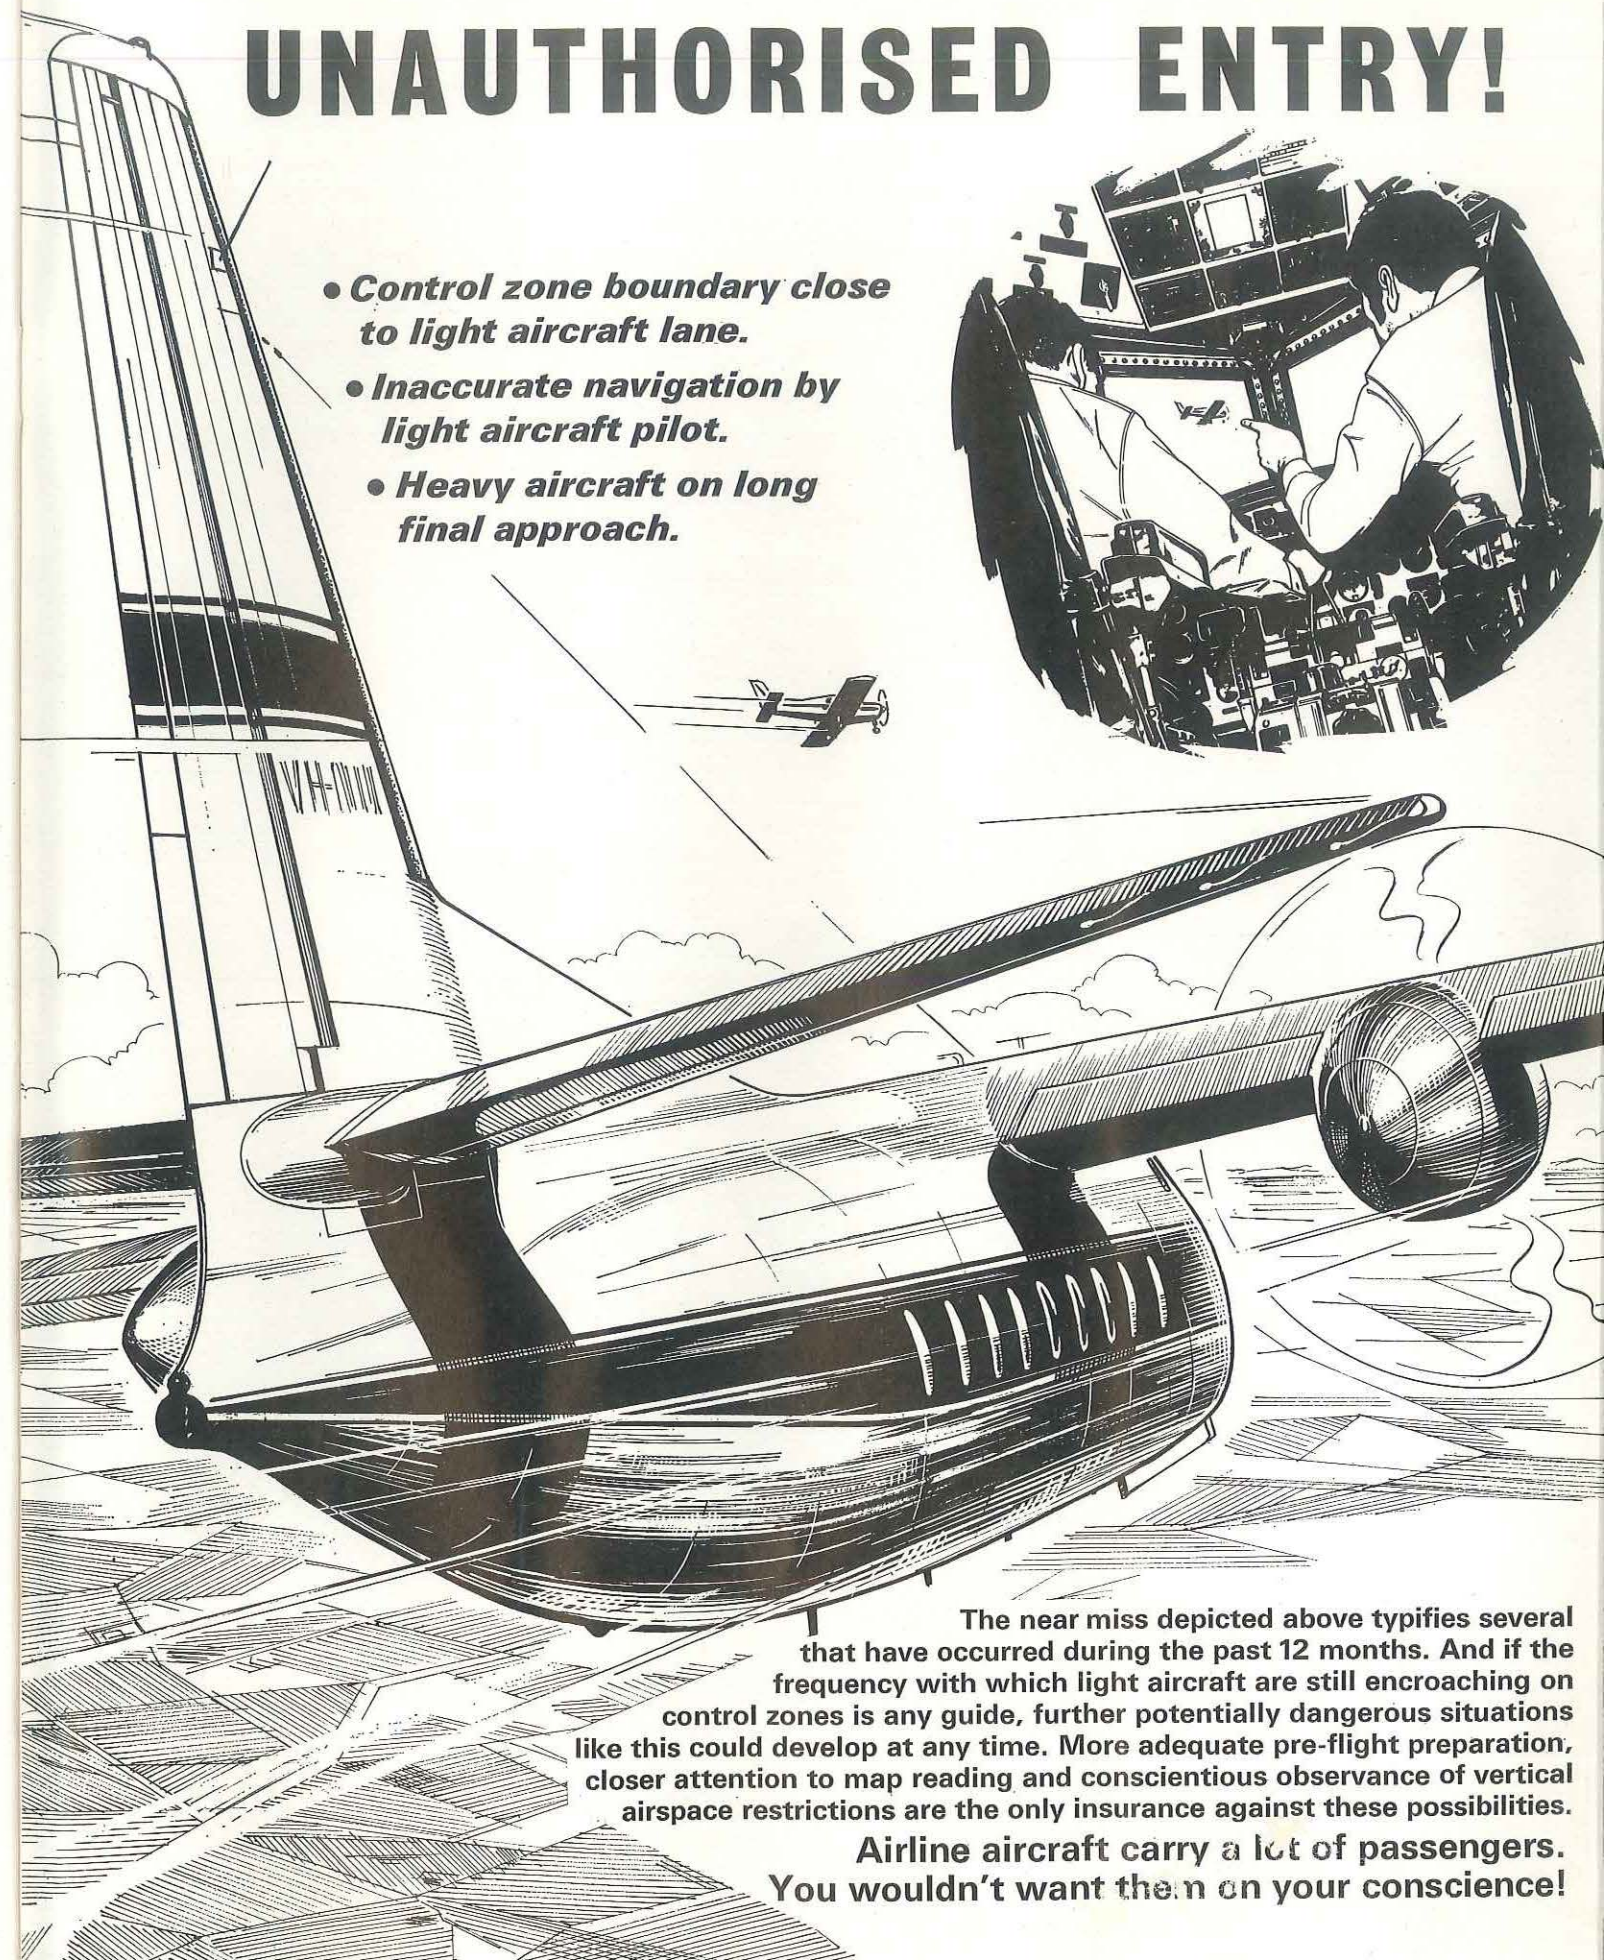
- *Control zone boundary close to light aircraft lane.*
- *Inaccurate navigation by light aircraft pilot.*
- *Heavy aircraft on long final approach.*

The near miss depicted above typifies several that have occurred during the past 12 months. And if the frequency with which light aircraft are still encroaching on control zones is any guide, further potentially dangerous situations like this could develop at any time. More adequate pre-flight preparation, closer attention to map reading and conscientious observance of vertical airspace restrictions are the only insurance against these possibilities.
