No. 62 MAY 1969

AVIATION SAFETY DIGEST

DEPARTMENT OF CIVIL AVIATION AUSTRALIA

FATAL OUT- LANDING

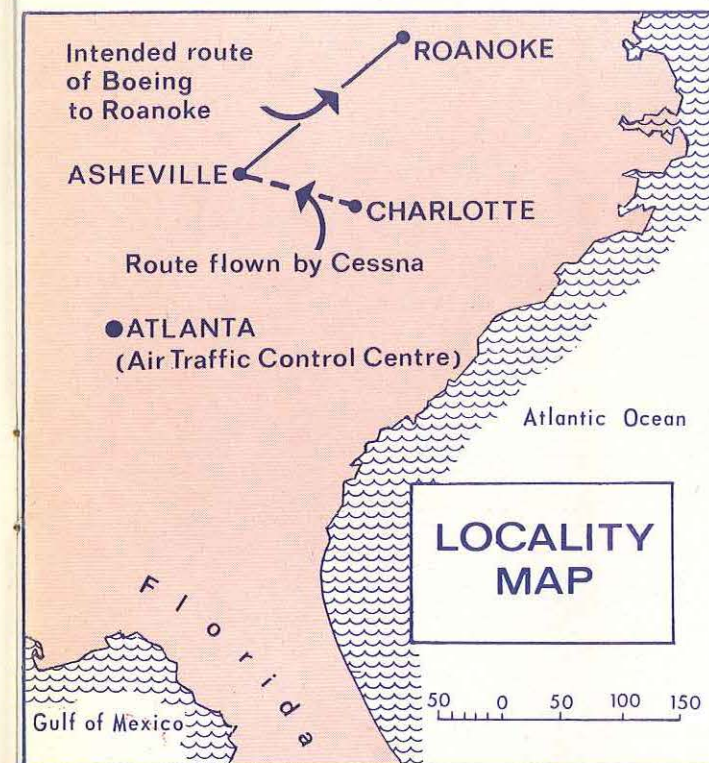
Map showing route flown by Cessna and proposed route of Boeing.

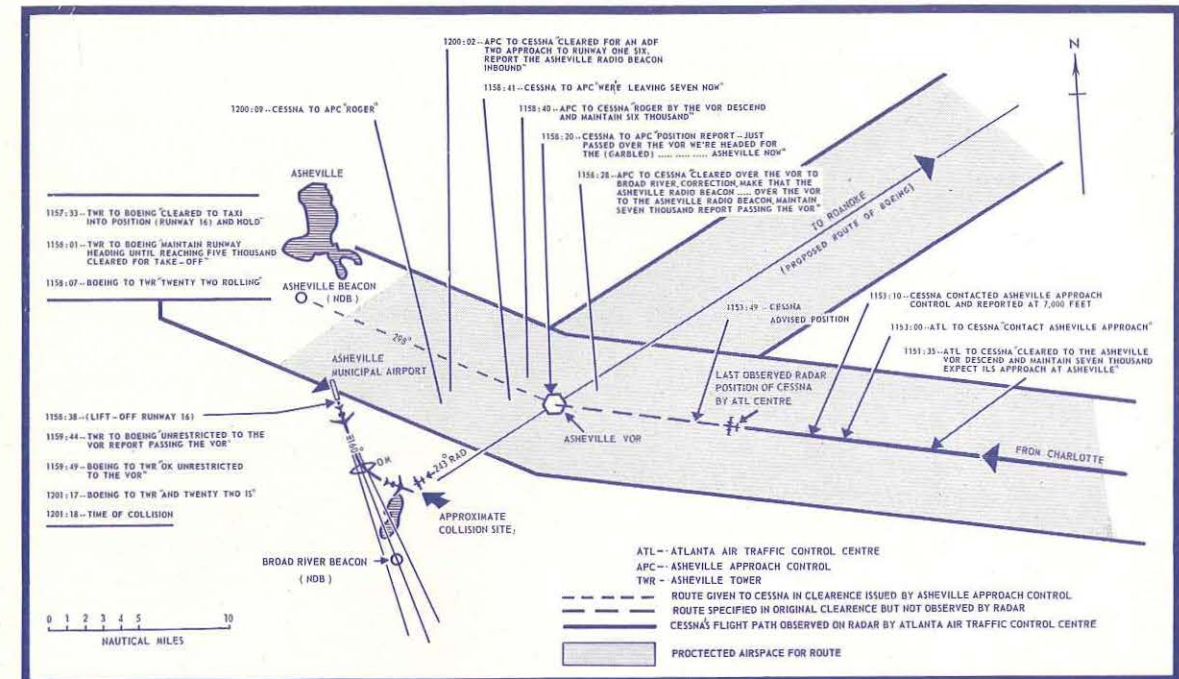
It was clear that the Cessna had failed to comply with the clearance to proceed from the Asheville VOR to the Asheville NDB. The site of the collision, nine miles south-west of the VOR on the 243 degree radial, indicates a flightpath which would

Reproduction of chart prepared during investigation of accident, showing airspace boundaries in vicinity of Asheville, position of radio navigation aids, and flight paths of aircraft to point of collision.

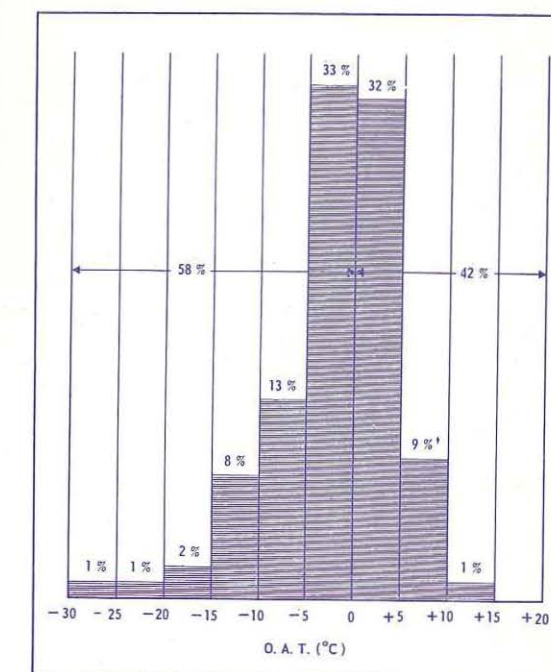
Figures 1 and 2 show the percentage of strikes relative to outside air temperature and altitude respectively and provides meteorological information regarding the most probable temperatures and altitudes for thunderstorms. It is worth noting that several strikes were recorded at altitudes over 20,000 feet and up to 30,000 feet.

Figure 1. Distribution of lightning strikes relative to temperature—Viscount, Vanguard and Comet aircraft.

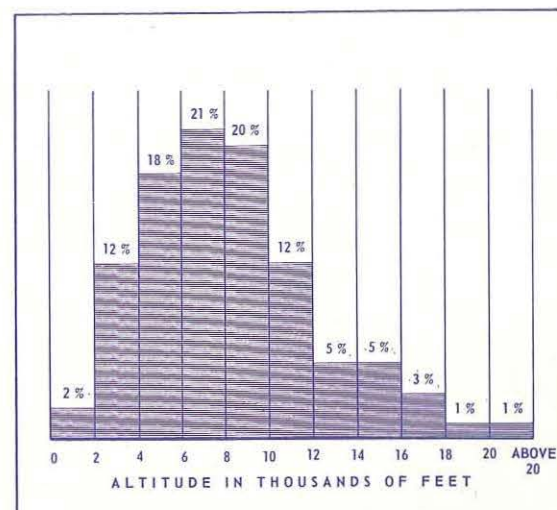
Figure 2. Distribution of lightning strikes relative to altitude—Viscount, Vanguard, Comet, Trident, VC10 and Boeing 707 aircraft.

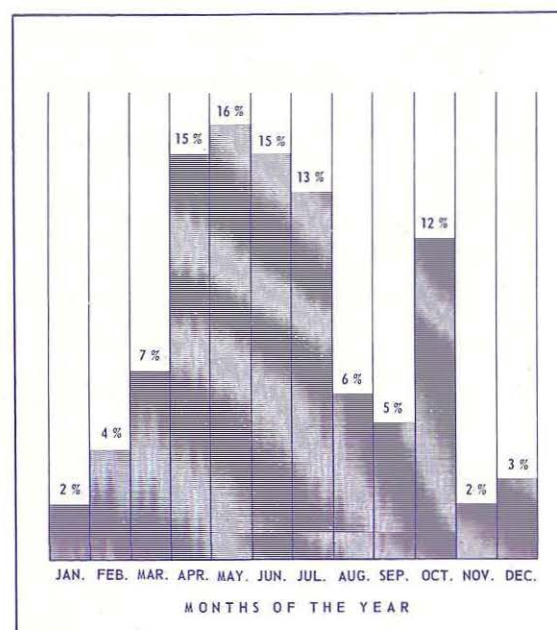
Figure 3 shows, for aircraft operating in Europe, the most probable months of the year for strikes. These percentages have not been corrected to allow for the increased flying hours of the aircraft during the summer months but this correction, if made, does not materially affect the overall pattern. This data therefore also supplies approximate meteorological information on thunderstorm activity over the year.

Figure 3. Occurrence of lightning strikes in Europe, relative to months of year — Viscount, Vanguard, Comet and Trident aircraft.

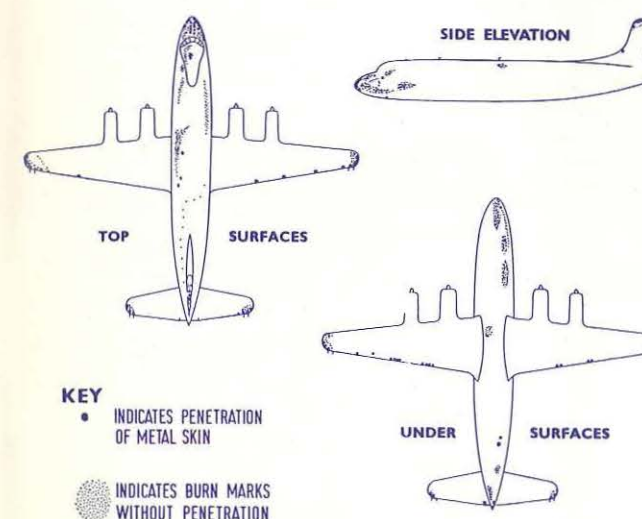
Figure 4. Position of lightning strikes on Viscount aircraft. March 1959 to June 1964.

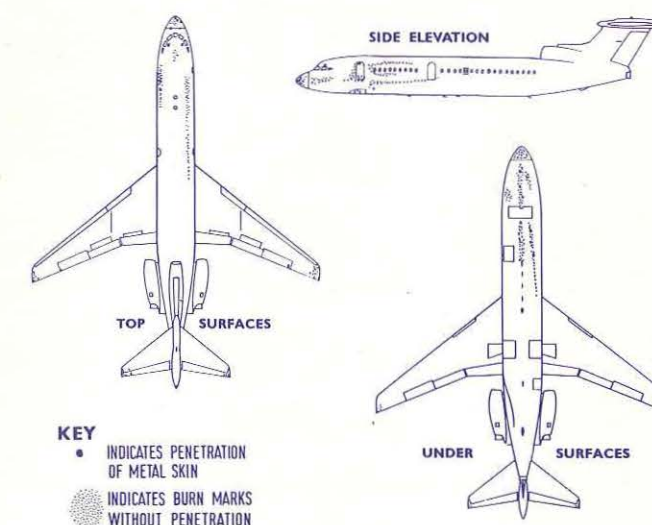
Figure 5. Position of lightning strikes on Trident aircraft. May 1964 to June 1968.

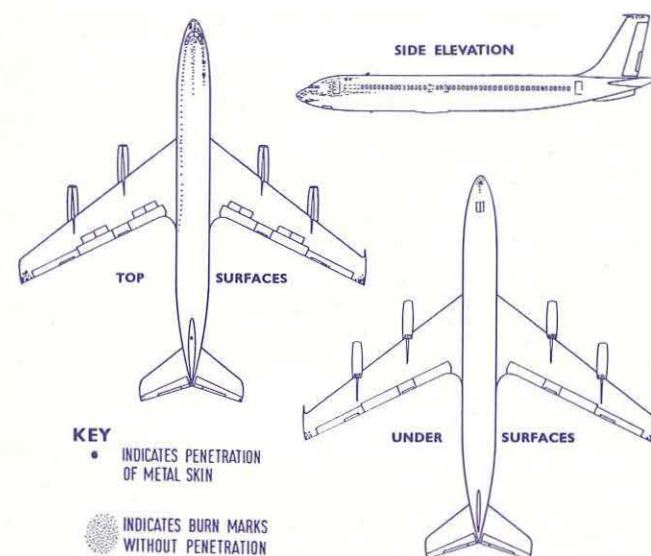
Figure 6. Position of lightning strikes on Boeing 707 aircraft, 1962 to 1967.

The above study of actual strikes shows that a fair proportion of strikes entered or left the aircraft at the trailing edges of the flying control surfaces. Thus, high currents must have passed across the hinge points of these surfaces. In some aircraft, flexible conductors of sufficient size to carry these currents are connected across the bearings. This may not be essential however, since tests carried out in England with peak currents of up to 100,000 amps through various bearings down to
