No. 63 JULY, 1969 DEPARTMENT OF CIVIL AVIATION, AUSTRALIA

THE PRICE IRRESPONSIBILITY

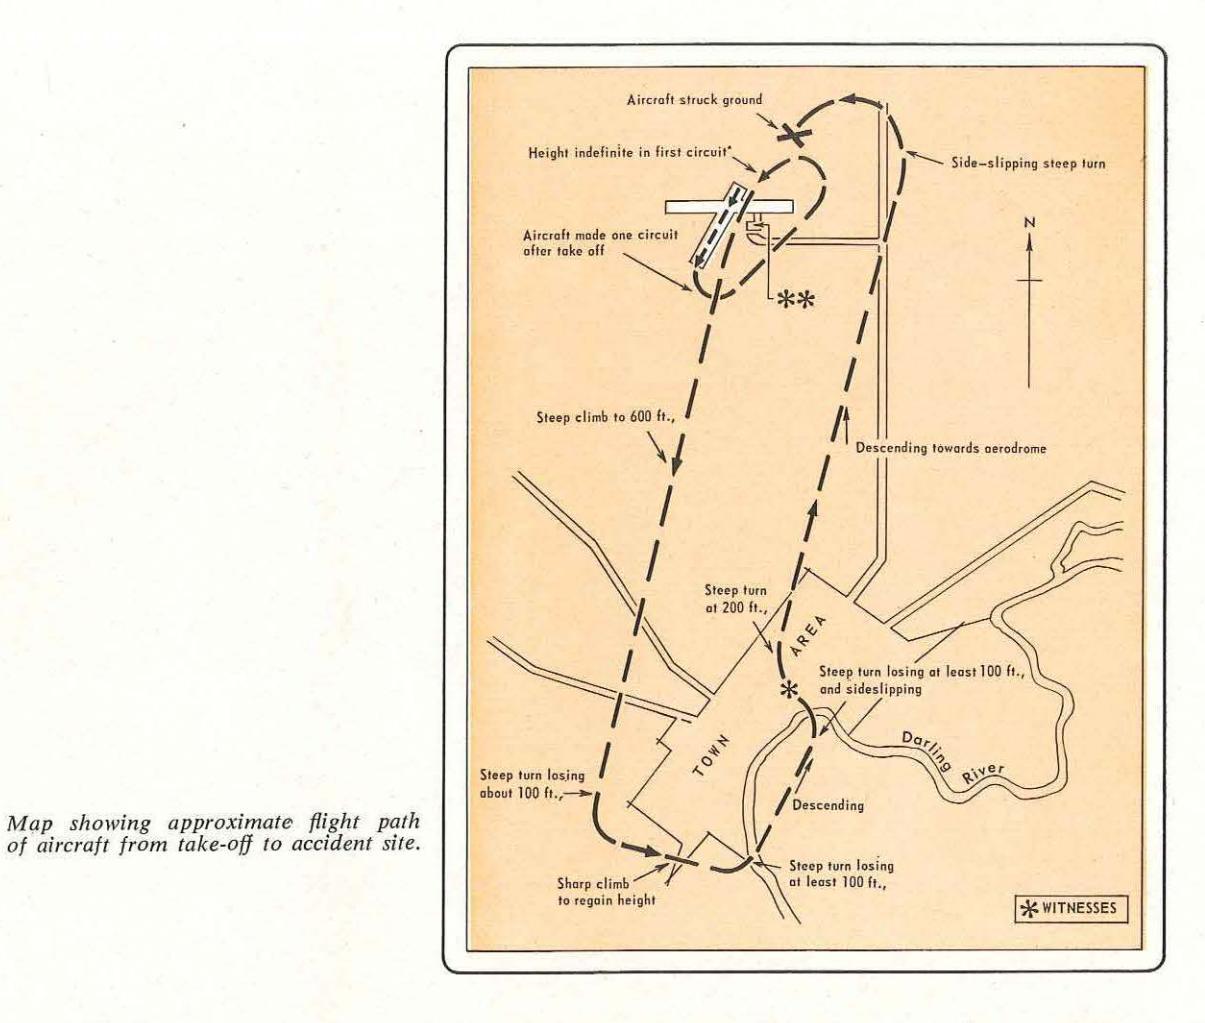
The fact and the circumstances of the "beat-up" of the town together with the behaviour of the aircraft in flight, clearly indicate that the skill and judgment of the pilot were grossly deficient. The aircraft's final manoeuvre in the vicinity of the aerodrome was badly executed, the angle of bank

The cause of the accident was that the pilot-incommand, whose judgment and ability to act in this capacity were impaired by the consumption of alcohol, permitted the aircraft to be operated at an unsafe height by a person whose judgment and capacity were also impaired by the consumption of alcohol.

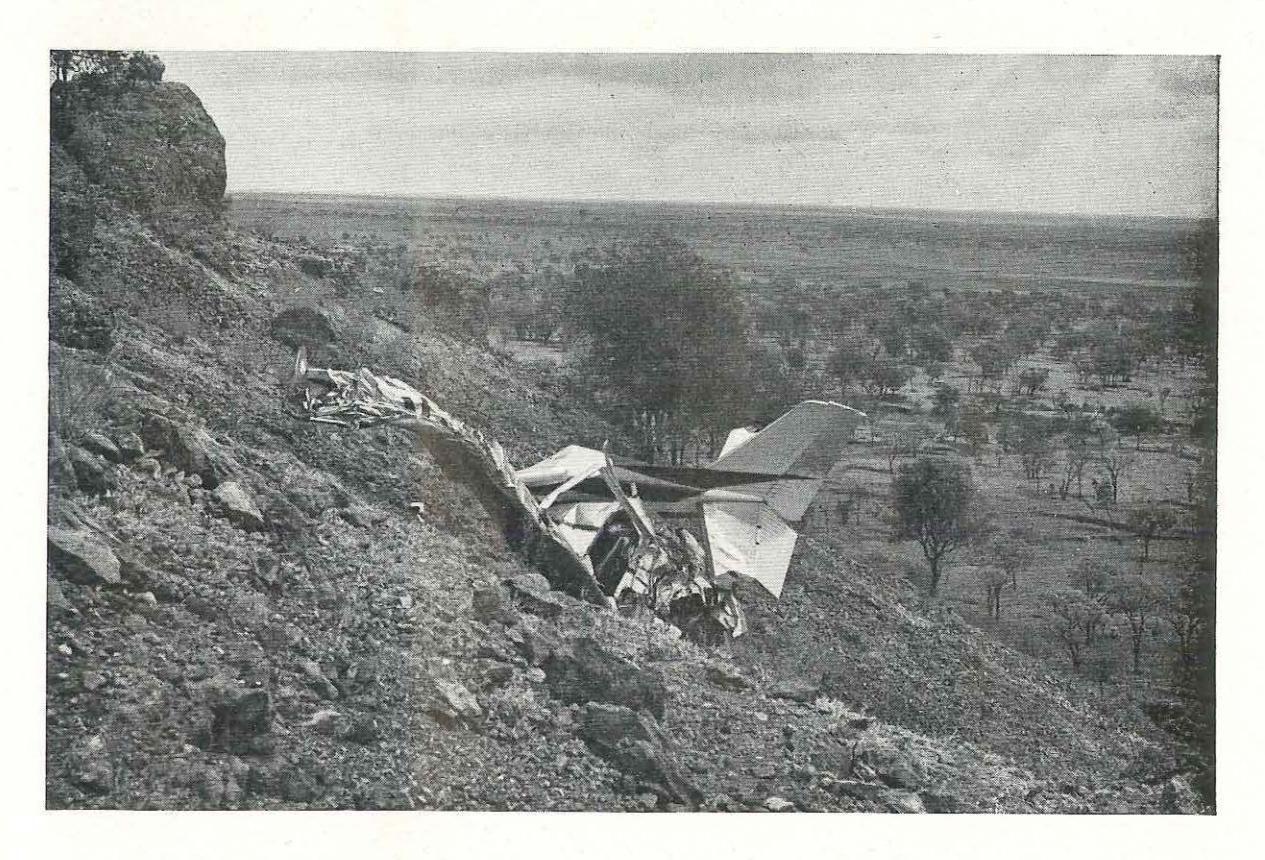
Examination of the wreckage produced no indication of any pre-impact defect having developed in the aircraft which could have contributed to the accident. There was evidence that the engine was developing substantial power when the crash occurred. The disposition of the wreckage and the severity of the damage it sustained indicated that the aircraft was travelling at considerable speed when it collided with the hillside. At impact the aircraft was in a near-level attitude, with 20 degrees of flap lowered.

The cause of the accident was that, while operating at an unsafe height, the pilot, for reasons that have not been determined, failed to detect an obvious obstruction to his intended flight path.

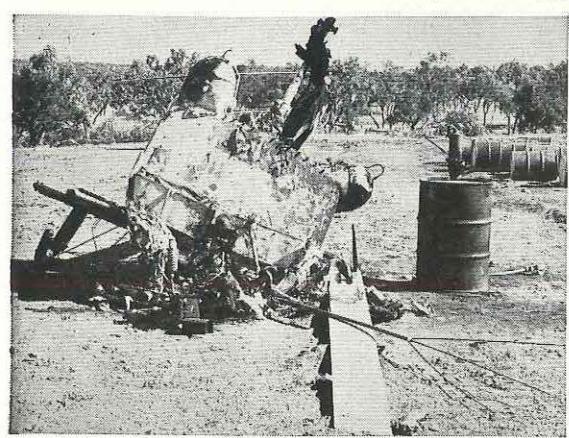
The photographs of the burnt-out Bell 47 tell most of the story. Operating in Western Australia on mineral survey work, the helicopter had been parked at the end of the day's flying, for maintenance and refuelling. Some 40 minutes after the engine had been shut down, by which time it was dark, the pilot and a ground engineer began to refuel the helicopter by torchlight. Using a quart

The actual mechanics of how the fire started is not certain. What is certain is that none of the recommended refuelling procedures were followed. Neither the helicopter nor the refuelling equipment were bonded to earth or even to each other. and the hose was evidently of a type that cannot

The refuelling had just been completed and the engineer, standing on the port side pannier rack, was passing the hose back to the pilot who was standing alongside the helicopter, when the area around the helicopter's undercarriage burst into flames. The flames leapt up waist high and both men had to run through the fire to get clear. Both suffered burns and were admitted to hospital. Neither was able to explain later how the fire started, other than to suggest the possibility of a static discharge from the perspex cockpit bubble or the delivery hose. There was some suggestion that the hose might have been dropped against the structure of the helicopter immediately before the fire started, but the pilot and engineer were not able to remember clearly.

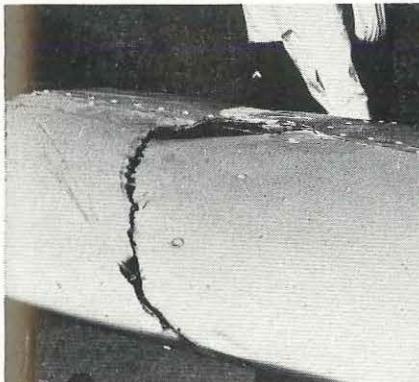
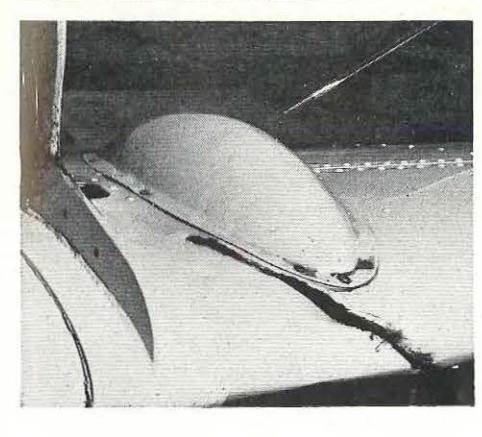
THE Grumman Agcat shown in the picture was engaged in spraying a crop of bananas on a property in hilly country on the north coast of New South Wales. The highly experienced pilot flying the aircraft had treated the same area some weeks before, but had found some difficulty in spraying it downhill. After making one spraying run downhill on this occasion, he decided it would be better to complete the spraying of the area by flying a pattern which followed the contours of the slope.

Approaching for the first contour run, almost at right angles to his previous flight path, the aircraft collided with a pair of steel cables which formed part of a "flying fox" system used to transport bananas from an adjoining field. The wires flattened about a foot of the leading edge of the port upper wing and tore deep, jagged gashes in the leading edge of the starboard lower wing before breaking free, leaving the aircraft trailing two long pieces of wire. The pilot immediately applied full power and despite the retarding effect of the trailing wires which were snagging in the crop, he kept the aircraft under control and lifted it clear.
