No. 64 SEPTEMBER 1969

AVIATION SAFETY DIGEST

No. 64 SEPTEMBER, 1969
DEPARTMENT OF CIVIL AVIATION, AUSTRALIA

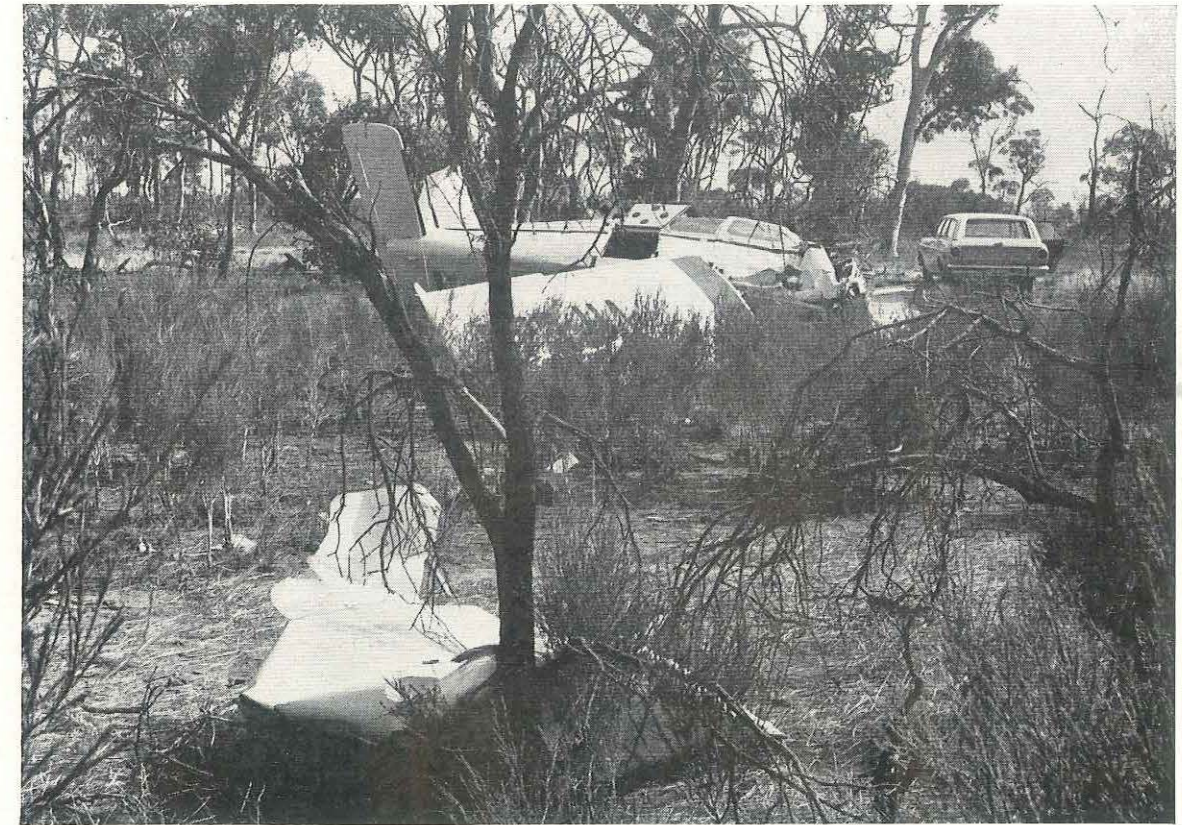
After taking off from a field at Highbury in Western Australia, a Piper Cherokee "Arrow" climbed steeply in an attempt to clear tall trees at the boundary fence. The aircraft cleared the first line of trees, but the port wing then dropped sharply and the aircraft dived into a heavily timbered area. Both front seat occupants were killed and one of the rear passengers sustained serious injuries. The aircraft was destroyed by impact forces.

From a detailed examination of the damaged aircraft and the evidence of witnesses who had observed the take-off, it was clear that there had been no structural or system failure which could have contributed to the accident. Witnesses heard the engine running normally during and after take-off and a workshop inspection subsequently confirmed that it was capable of normal operation immediately prior to the impact. The aircraft had been loaded within the approved weight and centre of gravity limits, although the gross weight at the time of take-off was close to the maximum permitted for the type as specified in the aircraft Flight Manual.

The point where the aircraft left the ground approximately 2,000 feet from the start of the take-off run, is consistent with its expected performance in the existing conditions of high gross weight and a tailwind component. After using such a large portion of the available distance to become airborne, it is apparent that the pilot then attempted to climb the aircraft at reduced airspeed as a natural reaction to his anxiety over the closeness of the trees at the boundary.

The cause of this accident was that the pilot did not ensure that, in the existing conditions, the selected flight path was safely within the performance capabilities of the aircraft. ●

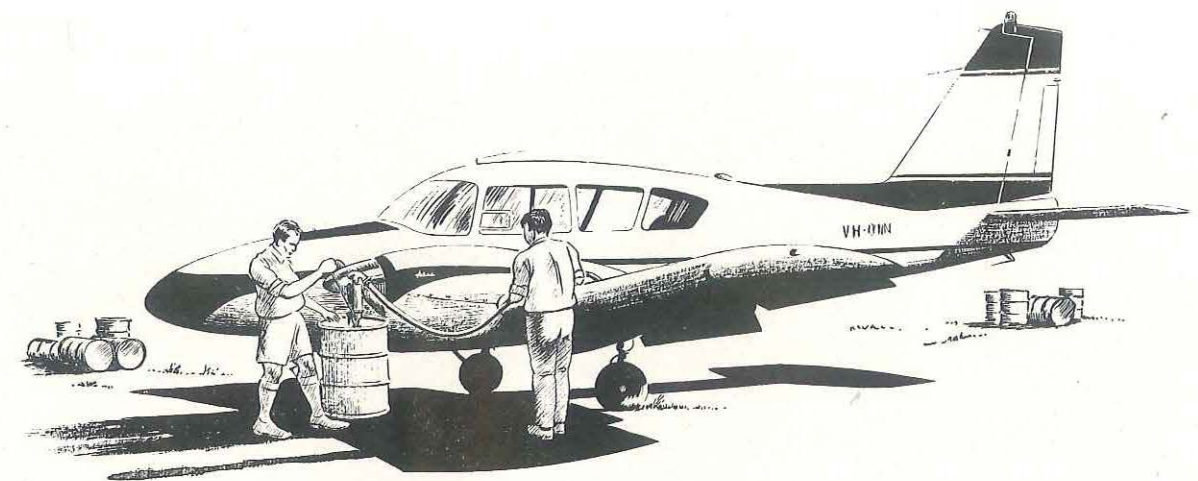
AT Gurney, Papua, a Piper Aztec took off for a flight to Rabaul, New Britain, with a refuelling stop en route at Popondetta. About ten minutes after take-off, the starboard engine began to run roughly. The pilot tried each magneto in turn but the roughness remained. He then noticed that the cylinder head and oil temperature indications for the other engine were rising rapidly. Forced to feather the port engine, the pilot diverted towards Raba Raba, ten minutes' flying time away. By this time the oil temperature for the starboard engine was also rising and despite a reduction in power and the use of full rich mixture, the starboard oil temperature was "in the red" by the time the aircraft entered the Raba Raba circuit area. The pilot nevertheless made a successful single-engine landing.

When the aircraft was inspected by a company engineer at Raba Raba, it was found that the fuel in the aircraft's tanks was contaminated with aviation turbine kerosene. Further enquiries revealed that before taking off from Gurney, the pilot of the Aztec, with the assistance of another professional pilot, had refuelled the aircraft from drums, not noticing that the drums were branded "Avtur" and not "Avgas". The pilots ascribed their error to the fact that the drums, supplied by a different oil company from the one they were accustomed to, were painted the same colour as the Avgas drums the pilots normally used.

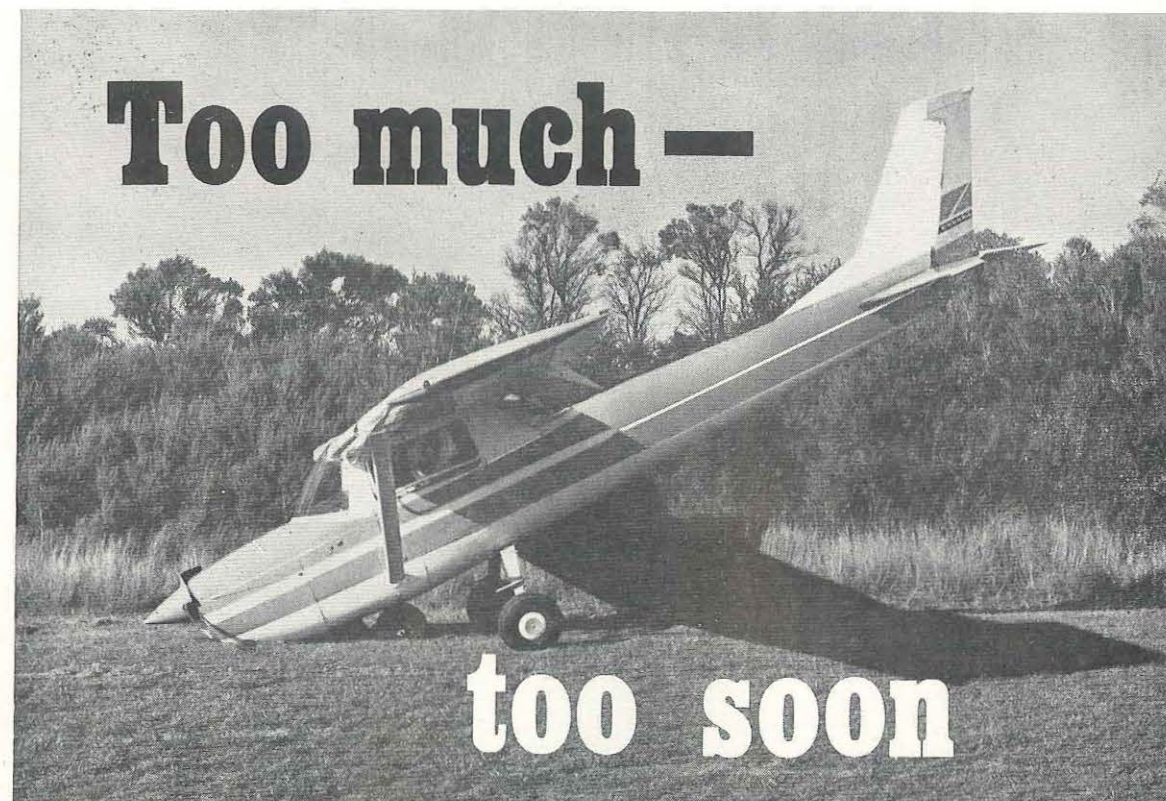
A STUDENT pilot making his second solo flight was attempting to land this Cessna 150 when he got into difficulties. He had carried out a satisfactory circuit and made the final portion of the approach with full flap and the throttle closed. The aircraft rounded out at a normal height, but then ballooned to about ten feet above the ground. The student continued to hold off at this height until the aircraft stalled and it landed heavily, nose-wheel first. It ran for about 70 feet, then the nose leg collapsed, and the aircraft skidded to a halt on its nose 35 feet farther on.

At the time of the accident, the student's total aeronautical experience amounted to only seven hours. He had flown five hours thirty-five minutes up to the day of the accident, all of it on the Cessna 150, and of this time, one hour ten minutes had been spent on circuits and landings.

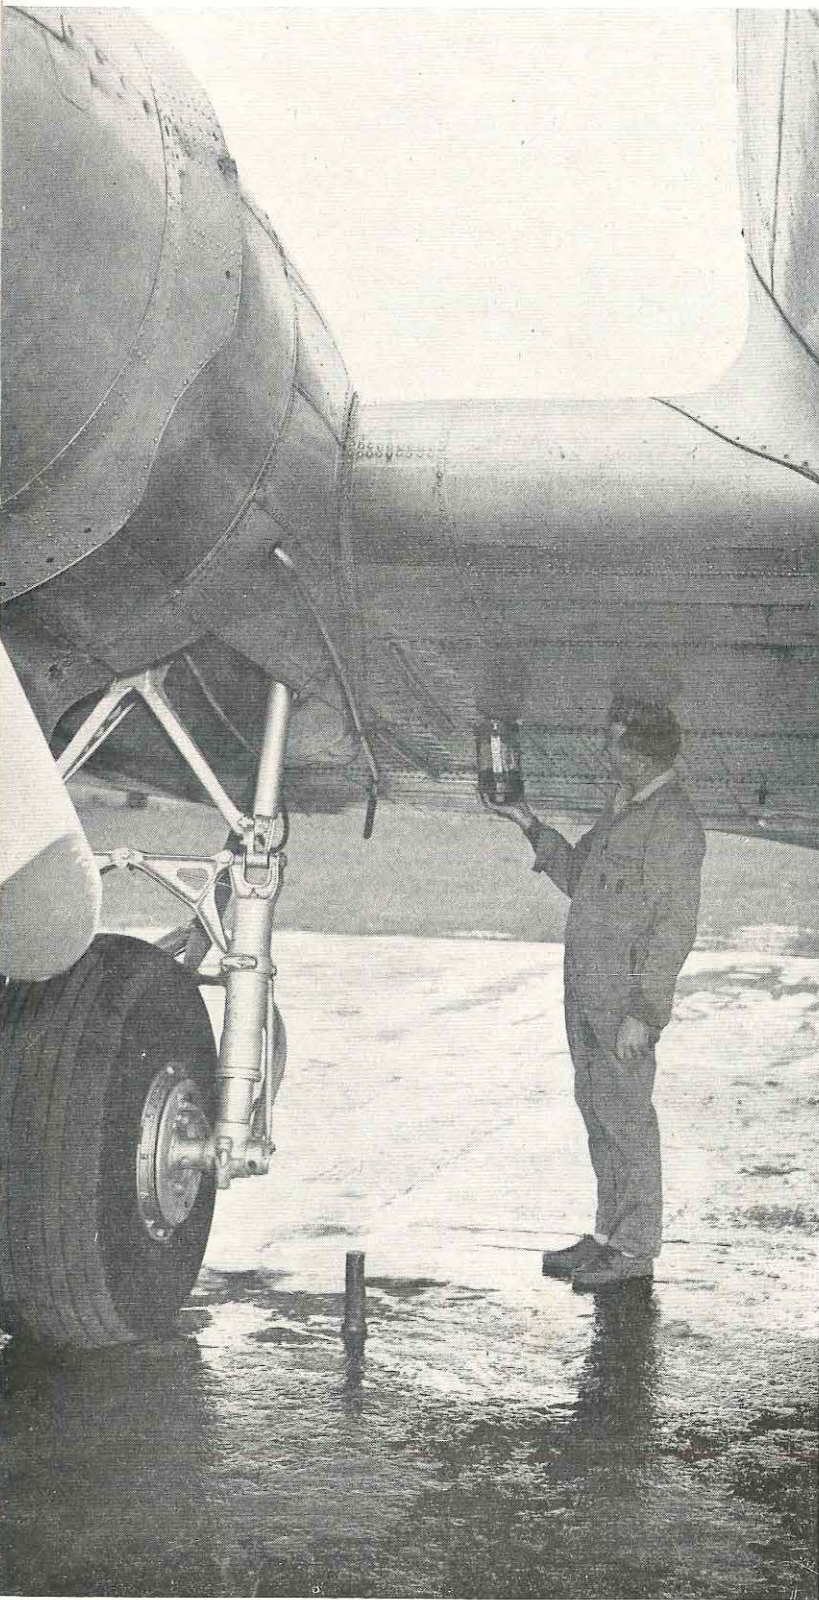
JUST before starting the engines for a flight from Lae to Mt. Hagen, New Guinea, the captain of a DC-3 decided to request an additional water check from all fuel tank drain points. A fuel sample, which had already been taken and left beside the aircraft, was clear but as the DC-3 had been standing in the open in heavy rain for a number of hours, the captain decided to "play safe".
