No. 66 JANUARY 1970

# AVIATION SAFETY DIGEST

DEPARTMENT OF CIVIL AVIATION AUSTRALIA

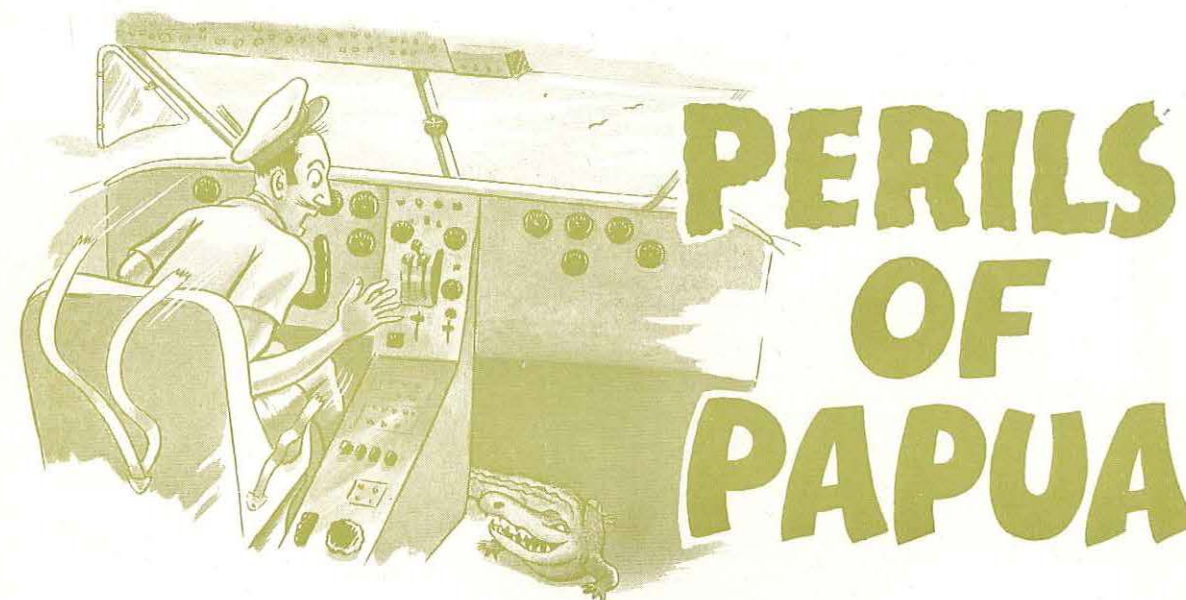
WE always knew that flying in Papua-New Guinea is a somewhat more adventurous way of earning one's living than flying sedately around the mainland—as witness the article on page 16. But perhaps we didn't appreciate the full extent of the hazards involved—at least not until this incident report from the pilot of a Short Skyvan, arrived on the Editorial Desk:

"Shortly after departing from Kerema for Mendi, a movement under the instrument panel caught my eye. Bending down, I looked into the space forward of the rudder pedals and discovered a live crocodile approximately three feet long. I decided to return to Kerema and off-load as it was not on the manifest. This was done and the flight proceeded without further incident."

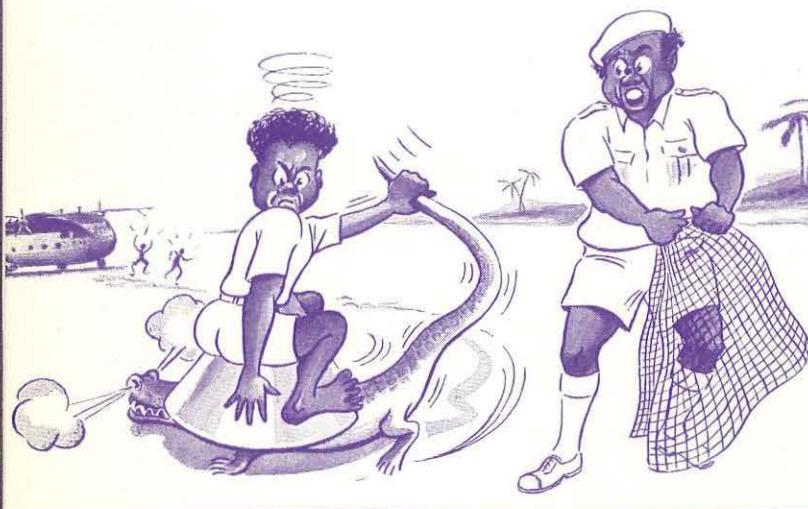
About this time a native labourer was unfortunate enough to arrive on the scene. Exhibiting a commendable willingness to delegate authority, the policeman thrust him into the aircraft with instructions to remove the reptile, together with any others he found present. After viewing the culprit the labourer also decided it would best be left alone and made to vacate the aircraft. By this time however, the pilot had positioned himself at one door and the policeman at the other, and indicated to the labourer that he would not be allowed to leave unaccompanied. Eventually the reluctant hero grabbed the crocodile by the tail and was then permitted to leap out the door. But

in doing so he lost his grip, and the crocodile fell to the ground where it commenced to show its displeasure at the treatment it was receiving by hissing and snapping at anything within reach. After a battle of wits the reptile was finally recaptured when the pilot managed to drop a cone marker over its head, and then had his unwilling assistant sit upon the marker to prevent the victim escaping. This did nothing to improve the crocodile's temper but by this time help was at hand, and soon afterwards the escapee was safely in custody once more.

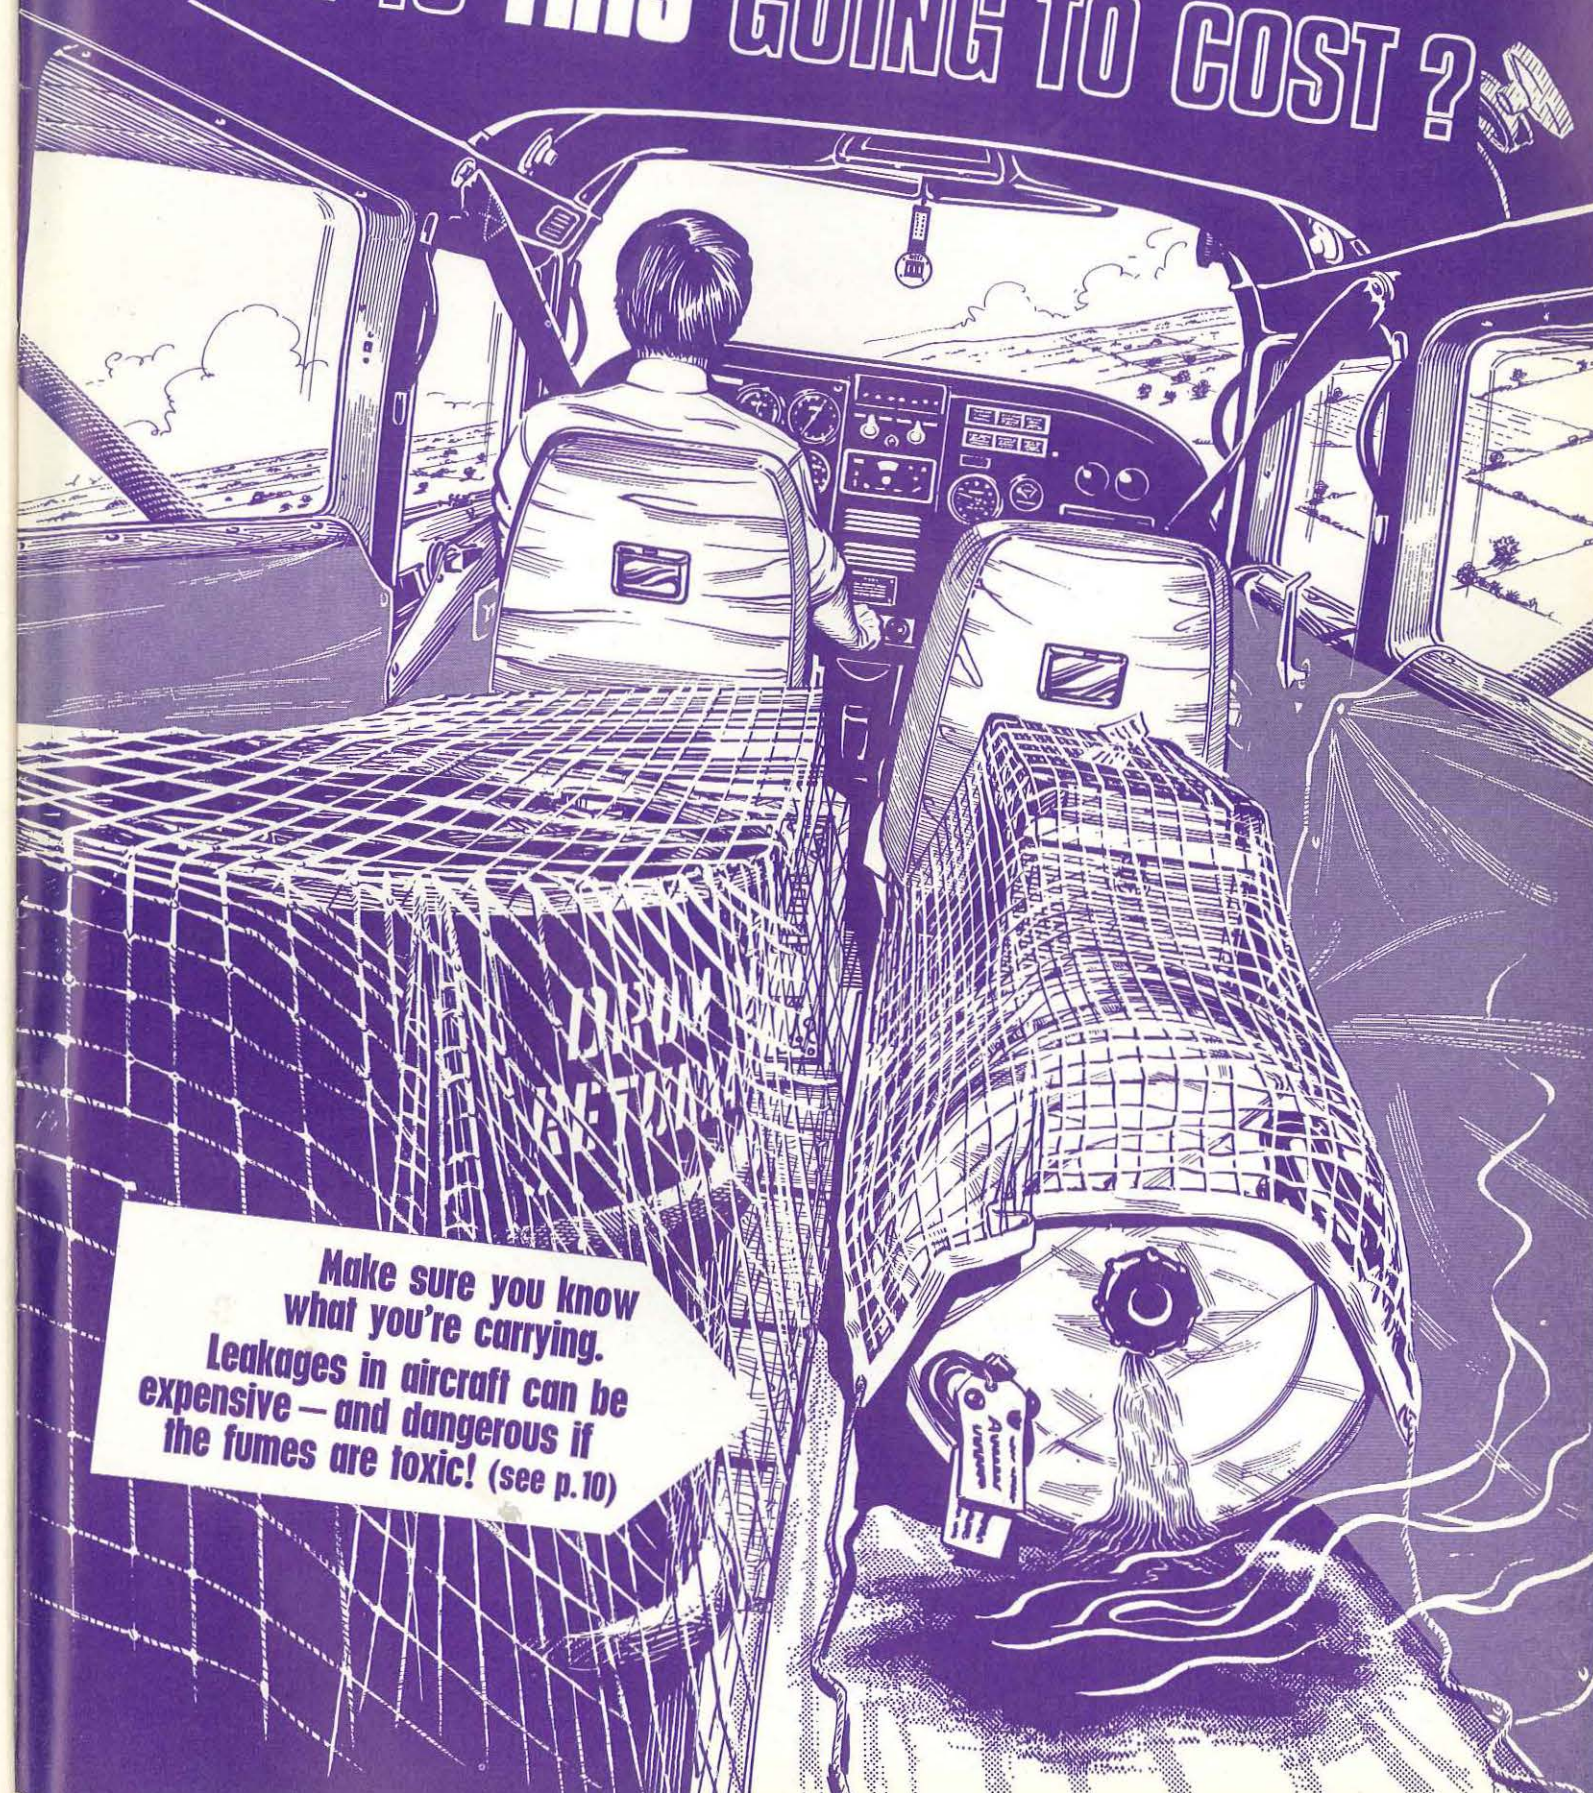
# WHAT IS THIS GOING TO COST?

Make sure you know  
what you're carrying.  
Leakages in aircraft can be  
expensive — and dangerous if  
the fumes are toxic! (see p.10)
