No. 68 MAY 1970

AVIATION SAFETY DIGEST

DEPARTMENT OF CIVIL AVIATION AUSTRALIA

Contents

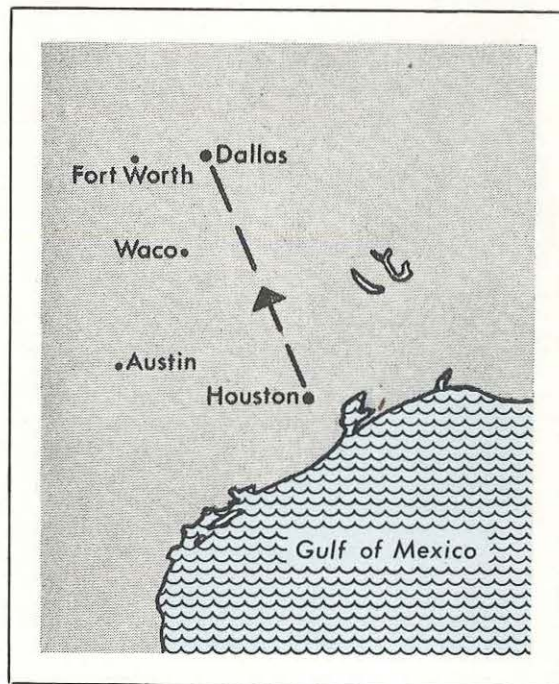
Locality map showing proposed route of aircraft.

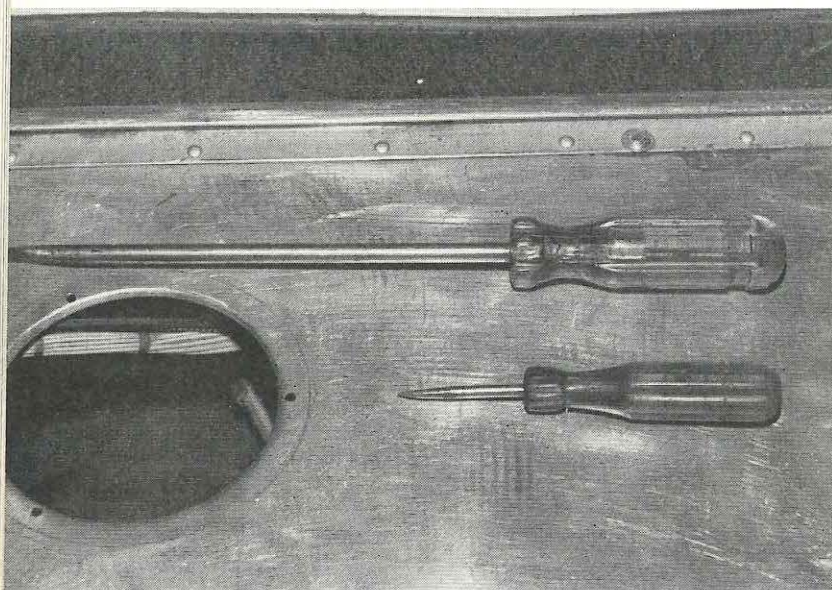
WELL, not spanners exactly, but in fact two screwdrivers that were found in "the works" of a privately owned Cessna 180 that was flown in to Archerfield, Brisbane, for a 100 hourly inspection.

Although neither screwdriver was actually fouling controls when discovered, their position was such that they could easily have been caught in the control linkage. The larger screwdriver, some 12 inches in length, was found beneath the cockpit flooring. With its blade tucked beneath the fuel selector valve, it was lying diagonally below the

What is the underlying cause of all these incidents which could clearly pose a threat to safety in the air? Surely it is that the maintenance engineers concerned have not positively accounted for all their tools at the conclusion of a job. Cleaning up, when an item of maintenance has been completed, is surely a task that demands as much care and attention as the technicalities of the job itself.

This is the **only** way to ensure that equipment is not left in obscure places in an aircraft. The importance of this phase of **any** inspection or maintenance work, cannot be over-emphasised. Similarly, if an implement or piece of equipment cannot be accounted for at the completion of a job, it is most important that the fact be reported promptly. In this way, action can be taken to locate the missing item before any damage is done.

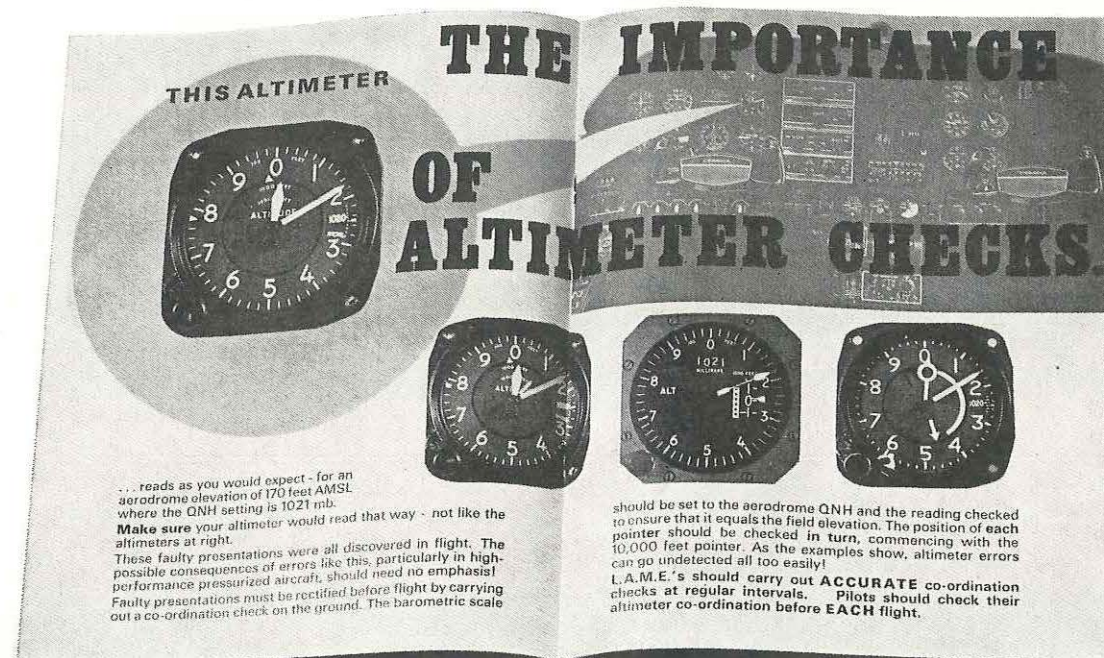
THERE were some very red faces in the Editorial Office recently when we took a second look at the altimeters displayed on the centre page of our November issue (Reproduced above). For much as it deflates our ego to have to confess it, we have unwittingly become the victims of the very mistake we were at such pains to warn our readers about. Far from being in error as implied, the centre altimeter in the group of three shown is reading quite correctly.
