DEPARTMENT OF CIVIL AVIATION AUSTRALIA

# AVIATION SAFETY DIGEST

No. 69 JULY 1970

## FATAL SEQUEL to loss of propeller blade

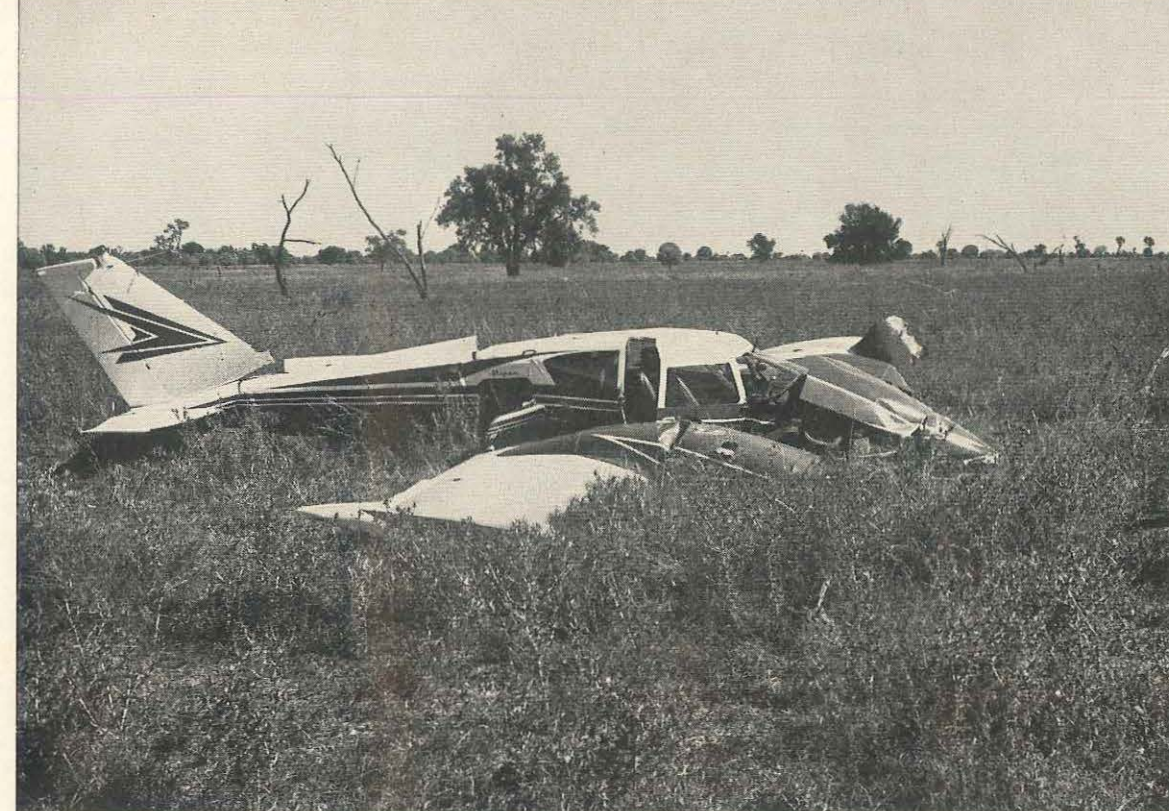
Apart from the damage which had obviously resulted from the impact with the ground, the most significant findings made when the wreckage was first examined were that one blade of the port propeller was missing and the port engine had been grossly displaced from its normal position. Ground impact marks and the nature of the damage to the port engine cowlings clearly showed that this damage had occurred before the aircraft struck the ground. The port engine, though still attached to the firewall by the broken and distorted engine mounting, was in an inverted position with the propeller spinner pointing outboard and its axis of rotation parallel with the leading edge of the wing. The remaining port propeller blade was embedded in the surface of the wing.

It was clear from the wreckage examination that one blade of the port propeller had failed in flight, close to its root end. The failure had resulted from normal operating loads applied to the blade after its strength had been greatly reduced by a fatigue crack extending over approximately 75 per cent of the cross sectional area of the blade-root. A strip examination of both engines and propellers disclosed no defect which would have prevented them from operating normally or have resulted in any unusual vibration, and the history of the failed propeller contained no record of any previous damage.

As a result of this accident, an Airworthiness Directive\* was issued by the Department requiring certain propellers of this type to be dismantled and the blades inspected for signs of corrosion in the balance weight hole. Any blade in which evidence of corrosion is found within the lower inch and a half of the balance weight hole is to be retired immediately. To date four such propeller blades have been found to be affected by corrosion in this way and have been withdrawn from service.

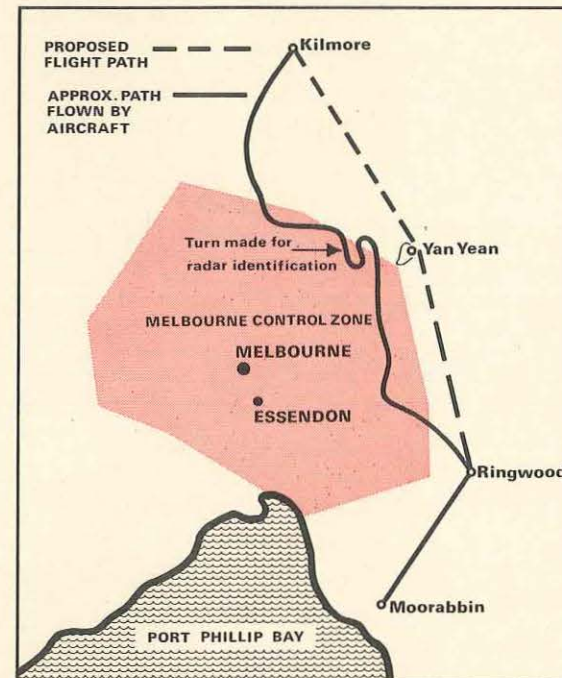
continued the flight, and the aircraft duly arrived over Ringwood right on E.T.A. After transmitting a position report, the pilot decided the headphones would not be necessary for the remainder of the flight, so he removed them and placed them on the coaming above the instrument panel. He then altered heading for Yan Yean.

Visibility in the area was still generally poor, and after maintaining the new compass heading for three or four minutes, the pilot was astonished to see the Melbourne city skyline some distance ahead and only slightly to port. Realizing at once that he had unintentionally entered the Melbourne Control Zone, the pilot immediately looked around for the Yan Yean Reservoir and, sighting it well to starboard, turned towards it.

The area above the instrument panel in a light aeroplane seems an obvious place to put articles during flight because it is so ready to hand. But as this and other incidents have shown, the consequences of utilising this space can have startling results. As our earlier article pointed out, it may be prudent to declare this area "out of bounds to all articles"!
