No. 70 SEPTEMBER 1970

AVIATION SAFETY DIGEST

DEPARTMENT OF CIVIL AVIATION AUSTRALIA

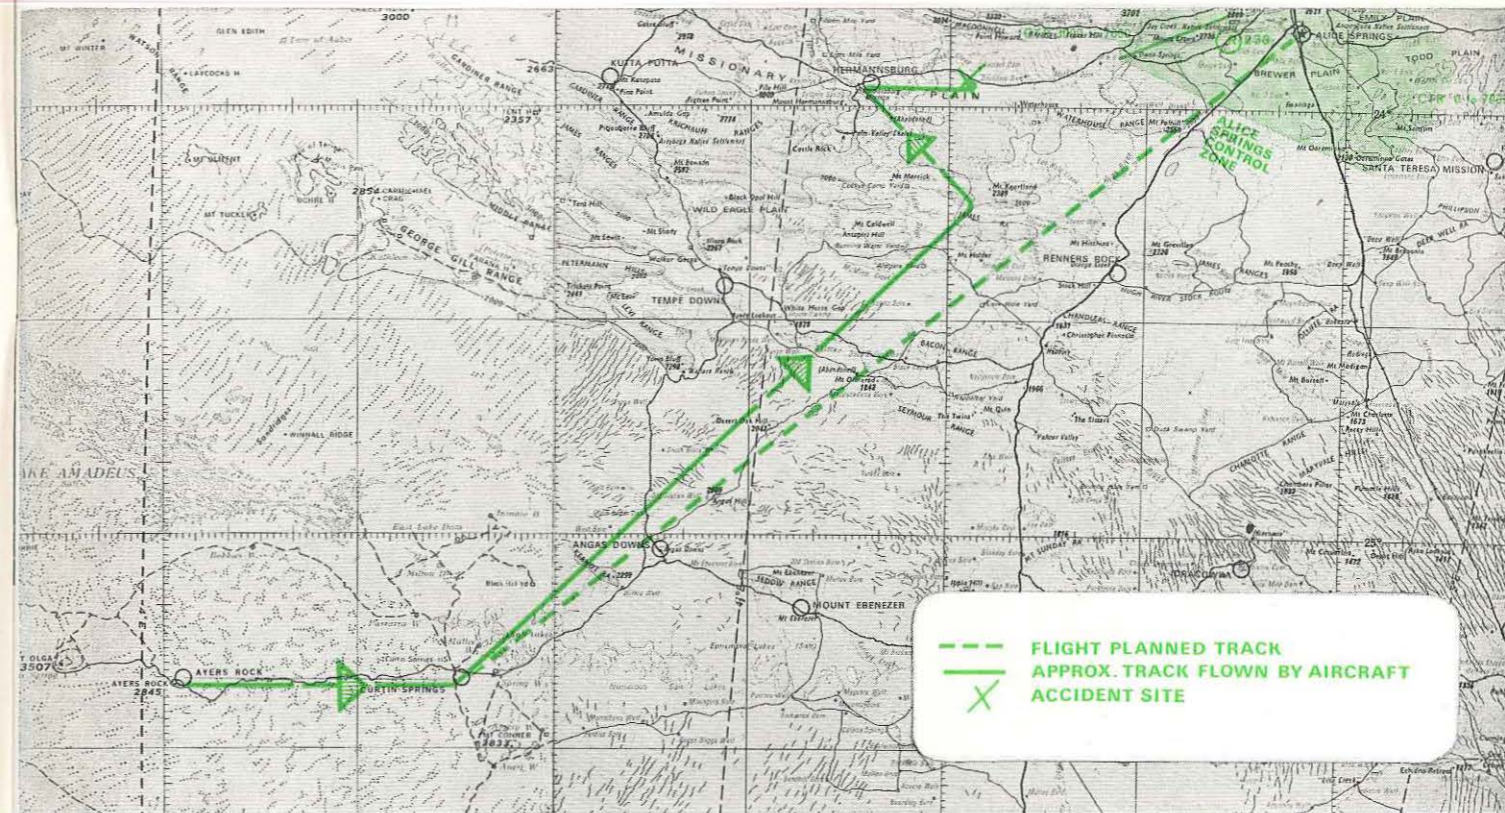
Map showing flight planned route from Ayers Rock via Curtin Springs to Alice Springs, approximate track actually flown by the aircraft, and position of accident site.

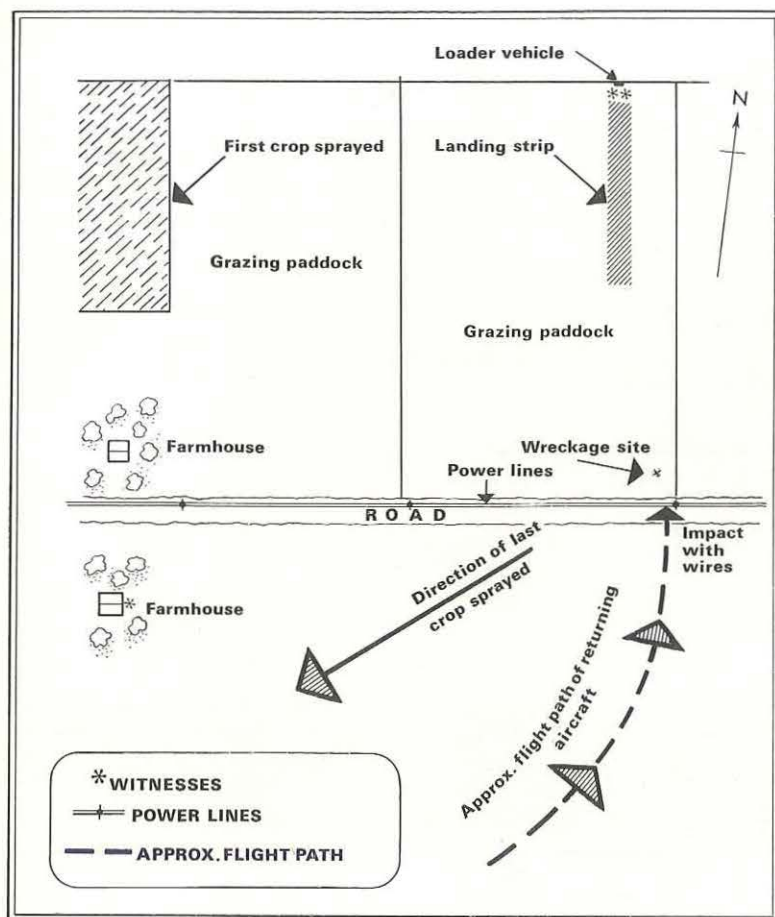
Map of area in which accident occurred showing approximate flight path and relative positions of wreckage, power lines, airstrip and witnesses.

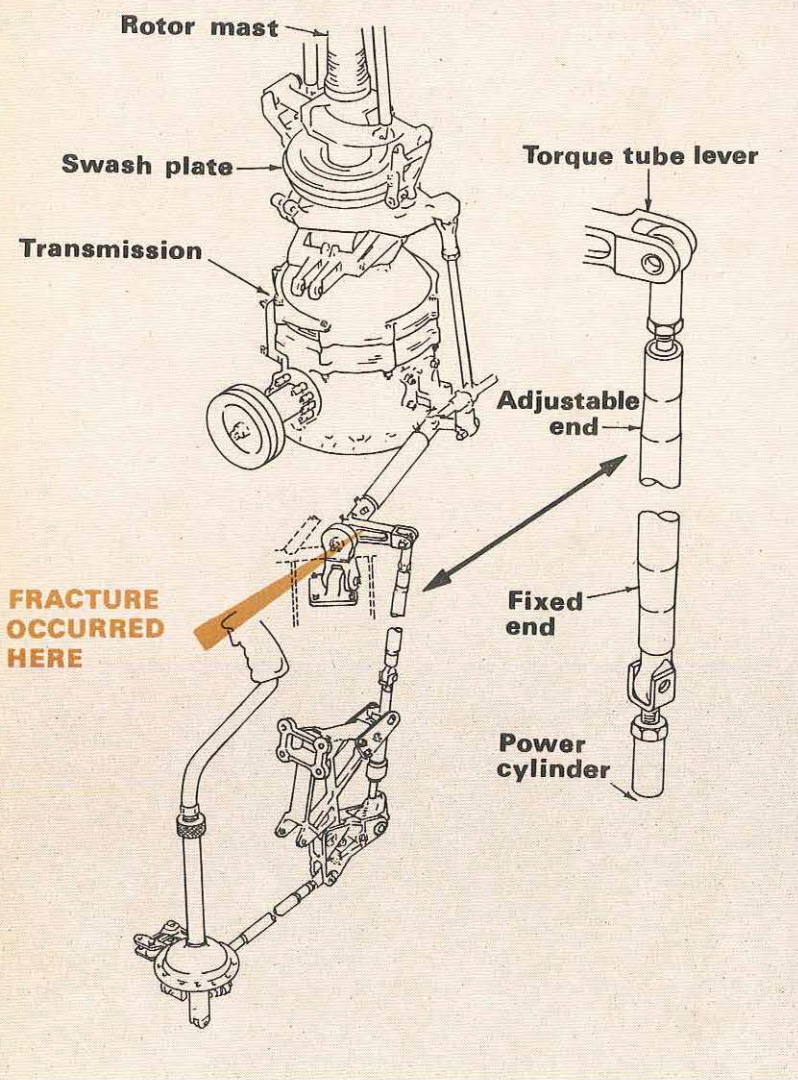
IN New Guinea recently, a Bell 47G helicopter was involved in an accident when a failure occurred in the cyclic control system. During the subsequent investigation, it was found that a torque tube lever in the lateral cyclic control linkage had fractured.

Further examination then revealed that the push-pull control rod connecting the lever to the cyclic control power cylinder had been installed some time previously in the reverse sense. It was evident that stresses imposed on the torque tube lever by this incorrect installation had, over a period of time, been responsible for its failure.

As shown in the diagram on this page, the adjustable end of the push-pull rod is intended to attach to the torque tube lever and is able to accommodate itself to the radial movements of the

remote areas, inspections of this type may become necessary when only one Licensed Aircraft Maintenance Engineer is available. In such cases, the pilot is usually called upon to take the place of the second L.A.M.E. in the duplicate inspection. It should go without saying that a pilot required to participate in a duplicate inspection should make himself thoroughly familiar with the system he is going to inspect. Duplicate inspections were introduced for the express purpose of preventing accidents such as the one mentioned in this article. Properly performed, they will do exactly that.

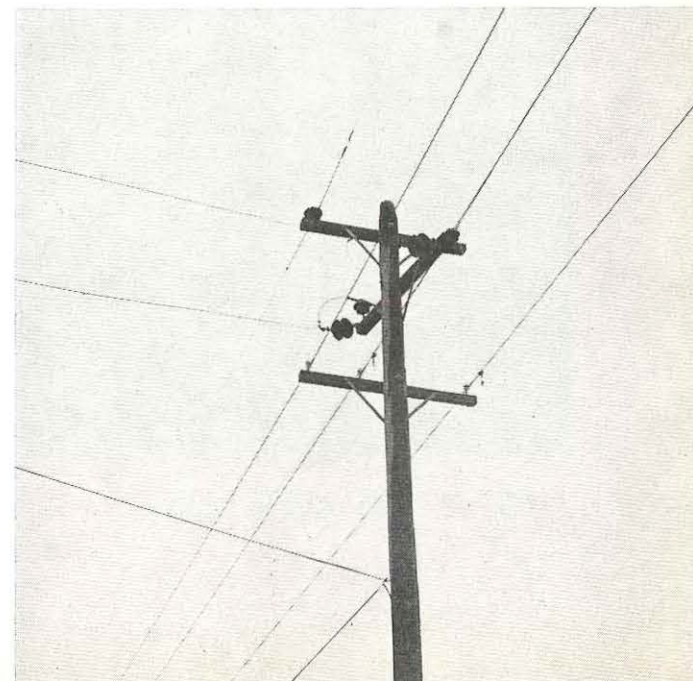
Cross-trees on pole indicate the direction of wire runs. Note that the insulators on the branch line in this case are inclined downwards, denoting a sag in the wires running in this direction. Two bracing wires are attached to the lower part of the pole.

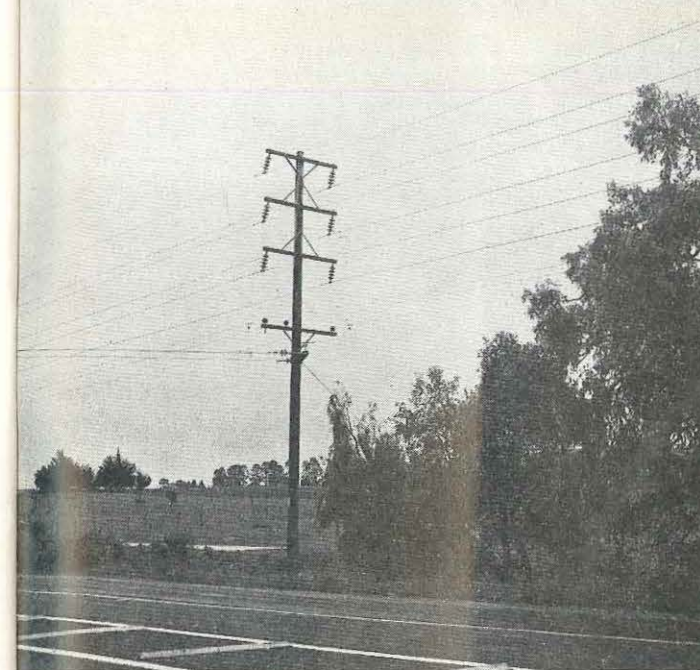
Insulators hung at an angle to cross-trees indicate a slight bend in the main wire run. The "hang" of the insulators denotes the direction of the bend. Note the tight branch lines, with insulators horizontal, and the stay wire almost obscured by trees.

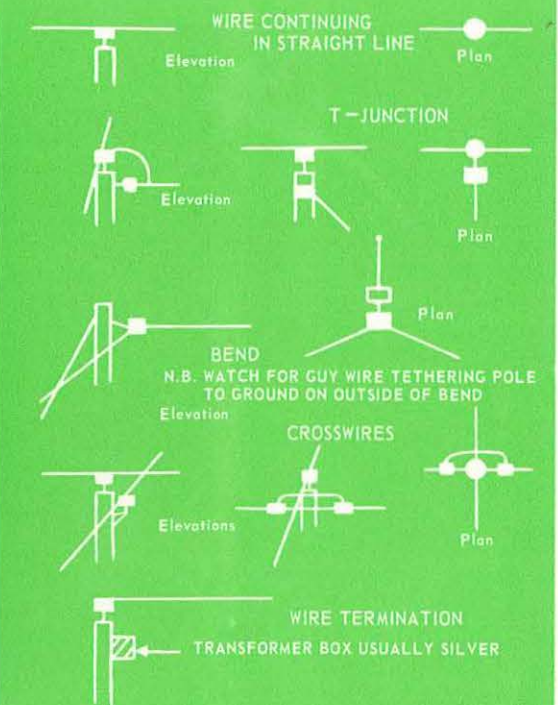
FIGURE 1

The insulators mounted on top of the poles of a single wire power line can be a useful guide in determining the run of the wire. Sometimes the insulators are of clear material which show up well in the sunlight, but in any case the size of the insulators used forms a bulge on the top of the pole which can usually be seen from

some distance away. Some typical single wire insulator arrangements are shown in Figure 1. Fig 2 shows some of the exceptions to the rule that can be encountered from time to time and which need to be looked at carefully.

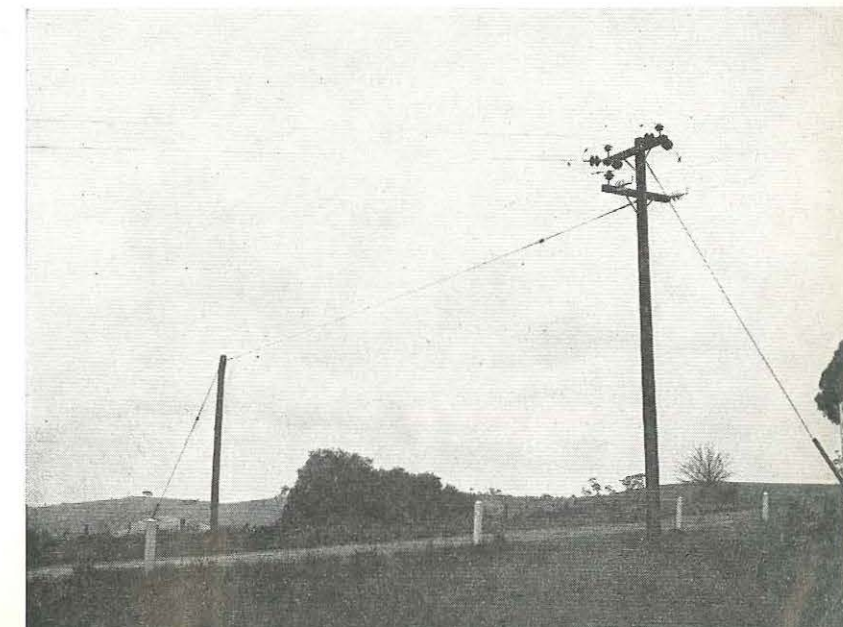
A dangerous combination. As well as the normal stay wire on the "outside" of the bend in the main wire run, a horizontal bracing wire, opposite the tight branch lines, leads to a pole and a further stay wire on the far side of the road.

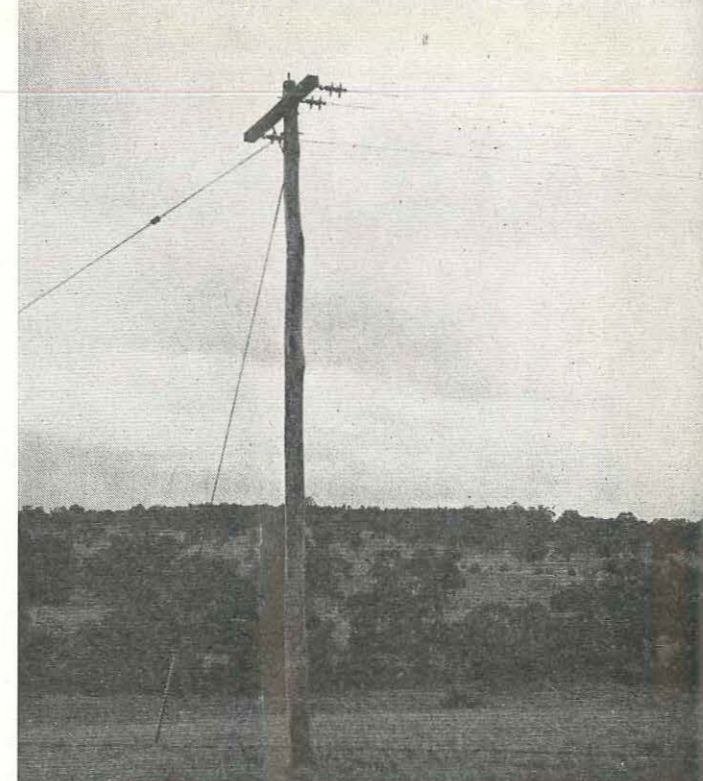
A power line termination, with horizontally mounted insulators and characteristic bracing wire arrangement. The insulators standing out at right angles show that there is little droop in the wires.
