DEPARTMENT OF CIVIL AVIATION AUSTRALIA

Number 73 March, 1971

## Forty Years Experience what has it taught us?

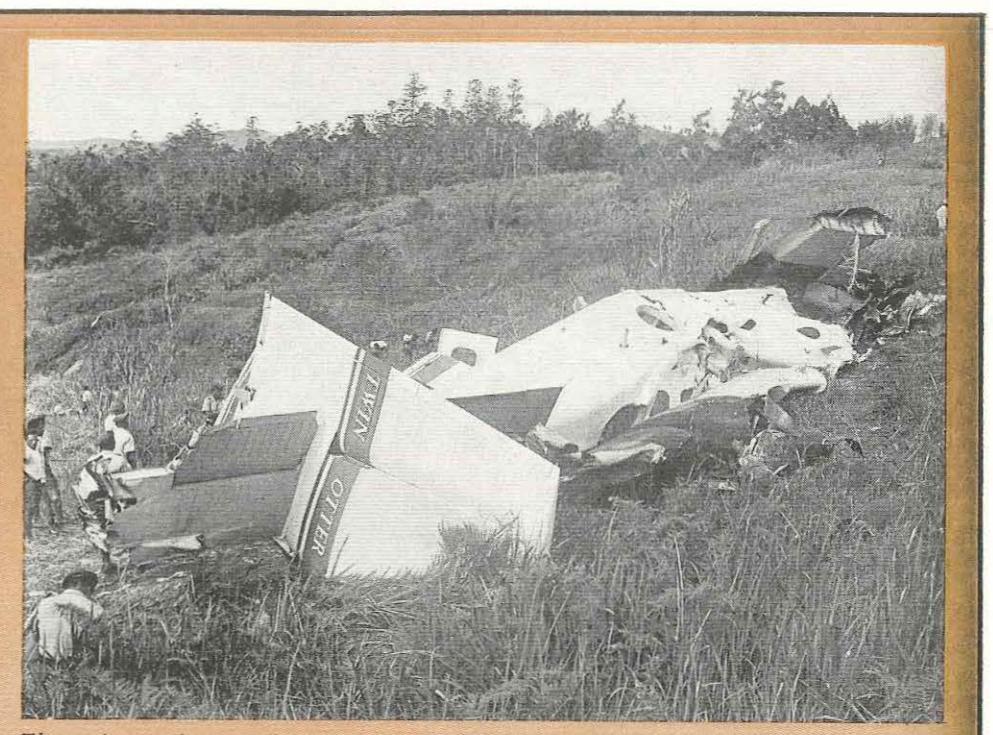
The main wreckage as it came to rest, looking approximately in the direction of impact. Extensive damage to the starboard side of the fuselage caused by the collapse of the starboard undercarriage when the aircraft struck the ground is evident in this picture.

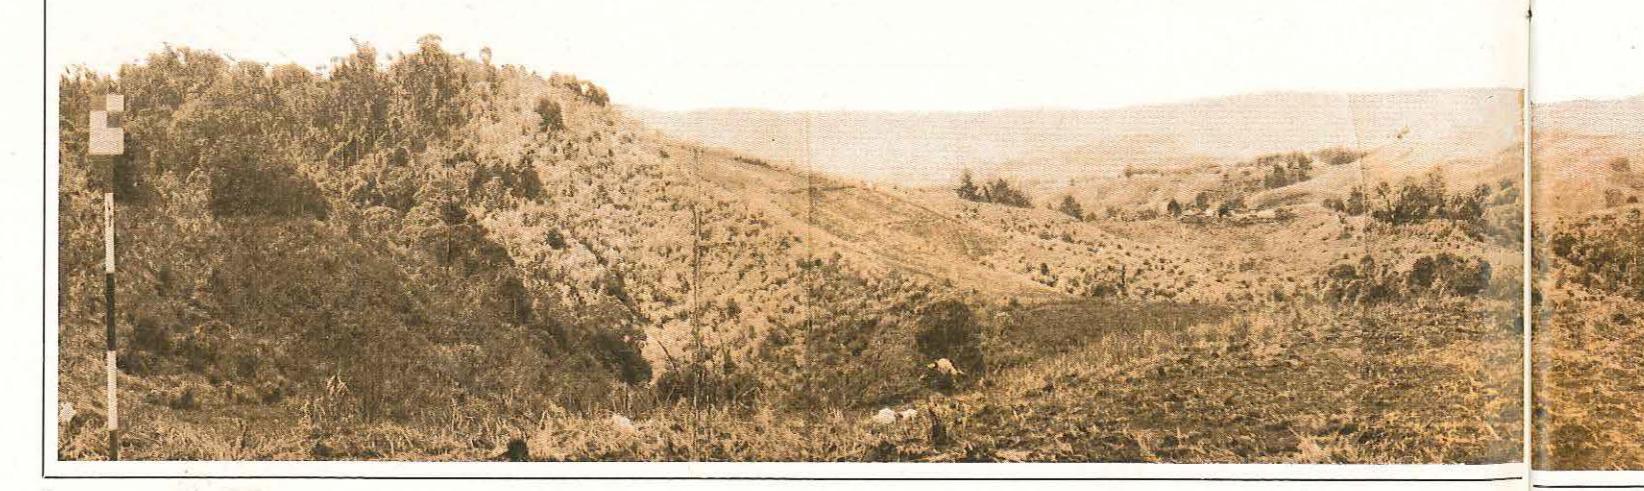
Bottom: Composite photograph of the saddle through which the aircraft attempted to pass on the latter stages of its flight from Goroka, looking towards the lower terrain in the direction of Kainantu aerodrome. The accident site is just out of view behind the marker post at left.

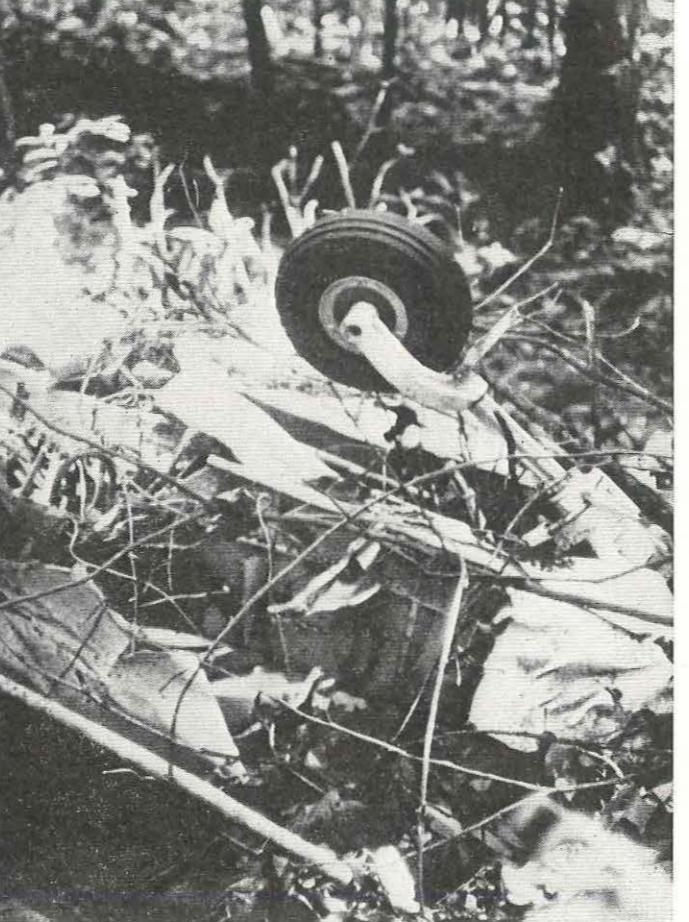
Right: Forward section of the Baron's fuselage, containing the instrument panel and nose undercarriage, as found by the investigation team.

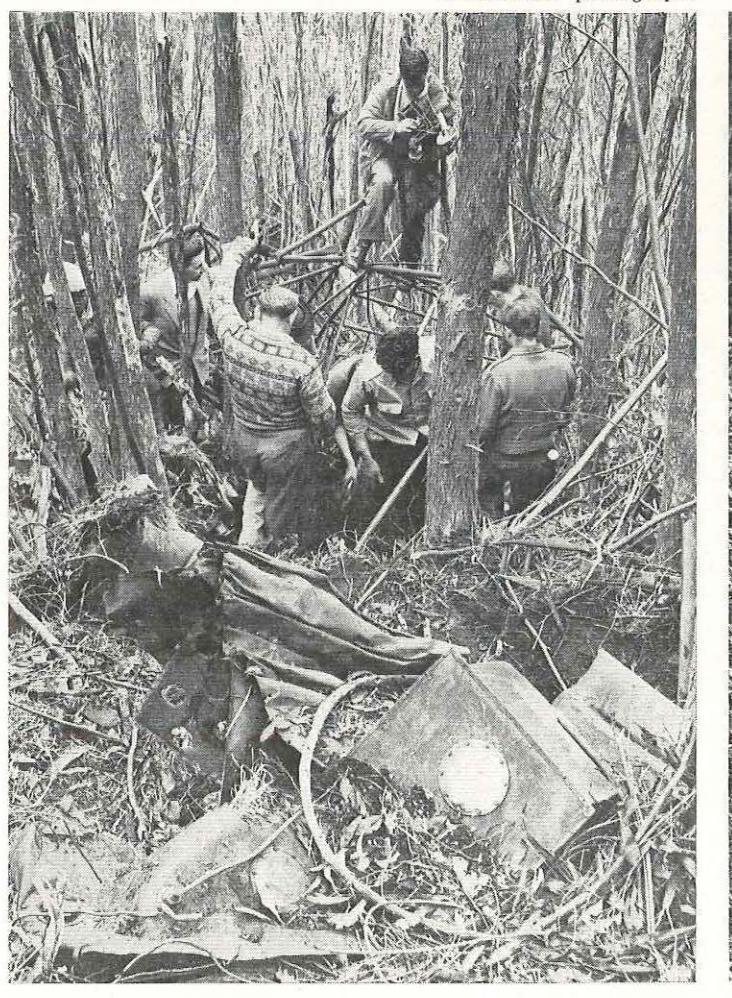
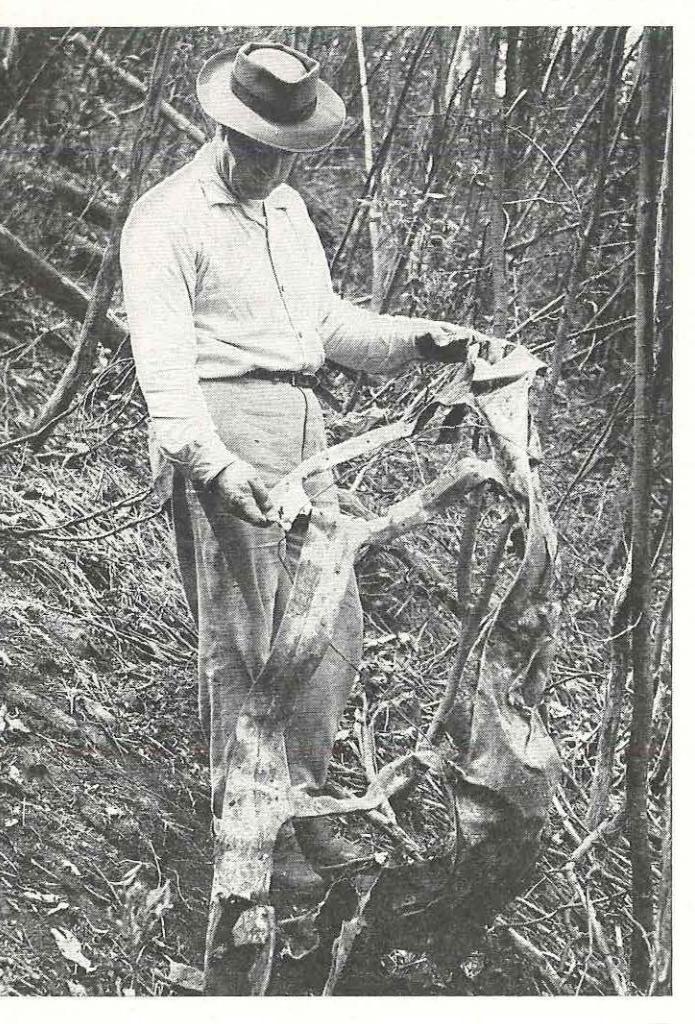
> The tubular steel fuselage frame was lying on its starboard side facing up the slope, with the starboard undercarriage beneath it but about seven feet rearward of its normal position. The forward and centre sections of the fuselage were badly telescoped. The remains of the windscreen frame and instrument panel were found immediately behind the firewall of the centre engine, which was embedded some three feet in the ground. The starboard engine was also embedded in the ground in approximately its correct position relative to the centre engine, but the port engine was located some four feet forward of the centre engine. The frame of the tail plane, fin and rudder had been twisted from its normal position and lay at right angles to the fuselage frame. Apart from the effects of corrosion and fire, all the elevator and rudder hinges were intact.'

From globules of molten metal found amongst the main section of wreckage. the melted face of one of the wrist watches and other indications, it was evident that the wreckage had been subjected to a fire of much greater intensity than a bush fire, and indicated that the aircraft had burnt after impact.

Left: Members of the investigation party at the accident site Right: A Departmental investigator examining the aircraft's badly shortly after the wreckage of the "Southern Cloud" was discovered. distorted windscreen frame.

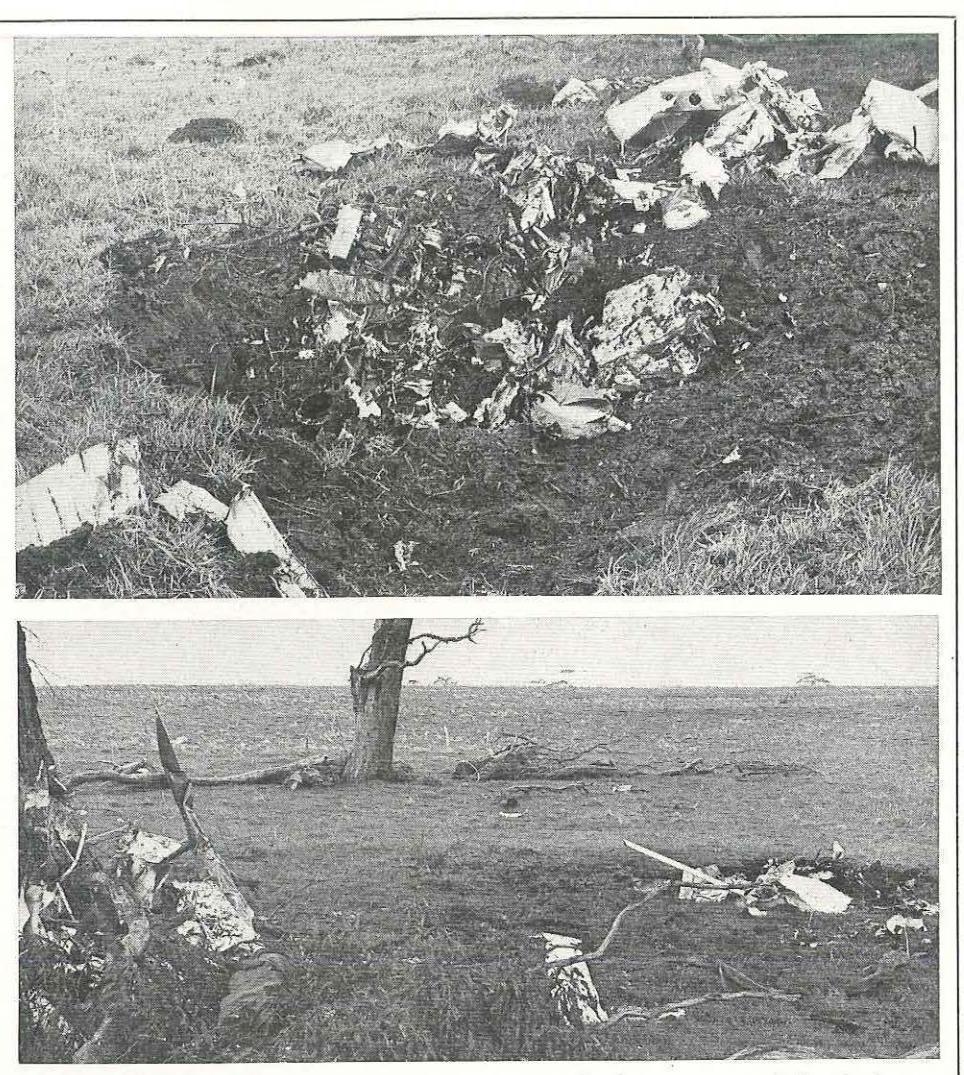
Top: The main wreckage of the Cessna 210 lying in the deep crater made by the impact. Bottom: General view of the accident site. The main wreckage and crater are towards the right of the picture, while the fin and rudder are resting against the tree at extreme left.

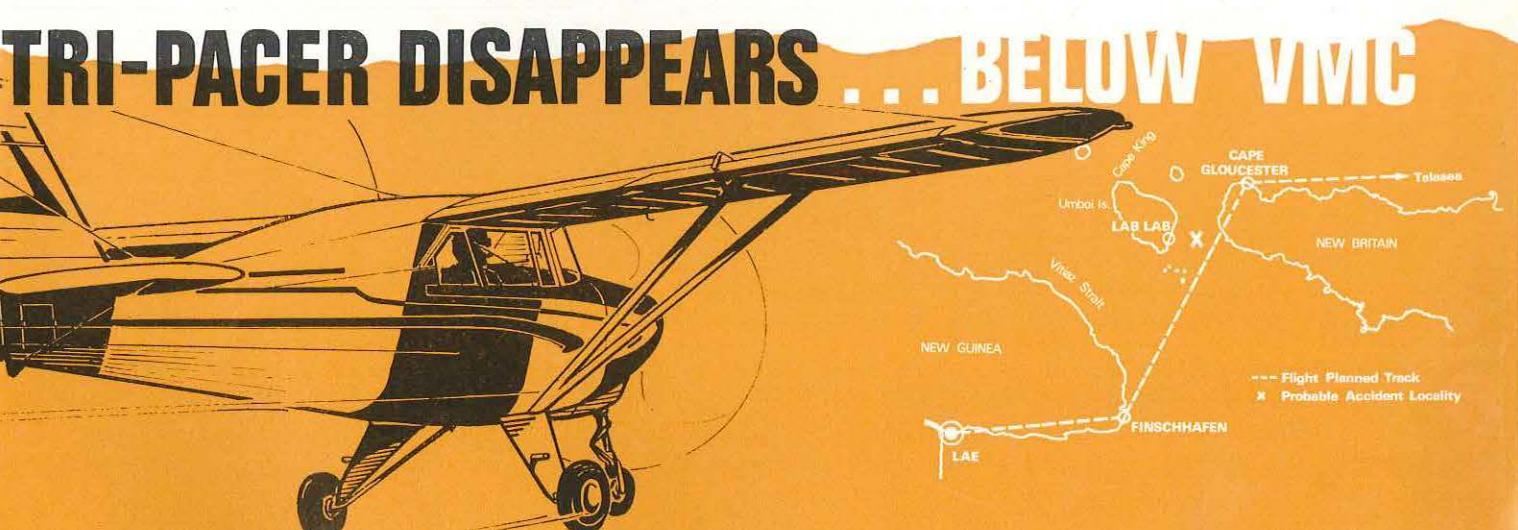
The damaged nose-wheel strut and rear seat squab from the Tri-Pacer found in the sea near Cape King on Umboi Island, were the only parts of the aircraft recovered.
