Number 74 May, 1971

DEPARTMENT OF CIVIL AVIATION AUSTRALIA

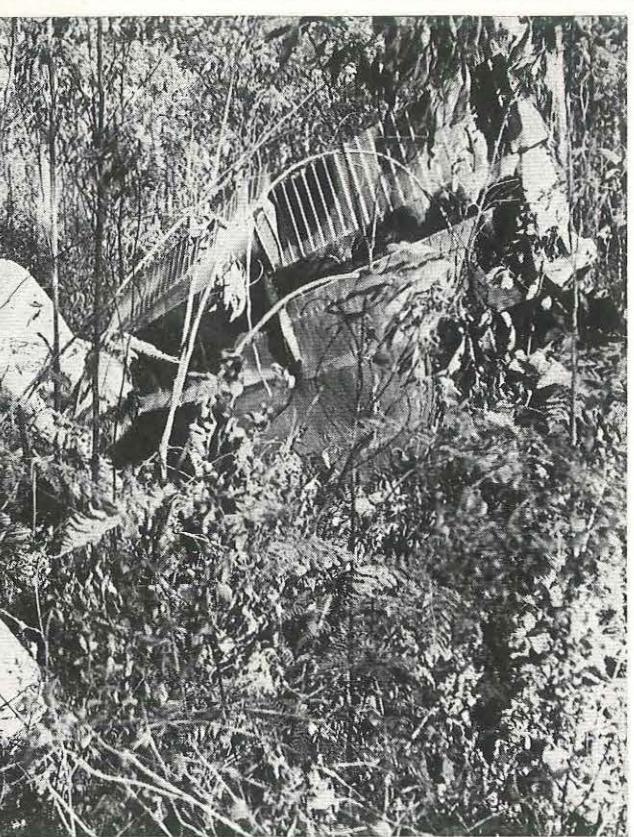
General view of the accident site, showing the main wreckage as it was found by the ground search party. The surrounding undisturbed vegetation indicates that the aircraft struck the ground at a steep angle.

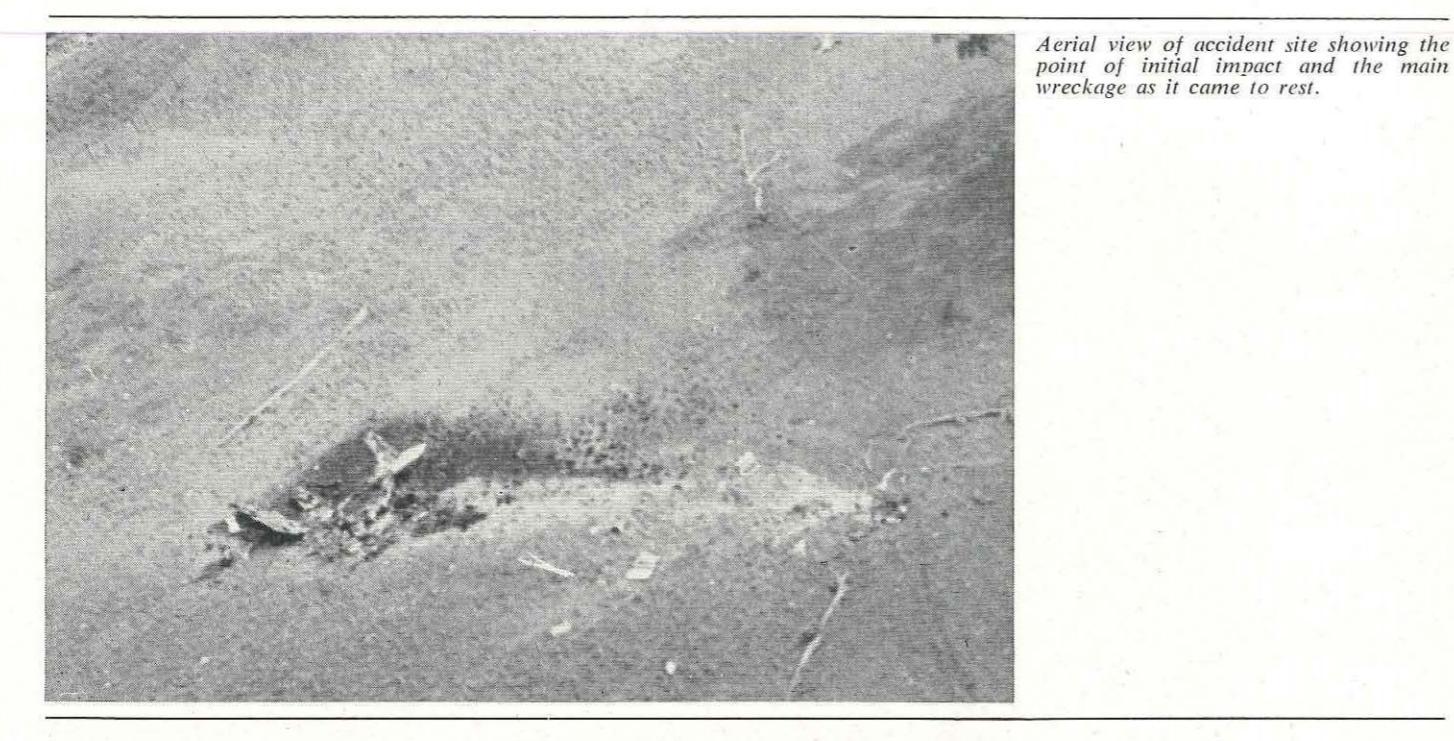
From an examination of the burnt-out wreckage and the nearby impact marks on the ground, it was evident that the aircraft had struck the ground with considerable forward speed in a nosedown attitude while banked to starboard. Impact forces had torn the propeller from the engine and one blade had been thrown 250 feet. The propeller hub, with the other blade still attached, was found buried in superphosphate amongst the main wreckage. It was evident from the damage sustained by the propeller that it had been rotating at high speed at the time of impact.

Close-up of the burnt-out wreckage of the Cessna 180. The engine and port wing are in the foreground.

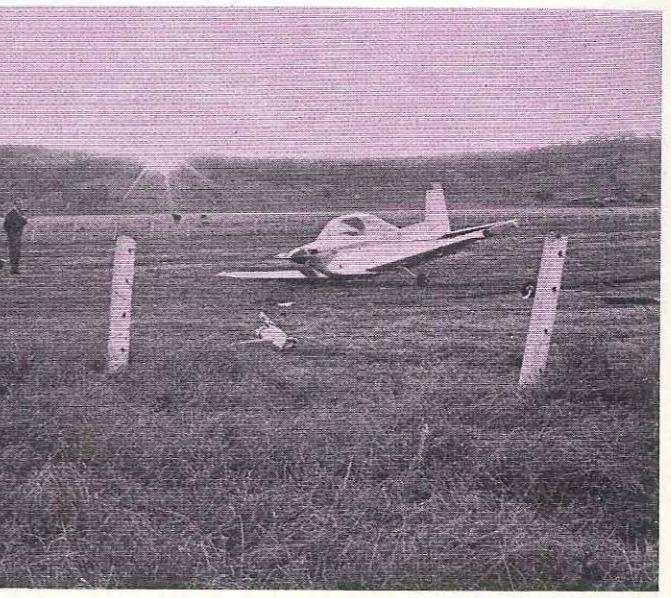
Inspecting the aircraft after landing, the pilot found that the leading edge of the wings and the flaps had been extensively damaged. Part of the starboard tailplane was missing, and the starboard elevator had been almost sheared off
