AVIATION SAFETY DIGEST

Number 77 January 1972

DEPARTMENT OF CIVIL AVIATION AUSTRALIA

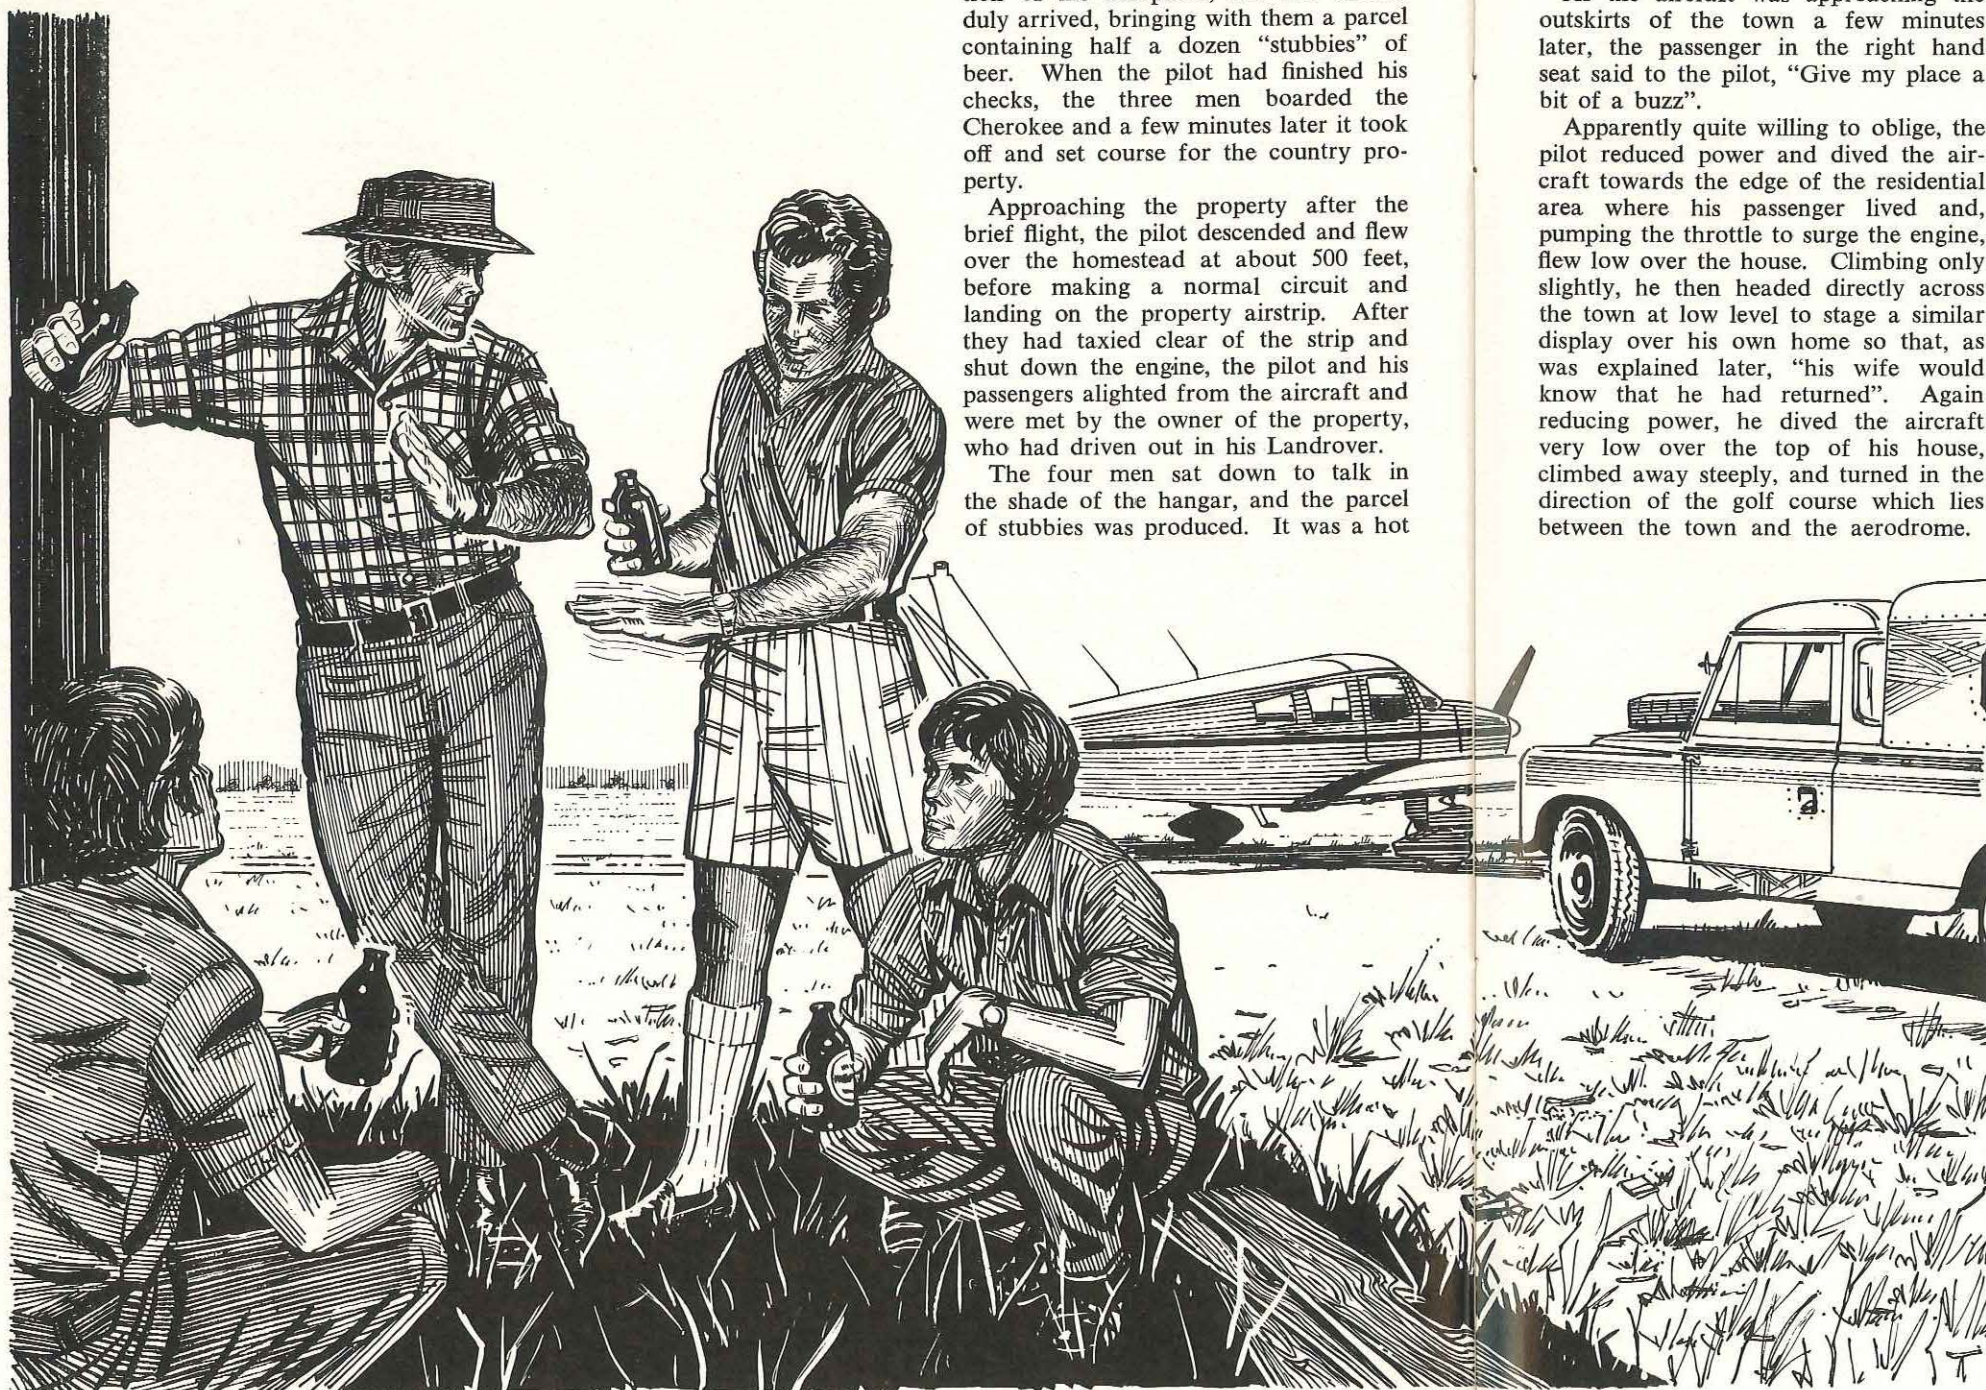
ON a Sunday afternoon at an inland town (which shall be nameless), the owner-pilot of the Cherokee so sadly depicted on opposite page, had decided to make a short flight to a country property some 20 odd miles away.
