Number 80 July 1972

DEPARTMENT OF CIVIL AVIATION AUSTRALIA

AVIATION SAFETY DIGEST

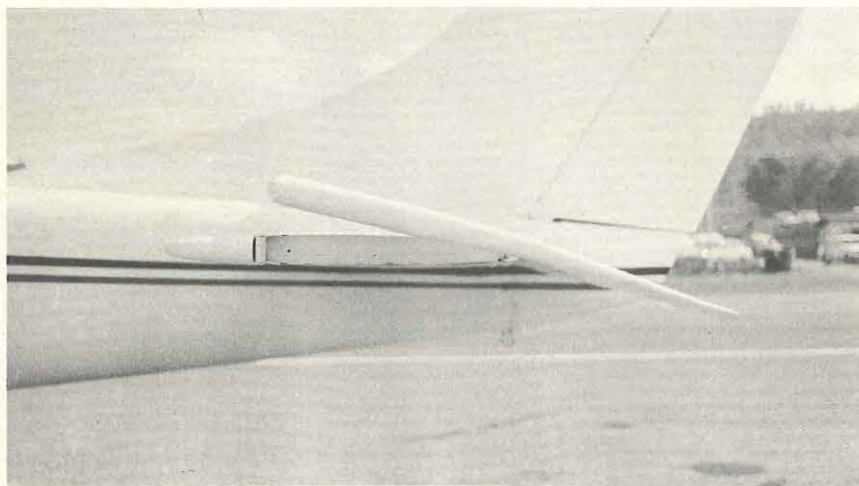
Above: Normal full downward deflection of elevator of Cessna 206.

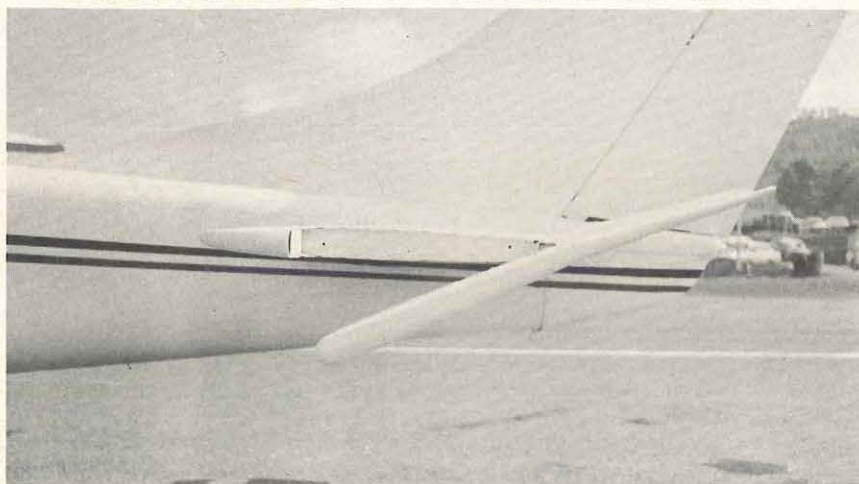
Below: Normal full upward deflection of Cessna 206 elevator control.

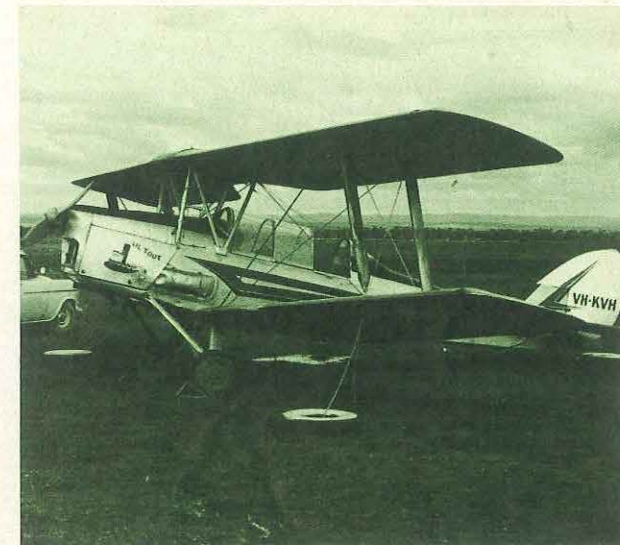
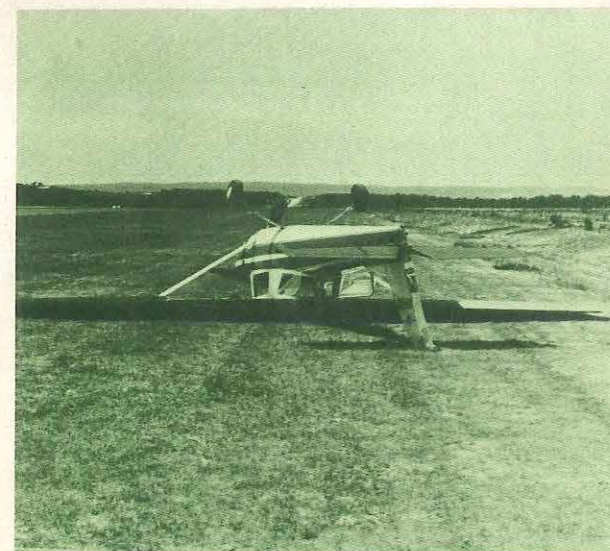
After climbing to 3,000 feet, and carrying out some aerobatics, he began a gliding descent back towards the aerodrome. Watchers on the ground saw the aircraft make a gliding approach and at about circuit height noticed that the engine had stopped. The aircraft turned downwind and they then saw that the propeller had stopped rotating in an almost horizontal position. The wind had freshened since the aircraft had taken off, and after it had turned on to final approach, it was clear to those watching that the aircraft was undershooting. It touched down in a three point attitude, 40 yards short of the aerodrome boundary fence and at low speed rolled through the fence and came to rest on its nose. The nose cowl and lower wings sustained damage. The pilot, who was unhurt, said afterwards that he thought he must have accidentally knocked the ignition switches off during the glide and that, when he had tried to restart the engine, it had spluttered and died. He had attempted to land on the strip but misjudged the approach because he did not realise the wind had freshened. No fault could subsequently be found with the engine.

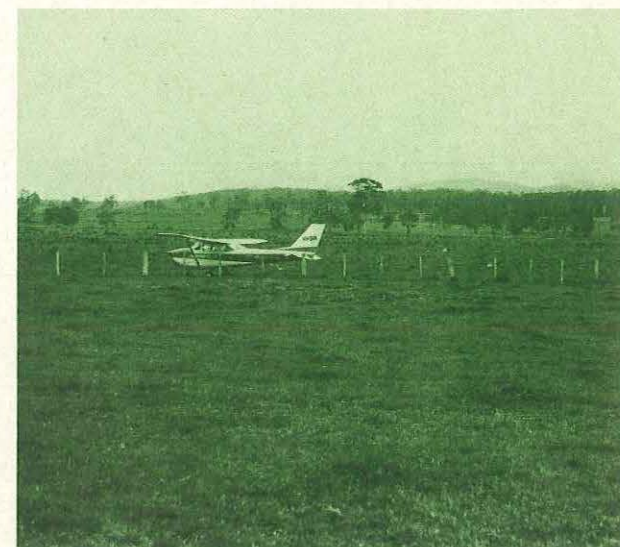
A commercial pilot had been engaged to make a charter flight from Launceston to Flinders Island and before departing he completed a flight plan, inspected the aircraft, and physically checked the fuel tank contents which he assessed as being full. The flight proceeded as planned and the aircraft landed at Flinders Island an hour and 20 minutes later. After off-loading his passenger, the pilot took off for the return flight. A little more than an hour later, when only 8 miles from Launceston Airport but over inhospitable terrain, the engine of the Cessna 172 suddenly lost all power. The pilot attempted to restart the engine but then saw that both fuel tanks were empty. Having lost precious time and height attempting to start the engine before he looked for a suitable forced landing area, the pilot found he was left with no alternative but to make a downwind landing in the only suitable field available to him. Unfortunately the length was not sufficient to bring the aircraft to a stop and, even though the pilot deliberately induced a ground loop to the right, the tailplane struck a fence post and was substantially damaged. It was found during the subsequent investigation that the aircraft's fuel tanks were not, in fact, full at the beginning of the flight and that, unknown to the pilot, the aircraft had flown about an hour and 45 minutes before he began the trip.

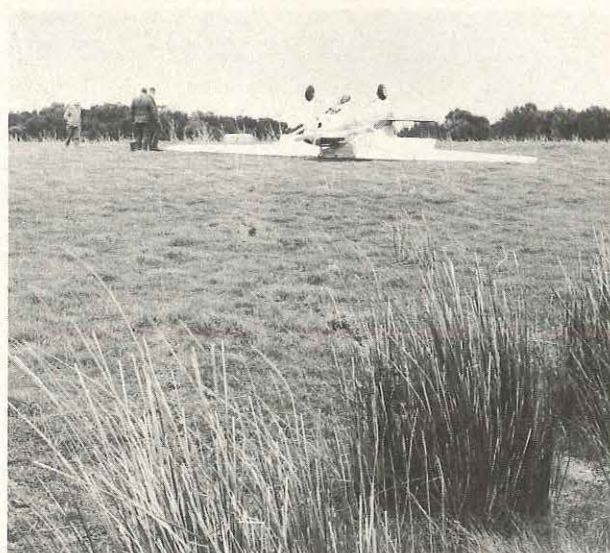
Arrangements had been made for a commercial pilot to ferry this Cessna 172 to a property in Victoria. Before taking-off, the Cessna pilot had been briefed by a private pilot on the location and layout of the property's two airstrips, one of which, because of its soft, wet surface, was unserviceable. However, the private pilot neglected to mention that only a short distance from the serviceable strip, which was not marked, there was another area which had been graded some time previously to form a strip, but which had subsequently been abandoned, leaving the surface badly rutted.

Arriving over the property, the pilot made several low inspection runs and, mistaking the graded area for the strip he had been advised to use, he landed on it, fortunately missing the roughest areas. At the end of the landing roll, the pilot turned the aircraft around and began to taxi back along the strip. But when the aircraft had rolled only a few yards, the nose wheel entered a deep hole. The nose leg was torn off and the aircraft came to a sudden stop on its nose.
