## Number 82 November 1972 DEPARTMENT OF CIVIL AVIATION AUSTRALIA

## Contents

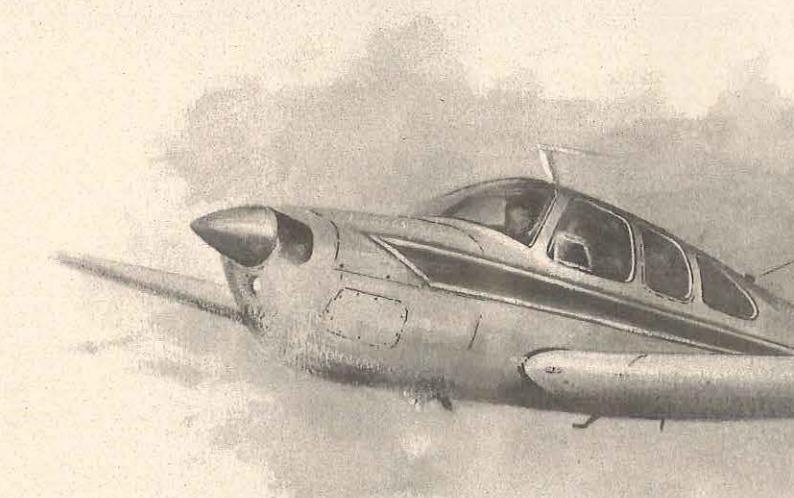
Early on a showery autumn morning, a Debonair carrying four friends returning to Sydney after a weekend playing bowls in the country, took off from Dubbo for Hoxton Park aerodrome. Less than 20 minutes later, all were dead and their near-new, fully serviceable Beechcraft, had been reduced to the charred mass of wreckage shown in the pictures.

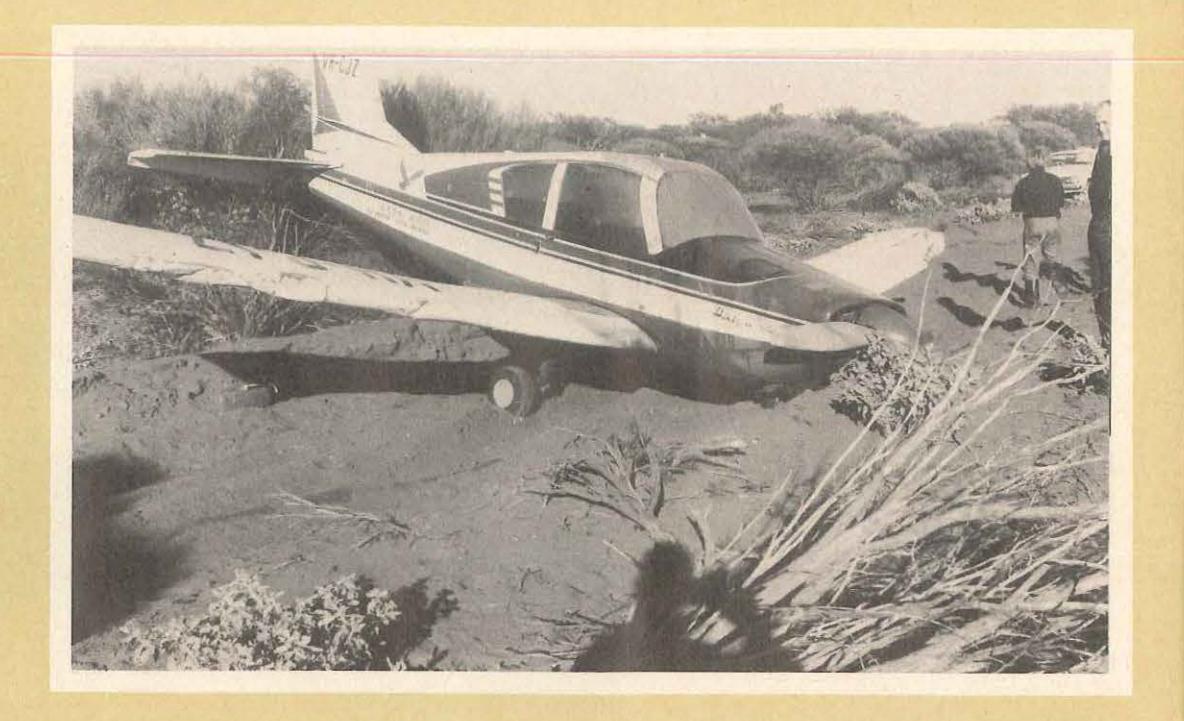
A commercial pilot had planned to make a flight from Ullawarra to Geraldton, W.A. in a Sud Horizon, and after departing at 0625 hours the flight continued uneventfully for an hour and a half. But then while cruising at 5,000 feet the pilot suddenly noticed spots of oil appearing on the windscreen. Ten minutes later, as the oil flow was obviously increasing, the pilot decided he would have to make a forced landing.

The terrain over which he was flying was very inhospitable, the whole area being covered in mulga scrub so, he turned towards a dry lake some miles away. After crossing a road shortly afterwards however, the pilot saw that the oil flow was decreasing and he decided to divert to the airstrip at Carey Downs Station. But after the aircraft had flown for about 10 miles in this direction the oil flow again began to increase so the pilot concluded that his best course of action was to return to the road he had seen and attempt a landing. By this time the entire windscreen was covered with oil, and he could only gain forward visibility by sideslipping the aircraft.

Arriving over the road, he saw that it was only a narrow track bounded by trees on both sides. As he lined up for a landing into the west, he noticed a large gum tree by the side of the road so he continued flying along the road until a lighter area of scrub appeared. He then shut down the engine, closed the fuel cock, turned off the ignition and master switches and approached to land straight ahead. Just before touchdown, the port wing struck a tree and was partially dislodged. The starboard undercarriage leg then dragged through a ridge of sand on the right side of the road, and the aircraft swung to the right, eventually coming to a rest at right angles to the track. The pilot was not injured and was rescued later that day. The aircraft was damaged beyond repair.
