DEPARTMENT OF CIVIL AVIATION AUSTRALIA Number 83 February 1973

Contents

A Moment's Thoughtlessness
The Final Link in the Chain
It Really Can Start
Minor Distraction – Major Catastrophe
Oh, How Could You!
The High Price of Distraction
Nothing Surprises Us Any More
In Brief
Pilot Contribution

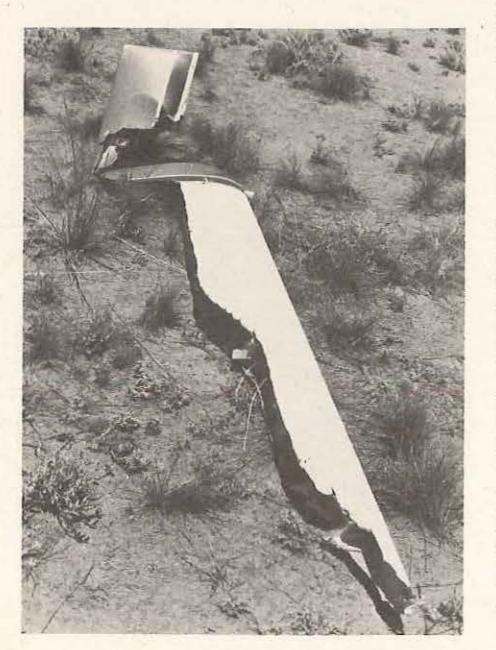
The leading edge section of the outer port wing. sliced from the aircraft when it struck the cable.

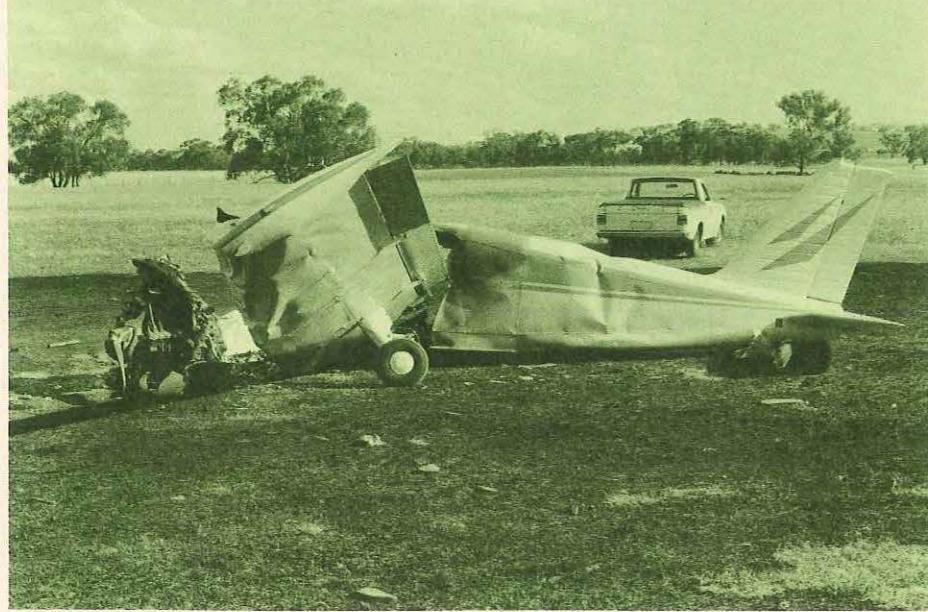
Close-up view of the burnt-out wreckage as it came to rest in the paddock.

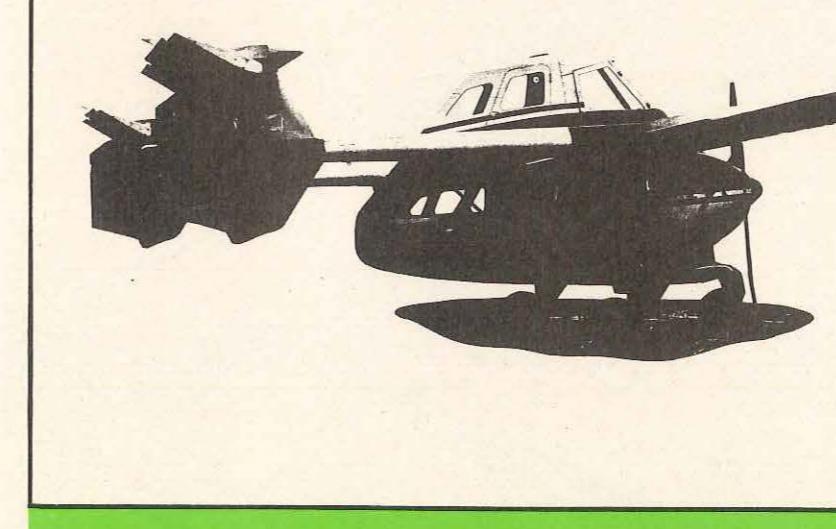
A N Airtruk had been hangared at its base overnight and, early in the morning, the pilot and a loader driver arrived at the aerodrome and pulled the aircraft out on to the tarmac ready to depart for an agricultural airstrip. The loader driver took his seat in the rear of the fuselage, and the pilot climbed into the cockpit ready to start. But the morning was cold and, after priming the engine, he found the starter would not turn it over compression. Assuming the battery was flat, the pilot got out again and went into the hangar to get another one. Meanwhile, the loader driver also clambered out and went around to the front of the aircraft to make his own investigation of the trouble. Grabbing hold of the propeller, he pulled it through one compression and called out to the pilot that the impulse start was "not clicking" As he pulled the propeller through the second time, the engine coughed, then roared into life and the aircraft began to move forward. Aghast at this sudden and unexpected turn of events, the loader driver saw to his horror that the Airtruk was heading directly towards a line of parked aircraft, and caught hold of the starboard wingtip to divert it back towards the hangar. Inside the hangar, the pilot had heard the engine start, and came running out. He tried to board the aircraft, but before he could do so, it collided with the hangar. Sparks flew as the whirling propeller chopped into the hangar door and finally ground itself to a stop. Both the aircraft and the hangar door were severely damaged.

Although the pilot had switched off the generator and master switches before leaving the cockpit, he had omitted to turn off the magnetos. Also, not thinking anyone would interfere with the aircraft in the short time he needed to get a replacement battery, he had not set the parking brake. The well-intentioned but misguided loader driver had been in the aviation industry only a short time, having previously been a plant operator with the local council. He had no training or instruction in hand-starting aircraft and vehemently denied any suggestion that he was attempting to start the engine in the pilot's absence. In fact he said, he "wouldn't have been game enough to try", even if the pilot had been in the cockpit. He "just thought that the starter was jammed" .-

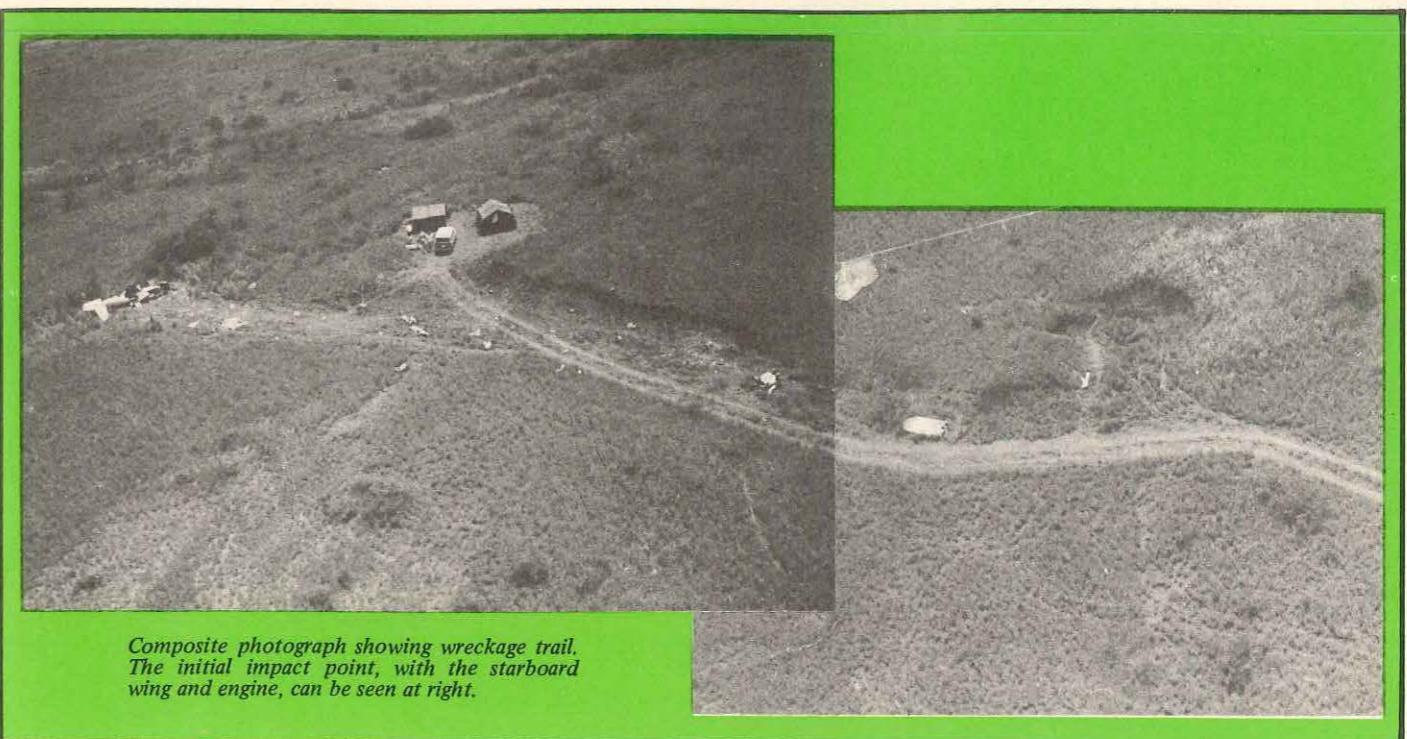
The still-burning wreckage trail of the Aztec, photographed from the Cessna 206, shortly after the crash. The initial impact point is at the left of the picture.

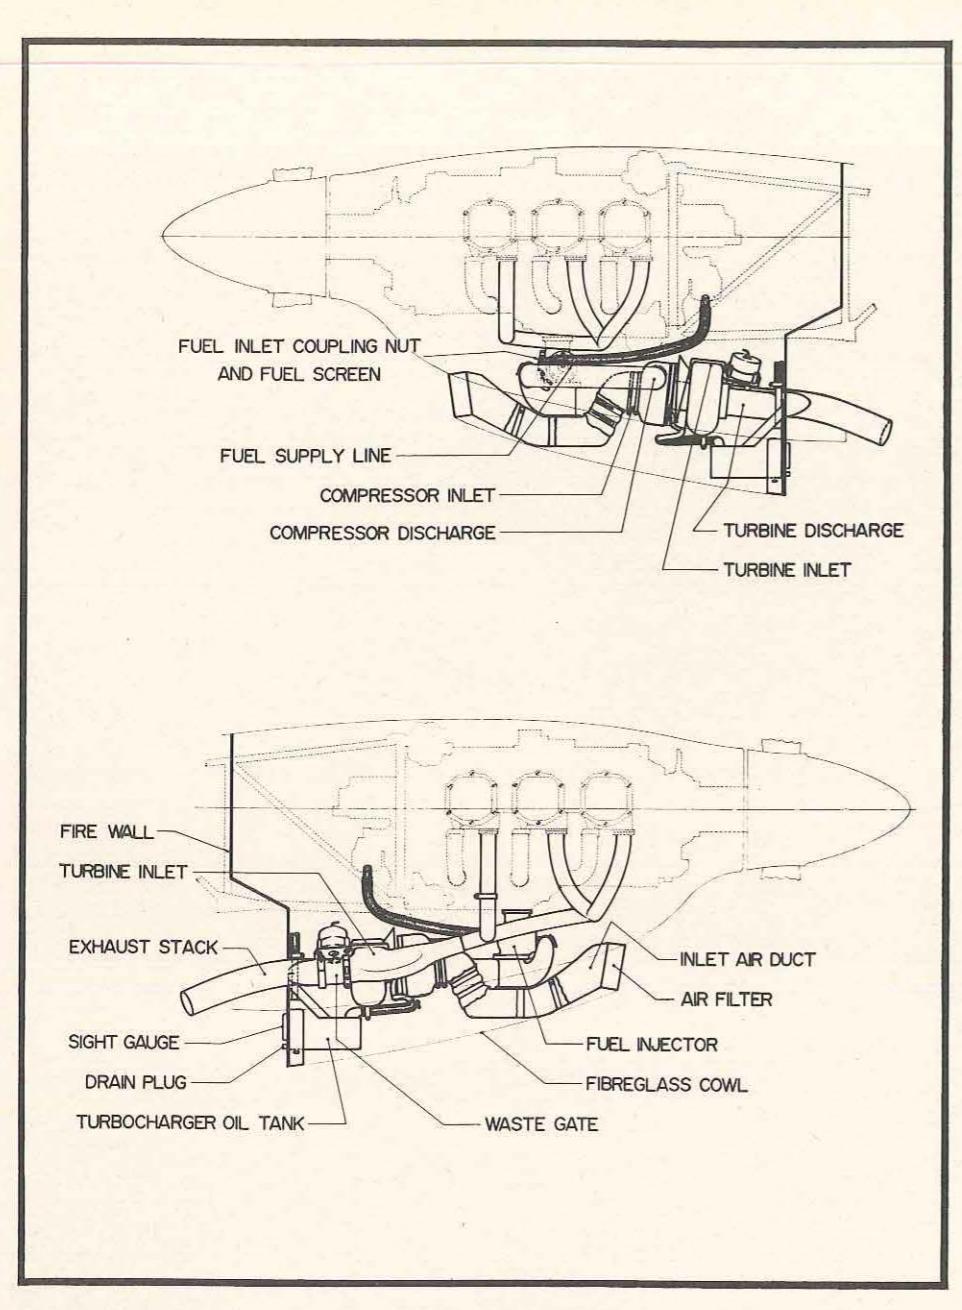
TURBOCHARGER INSTALLATION

engine revealed that the coupling nut that would have been uncovered when connecting the fuel line from the the turbo-charger oil tank was consumed. engine-driven fuel pump to the fuel At this stage, both the inboard and injector was loose about a third of a turn. outboard fuel tank lines were breached Further examination of the wreckage by the fire upstream from the fuel cocks, disclosed no other defect which could have contributed to the accident and, intensify the fire. As a result, the main with the exception of the structural spar had been subjected to intense heat, covered terrain about three quarters of a failures within the starboard engine reducing its load-carrying capacity until it mile nor'-nor'-west of the western end of nacelle, all damage was consistent with failed in upward bending close to the

From the results of the bench tests carried out during the investigation, it is understandable that while the coupling nut remained finger tight, no detectable leakage of fuel would have occurred. It seems likely therefore, that either during ing him with the engine inspection, or shortly after the take-off from Lae, the fuel line coupling nut worked loose, allowing fuel to spray out and collect in It is probable that the aircraft was at the bottom of the engine cowling. The about 5,000 feet when the fire became exhaust-driven turbo-charger installation evident to the pilot and, in these below the engine, operating at red heat. circumstances, his decision to land at would have provided a ready source of Nadzab which would have been at most ignition for this fuel and its vapour. Once only about four miles away to the north, the fire had started, the contents of the was jacked and the airframe inspection light alloy turbo-charger oil tank and its was entirely proper. While it is obvious associated lines, which were directly in that the aircraft could have been on the Next morning, the L.A.M.E. was a little the path of the fire, would have provided ground sooner had it been possible to late in getting to the hangar, and found a further source of fuel. It is evident that land into the west, as the pilot of the 206 that the engine cowls were already being on becoming aware of the fire, the pilot at first thought the Aztec was going to

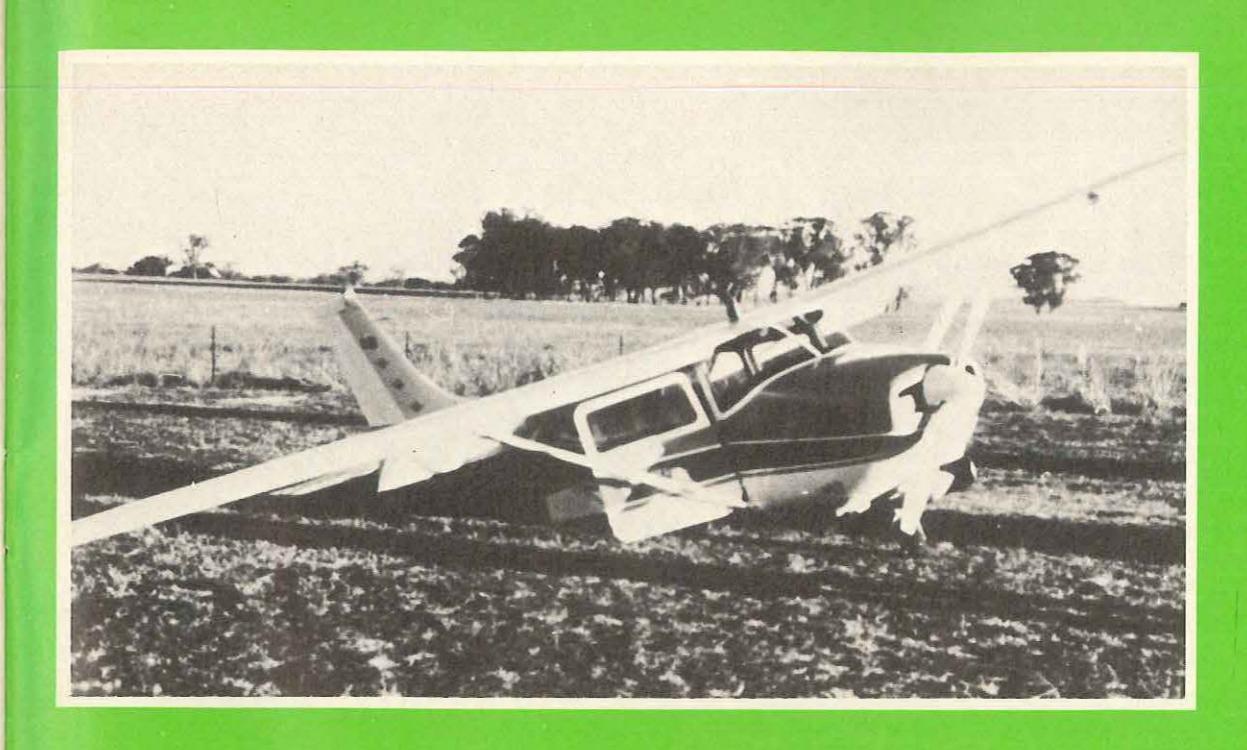
With two passengers on board this Cessna 210 a private pilot departed from Cudal, New South Wales for Merimbula via Bankstown. The initial stage of the flight was uneventful, but on landing at Bankstown the pilot discovered that the starboard brake was not working at all With the assistance of a local instructor, the pilot diagnosed the fault as a hydraulic leak and refilled the reservoir. The instructor suggested looking into the problem further, but the pilot declined, saying that he would have the trouble rectified on his return to the workshops at Cudal Immediately after take-off the tower notified him that the starboard undercarriage had failed to retract. The pilot subsequently cycled the gear several times, but this failed to rectify the problem, so after an aerial and visual inspection from the ground, the pilot was given permission to return to Cudal for an emergency landing. All preparations were made at the field and detailed instructions were passed to the pilot on how to conduct the landing. After touchdown the pilot held the wings level with aileron for as long as possible, then as the wing began to lower, he swung the aircraft to the right. In this way he was able to keep the wing tip off the ground until the aircraft had almost come to a stop.

The pilot is to be congratulated on his skill in landing the aircraft with a very minimum of damage. Nevertheless, it needs to be said that the accident could have been avoided altogether if the hydraulic leak had been investigated at Bankstown. This would have revealed that the starboard undercarriage actuator spindle had fractured.

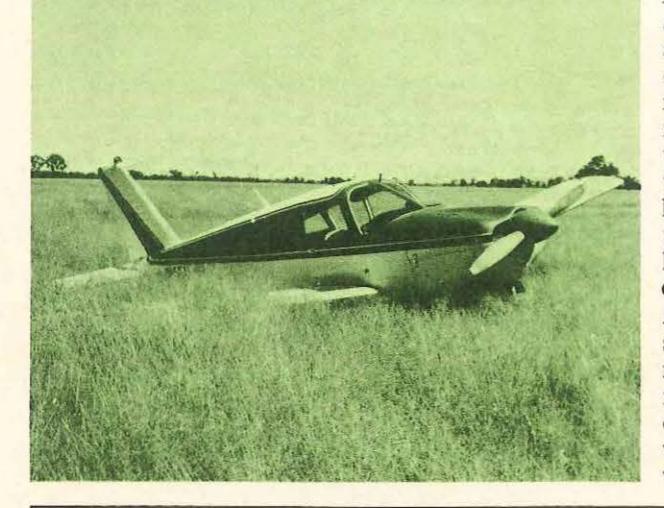
At the end of a charter flight to Gulargambone, N.S.W., the pilot of a Cherokee had difficulty in finding the airstrip adjacent to the town. He had not landed there before and as a result of recent heavy rain, the area had become overgrown with long grass. The pilot therefore flew to another strip on a private property four miles away. This strip also was overgrown but its outline and tyre markers were clearly visible. After a normal landing, the pilot parked the aircraft and the occupants went into town. Returning several hours later, the pilot and his passengers walked along the strip and found the surface satisfactory. They boarded the aircraft and the pilot began his take-off run. But when the aircraft had accelerated to about 60 knots, several sheep suddenly ran out of the long grass directly across the take-off path. The pilot immediately lowered an additional notch of flap and attempted to lift the aircraft over them, but its speed was too low and it became airborne only briefly. As it did so, the occupants felt several severe thumps. As the aircraft sank back onto the ground, the pilot closed the throttle and moved the mixture control to idle cut off and the aircraft gradually heeled to the right until the wing tip contacted the ground. The occupants climbed out unhurt to find the starboard undercarriage leg collapsed and the wing badly buckled. Further back along the strip were three dead sheep which had obviously been struck by the undercarriage.

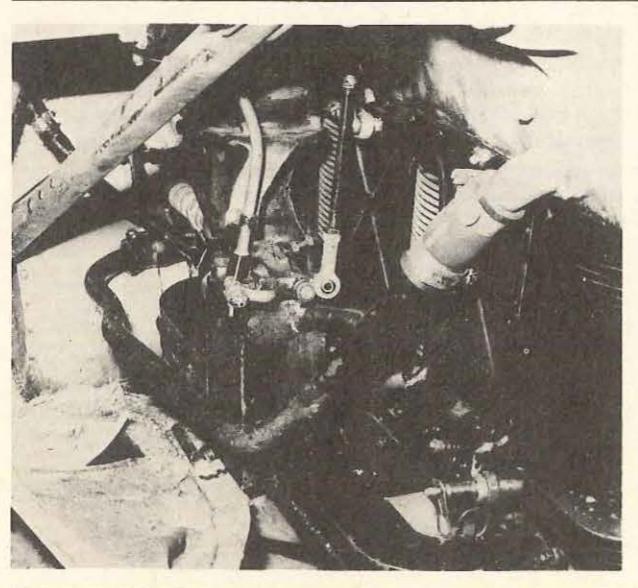
Late on a clear, still afternoon at Orange, N.S.W., a private pilot decided to take an Auster J5 on a local flight. He inspected the aircraft very thoroughly, as it had not been flown for some time, and ran the engine for about half an hour. Everything appeared normal and so he took off and after making some touch and go landings, headed for the local training area. After a further 45 minutes he returned to the aerodrome, and, after descending to circuit height, he attempted to apply power again to maintain altitude.

Although the throttle lever moved, the engine failed to accelerate above 1,400 RPM and it was obvious that the throttle had become disconnected. Turning on to base leg, the pilot lowered one notch of flap and then decided to "cut the corner" on to final. But he found the aircraft was now high, so he lowered a second stage of flap. However, the pilot soon saw that he would not be able to complete a landing within the confines of the runway, so he raised the nose and turned left to try and reach a cross strip that was behind him. By the time this 180 degree turn had been completed, the aircraft had lost height and speed. Shortly afterwards it stalled and crashed to the ground. The pilot was not hurt and when asked later why he did not attempt to control the engine power with either the switches or mixture, he replied "I did not think of it".

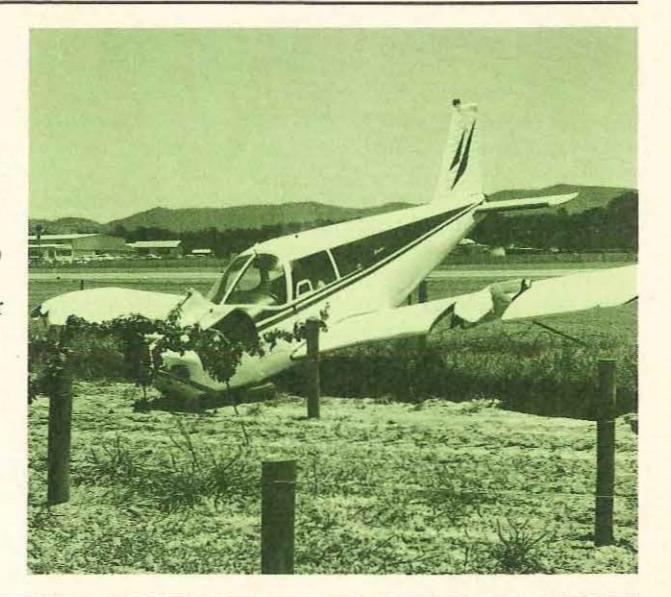
The student pilot of this Cherokee had been making a practice, during touch-and-go landings, of raising the flaps to the take-off position before applying full power. On the morning of the accident however, the student underwent a dual check with his instructor and the instructor told him to apply power first and establish a climb before selecting the flaps up. At the completion of the check, the student was authorised for further solo. By this time, there was a cross-wind of 10 to 15 knots.

The pilot carried out two successful "touch-and-goes", the first with no flap and the second using only take-off flap. He made his third landing with full flap. At a speed of about 55 knots, he again applied full power but the aircraft began to veer to the left. The pilot closed the throttle and although he prevented a ground loop, he was unable to stop the aircraft before it collided with a wire fence. The nose leg collapsed and the aircraft came to rest on its nose, badly damaged. With the flaps fully lowered, it seems almost certain that the main wheels lifted off the ground when the power was applied, and the aircraft began to "wheel barrow". This condition, which is highly conducive to directional instability, is the result of pilots holding the control column too far forward during the take-off roll.*

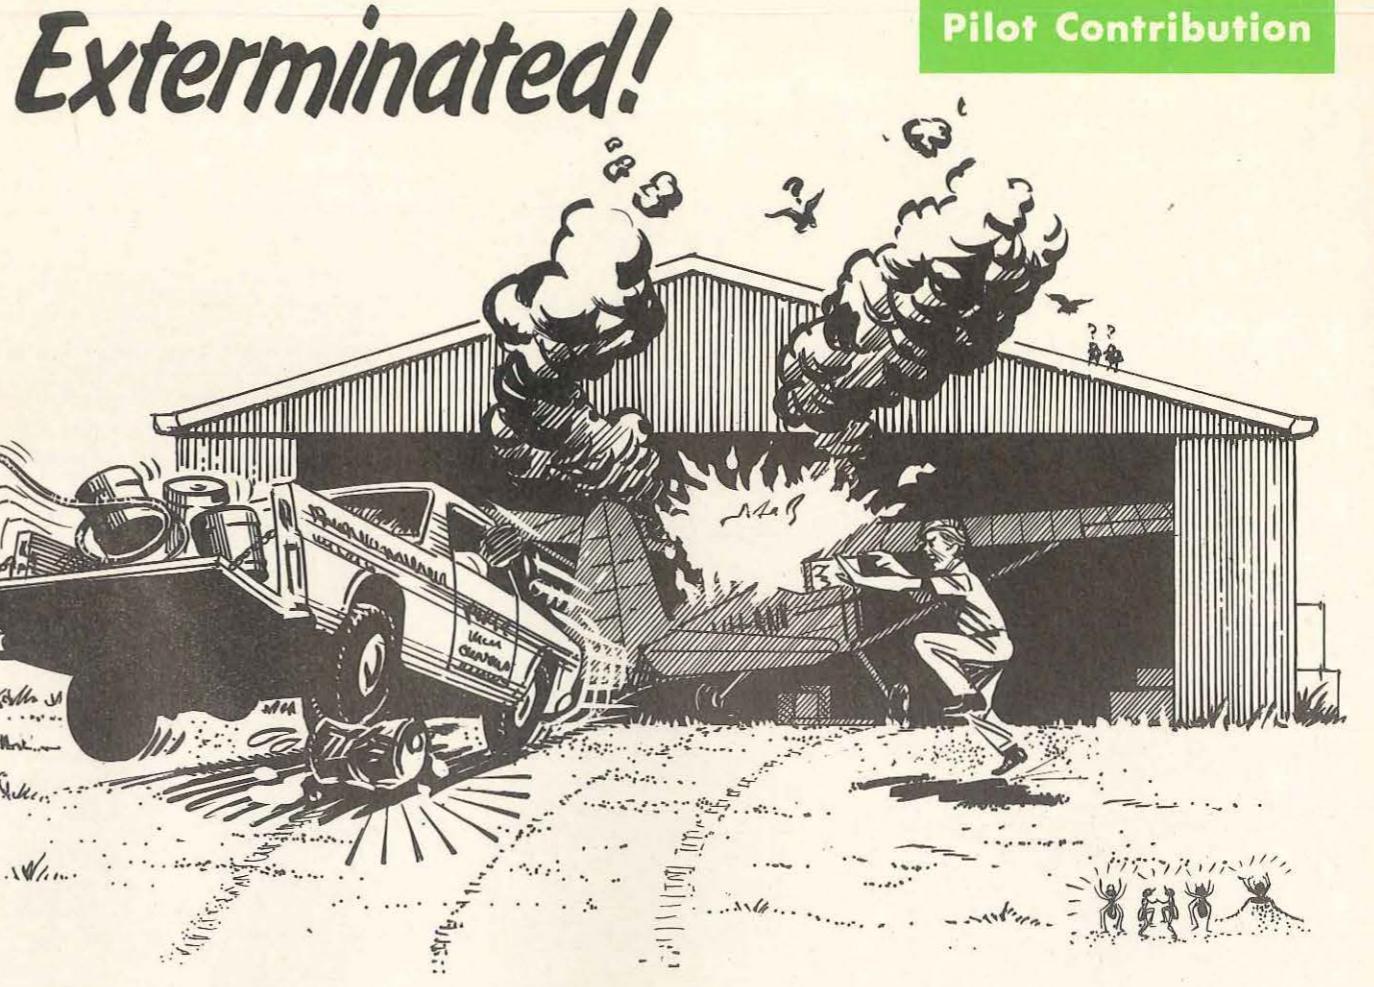
The Auster was completely destroyed I questioned this too, but he said it had and the hangar severely damaged, despite to be done to keep the gas in. He again efforts with fire fighting equipment which we brought from the house. The said he would spray the ground while the fire also spread to grazing land and a

I believe the fire was caused by sparks erupting from the "bombs" on to the fabric on the lower side of the fuselage.
