DEPARTMENT OF CIVIL AVIATION AUSTRALIA

Number 84 April 1973

# AVIATION SAFETY DIGEST

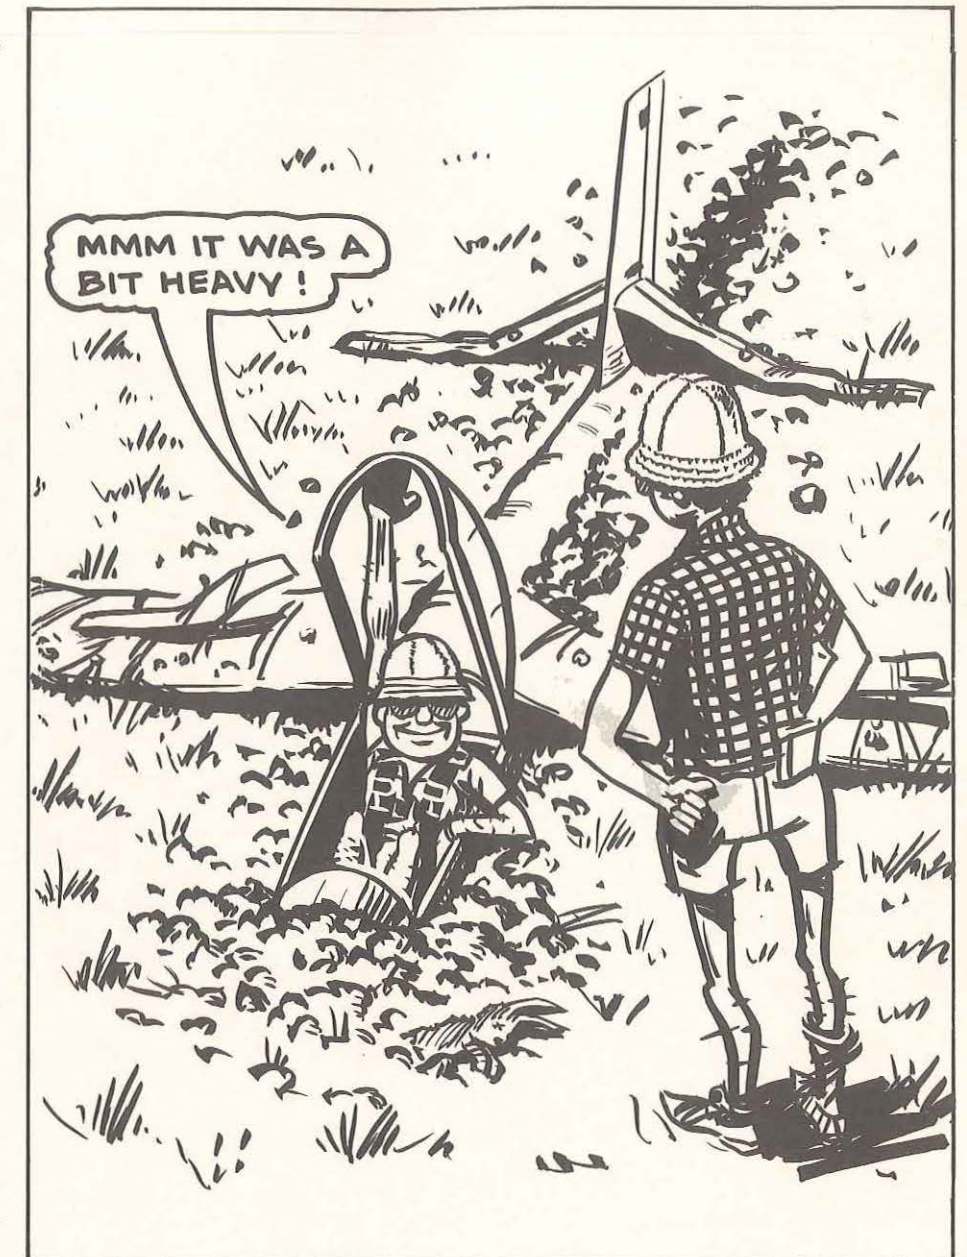
"...a stall and a very heavy landing."

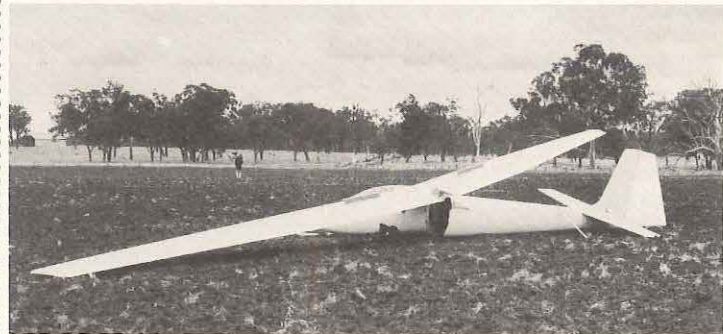
**T**HE pilot of this Slingsby Skylark was on the last leg of a competition cross-country flight, originating and returning to Massey Field, Warwick, Queensland. About 15 miles short of his destination, while soaring at 4,000 feet the pilot encountered overcast cloud and began losing height. When he had descended to about 2,000 feet, he began looking for a suitable paddock in which to make an outlanding.

From 1,500 feet, he selected a ploughed field which he considered suitable and well situated. The field was rectangular in shape, with its longer side of about 1,200 feet aligned north-south. The pilot circled the field twice, losing about 500 feet as he did so, and noticed that there was a powerline, also aligned north-south, passing through the middle of the field.

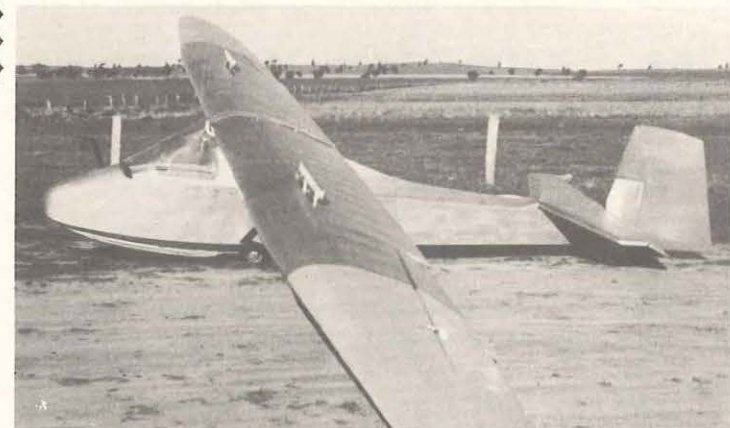
The subsequent investigation established that there had been no failure of the winch, and it

contributed to the force of impact.

Consideration was also given to the possibility that the club's procedure in laying the cable along one side of the strip, so as to keep it well away from landing aircraft, could have contributed to the accident. Laid in this way, the cable has a considerable bow in it when the launch commences, which is taken up as the launch proceeds. In the case of Kookaburra launches, because of the weight of the aircraft, this bow poses no problem, as the resulting slack in

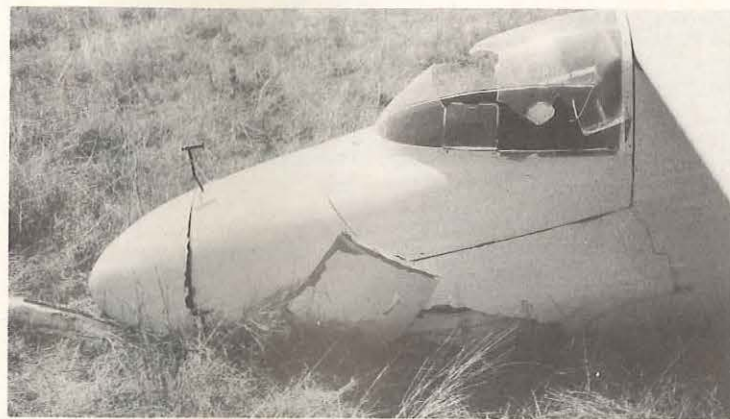
When about three miles downwind from the field, the Bocian broke off and returned to the aerodrome, but at about this time, the pilot of the Skylark found some particularly good lift. Wanting to make the most of it for his endurance attempt, he concentrated on working this

lift to the detriment of noticing that he was continuing to drift away from the field. The pilot admitted he was not paying as much attention to drift as he should have with such a strong wind blowing. When he finally ran out of lift altogether, he found himself at 3,800 feet, but six miles downwind from the field. At the Skylark's normal angle of glide of 24:1, this height would have been more than sufficient to return to the field, but against a 30 knot head-wind, it became a doubtful proposition. The pilot saw this might be so, but decided he would try it anyway.

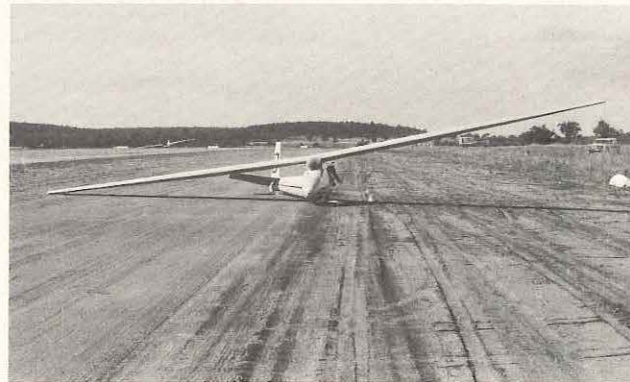
The evidence of witnesses who were watching the launch indicated that the glider was in a full climb attitude at a height of about 100 feet or less. Also, from the evidence of both the pilot and those watching from

the wing and the wreckage skidded to a halt about 50 feet from the initial point of impact. The pilot was not hurt.

It was learned that the winch driver, soon after he had opened the throttle to full power, had heard an unusual banging noise in the winch. At this stage he looked down the strip and saw the glider was still on the ground. Almost at the same time, he heard the winch engine
