DEPARTMENT OF CIVIL AVIATION Number 86 August 1973

OUT OF EVERYTHING

CATASTROPHIC

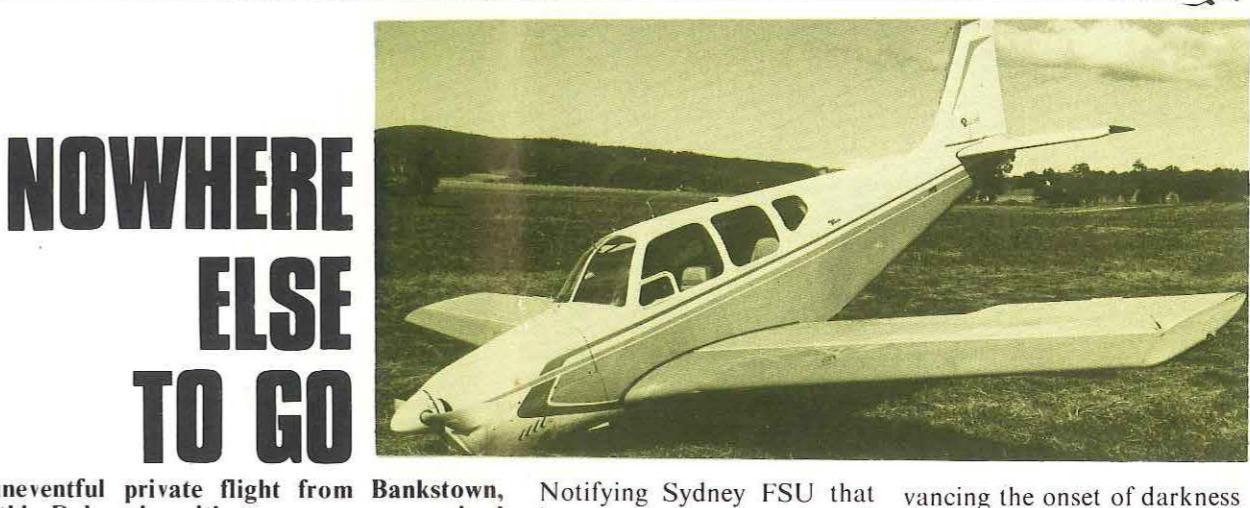
FTER an uneventful private flight from Bankstown, the pilot of this Debonair, with two passengers arrived A the pilot of this Debolian, with the pilot of this Debolian, with the pilot of this Debolian, with the pilot of this deboliant, with the pilot of Frontal weather had been forecast and, at about 1630 hours while the party were at the homestead a heavy storm broke.

After selecting one of several paddocks and making a low run across it towards the west, he saw there was a gully at its eastern boundary and that there were two diverging powerlines crossing its western boundary, but judged it suitable for a landing. He therefore climbed, carried out a circuit, and approached to land into the west. The aircraft approached over the gully, touched down about 100 feet in from the paddock boundary, and ran up a rise as the pilot applied gentle braking on the wet surface. As the aircraft passed under the first set of powerlines near the crest of the rising ground, he sighted the western boundary fence not far ahead and realised that he would not be able to stop the aircraft before reaching it. He applied full power and after passing under the second set of powerlines the aircraft lifted off, but too late to clear the fence. The undercarriage struck the fence, the nose pitched down and the aircraft struck the ground heavily, demolishing two more wire fences in quick succession before running across a road and tearing its way through a fourth fence. The aircraft then ran up an embankment, passing between two trees as it did so, slid over the top and overturned. The pilot, still hanging by his seat belt, was unhurt and, after turning off the master switch and fuel, released himself and climbed out of the wreckage without assistance.
