AVIATION
SAFETY
DIGEST

Number 87 1974
CONTENTS

Fatal Fuel Mismanagement	2
No Room for Recovery	6
Unlocked Door — Disaster	8
Taking Stock	12
Advice Heeded	16
Wake Turbulence	20
Mixture Control	22
Around the Industry	26
Blind Mans Buff	28

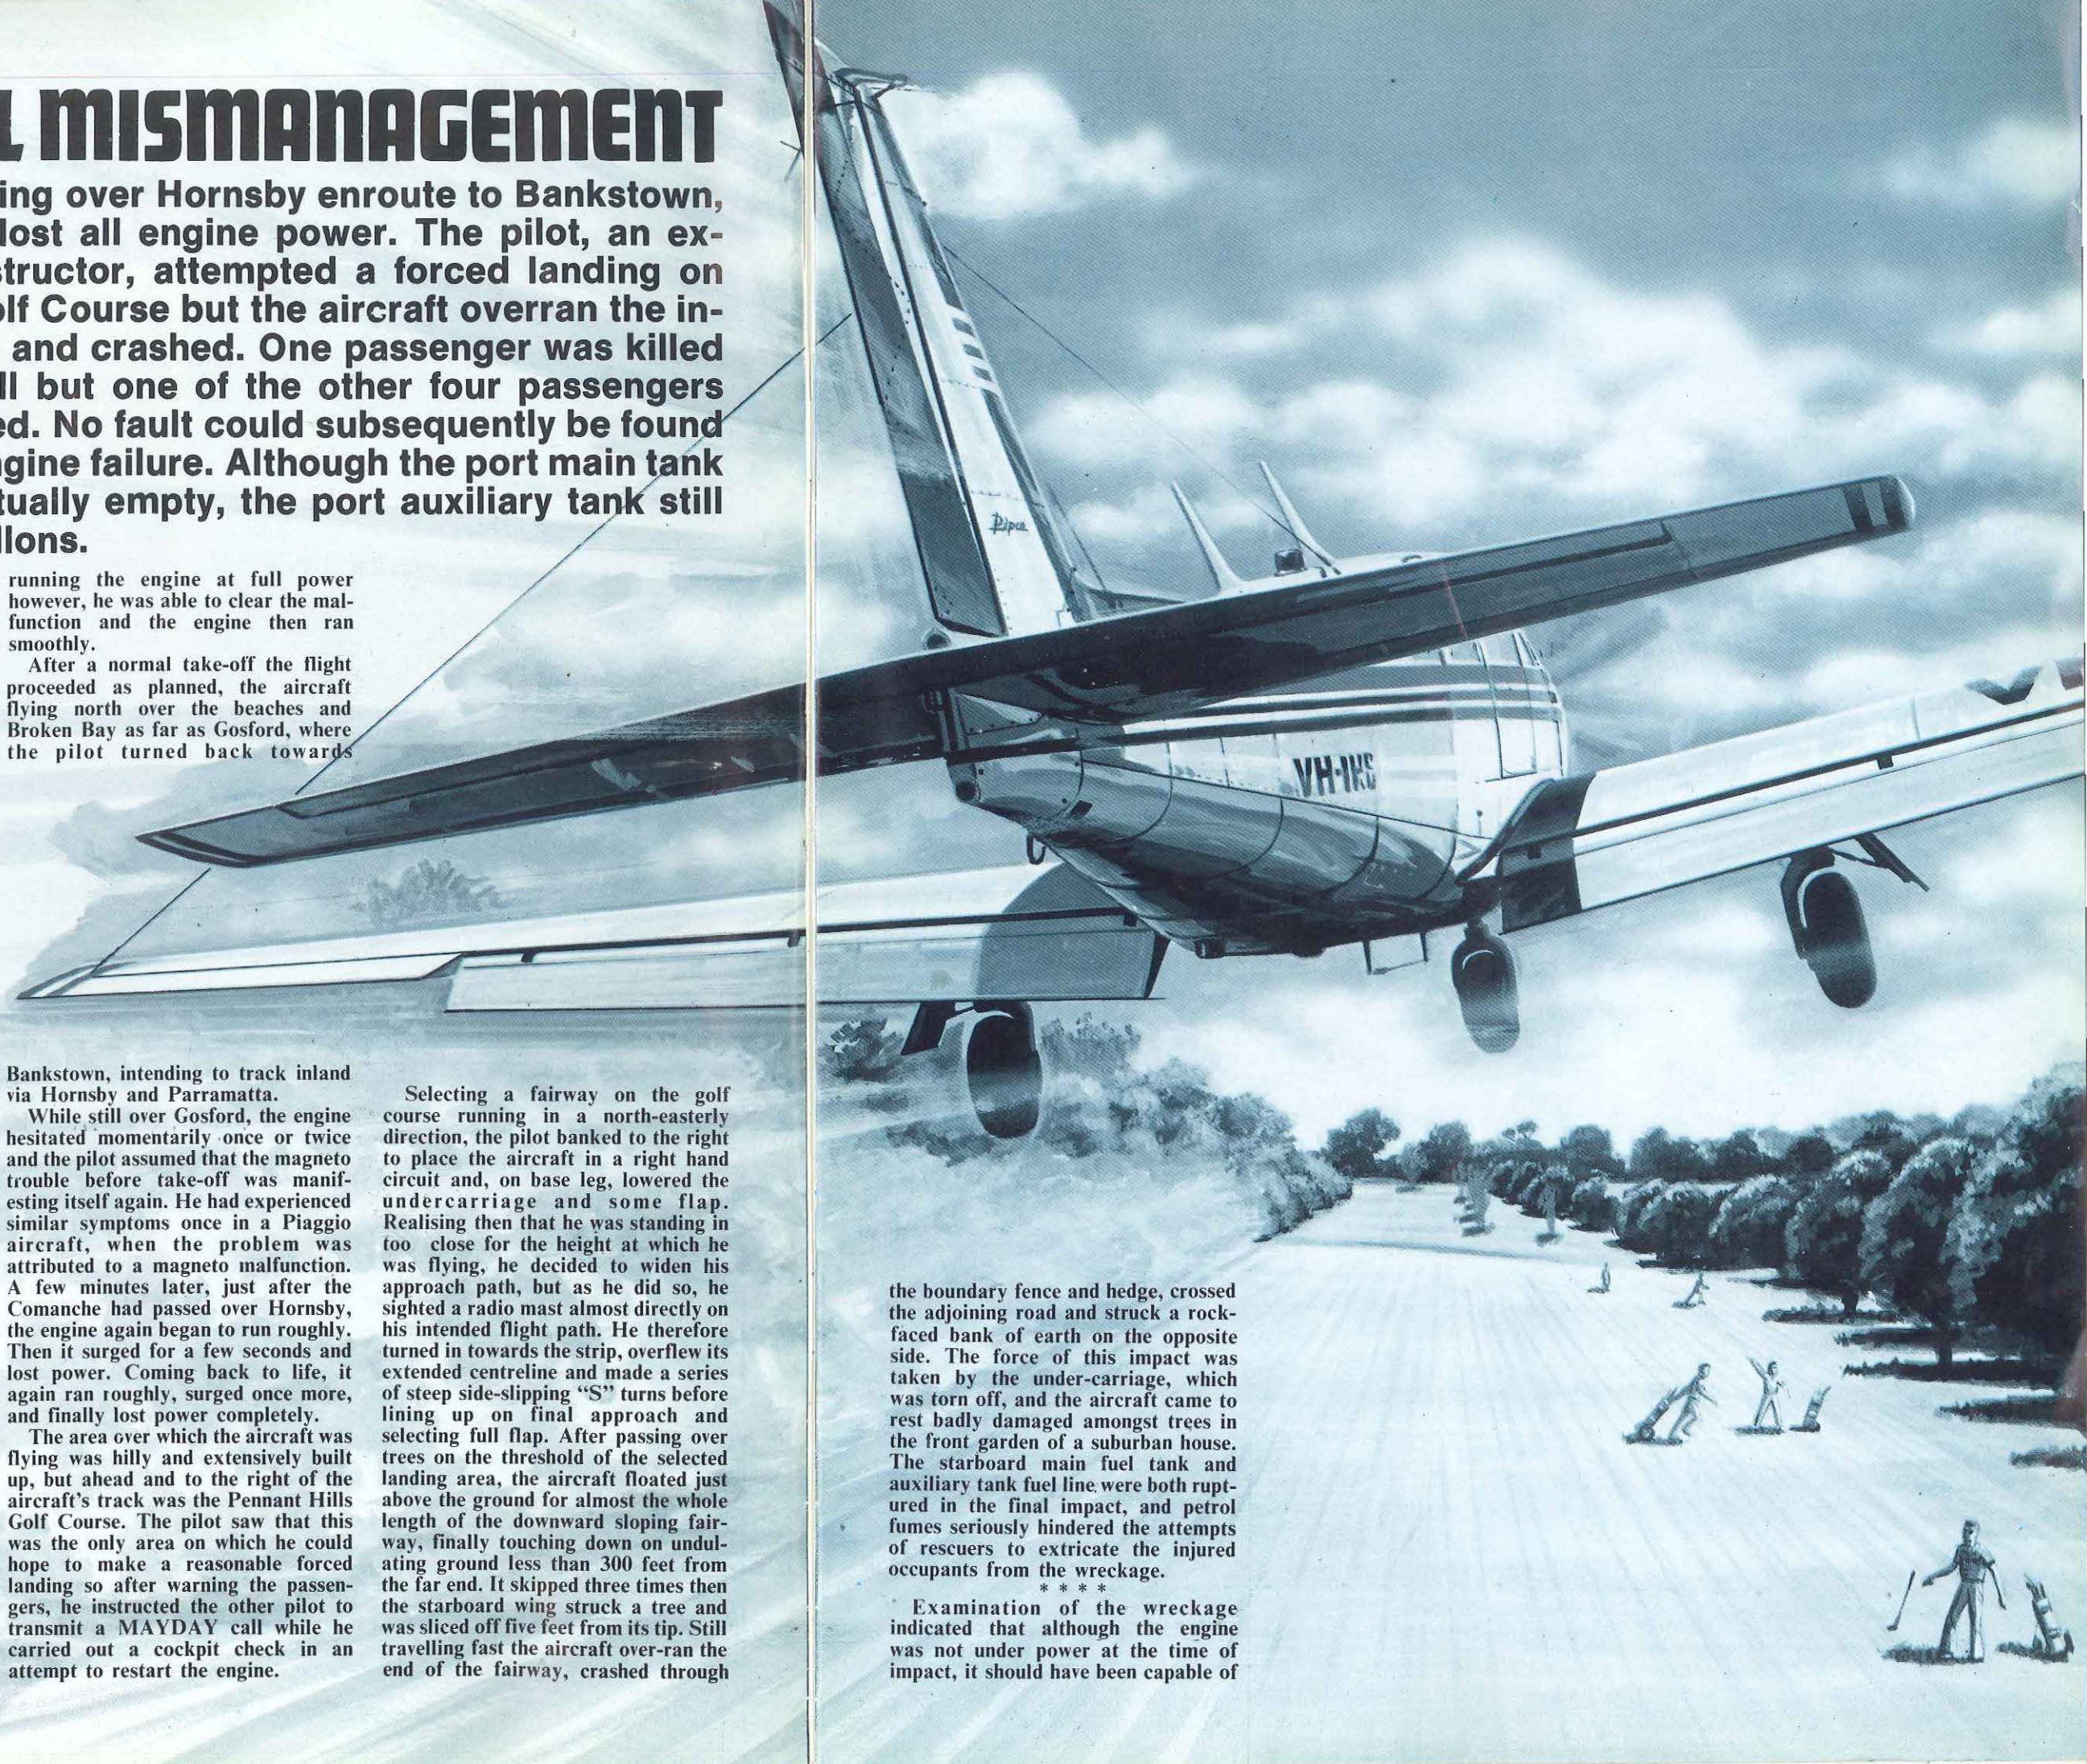
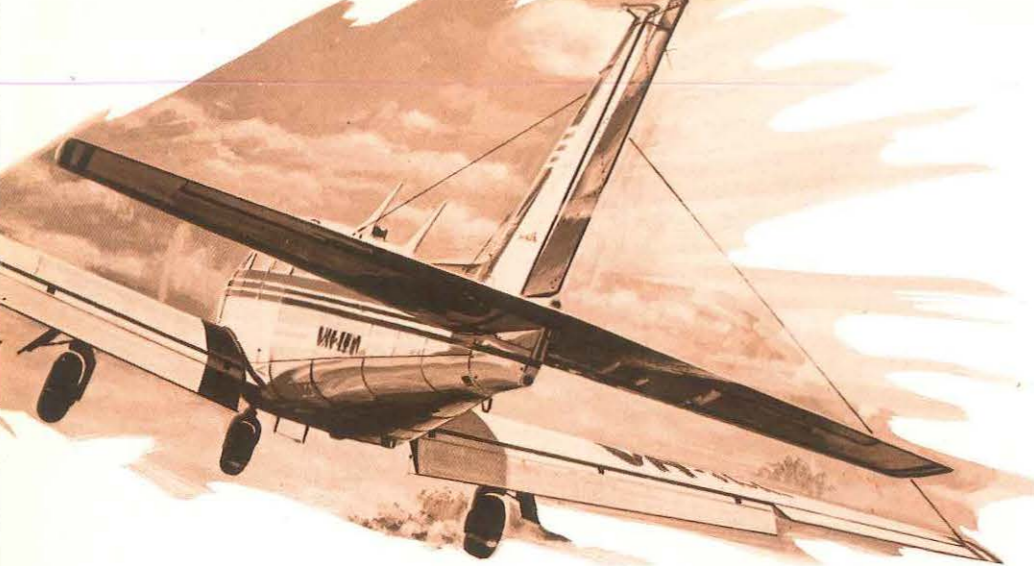
Examination of the wreckage indicated that although the engine was not under power at the time of impact, it should have been capable of

normal operation. The fuel selector was positioned to the port main tank which was empty. There were seven gallons in the port auxiliary tank. It was not possible to determine the quantity in the two starboard tanks because of the damage they had sustained in the final impact, but the soil beneath the damaged starboard wing contained traces of fuel to a depth of several inches and small amounts of fuel remained in the ruptured tanks. Little fuel was present in the fuel lines ahead of the fire wall, but the fuel selector assembly was found to function correctly in all positions. An electrical fault was found in the fuel gauge wiring, which caused the gauge to indicate full for each tank selected, regardless of the tank's actual contents.

The damage sustained by the engine itself was comparatively slight, and after being removed from the damaged airframe, it was mounted in the test stand and subjected to a 40 minute test run. Initially, excessive RPM drop was experienced when each magneto was tested in turn, but this eventually cleared and the engine then delivered acceptable power. The RPM drop was ultimately found to be resulting from a defective ignition lead but although the malfunction would have been sufficient to warrant rectification before flight, it was not considered to have had any direct bearing on the accident.

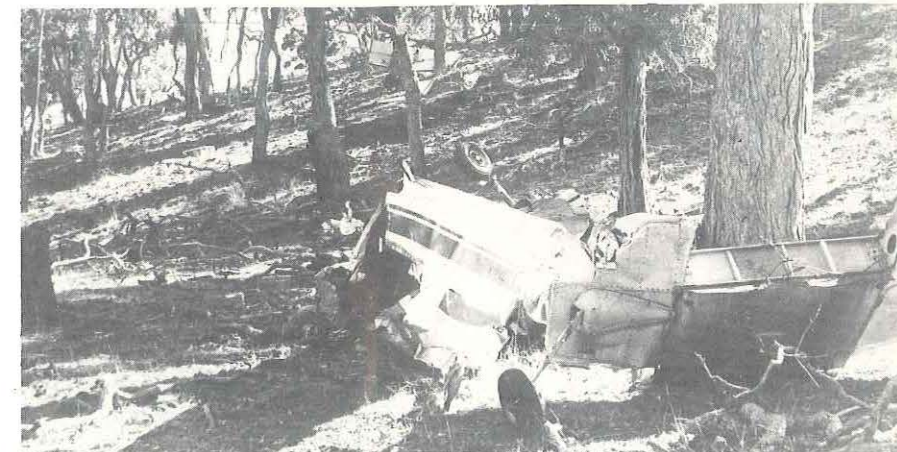
Fire had not broken out in the wreckage, and all major components of the aircraft were accounted for at the accident site. A detailed examination of the wreckage did not reveal any evidence of in-flight structural failure, or any damage to the airframe, its systems, or the engine other than that which could be directly attributed to impact with the trees or the ground.

badly damaged in the accident, its sub-scale was found to have been set close to the QNH current at the time. Its exact reading could not be determined, but it appeared to have been approximately 2,000 feet. The elevation of the accident site was 1,900 feet. The instructor normally operated from Bankstown and had probably carried out most of his aerobatic flying in the local training area, where the height of the terrain generally is not more than about 500 feet AMSL. On these flights, assuming it was his habit to set QNH on the altimeter sub-scale, his actual height above the ground would not have differed greatly from the altimeter reading. But on the flight on which the accident occurred, he was operating over unfamiliar terrain that was between 1,500 and 2,000 feet higher than he had been used to in the Bankstown training area. If, on this flight, he was using as his lower height reference an altimeter reading of 3,000 feet, the aircraft would only have been about 1,000 feet above terrain even though the altimeter, set to QNH, would still have been reading close to the range of indicated heights he normally used.

The probable cause of the accident was that an acrobatic manoeuvre was commenced at an unsafe height.

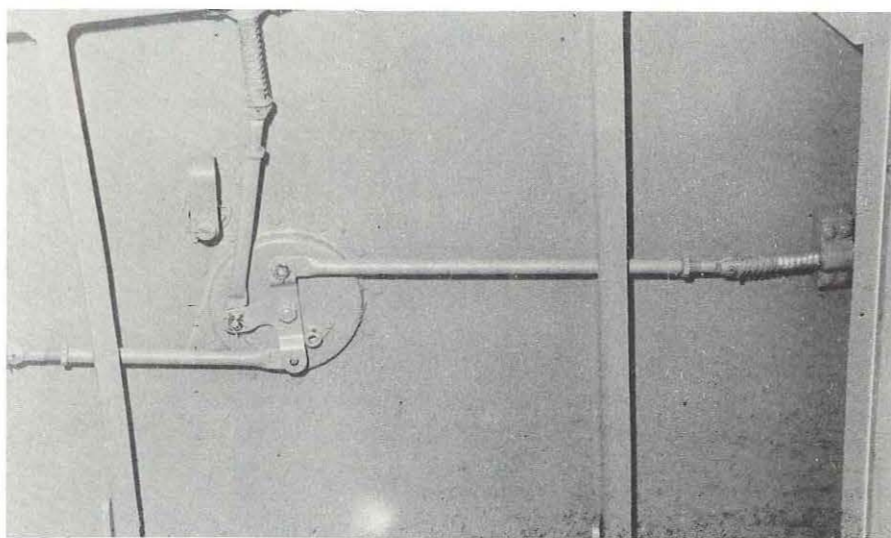
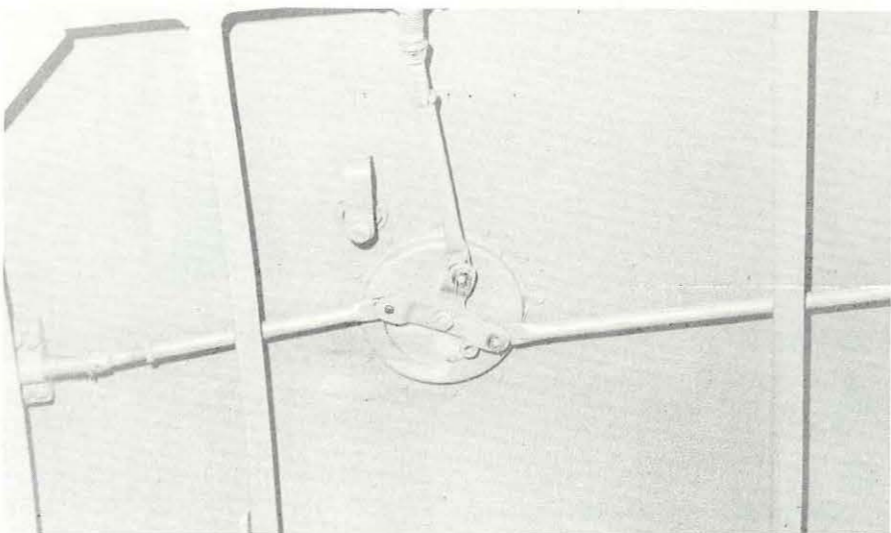
The forward cargo compartment door was recovered from the wreckage and the door locking mechanism, which was found in the unlocked position, was checked and found to function properly. The locking mechanism consists of three bayonet-type latches which slide into holes in the door frame and are held in place by an over-centre cam. During the locking operation which requires 40 inch pounds of torque, the overcentre cam action has a distinctive "feel" which serves as confirmation of its locked position. The statement of a pilot formerly employed by the oper-

CENTRE: Latched but not locked

BOTTOM: Latched and locked.
