AVIATION SAFETY DIGEST

Number 88 1974

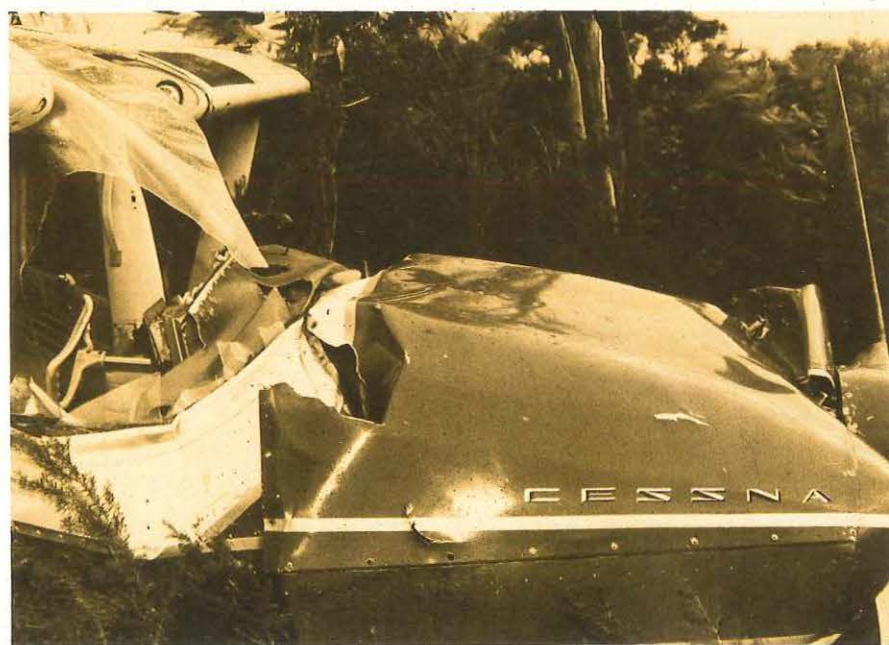
TOP: View of landing area. Wreckage is in scrub at right of picture.

CENTRE: The badly damaged Cessna after the accident.

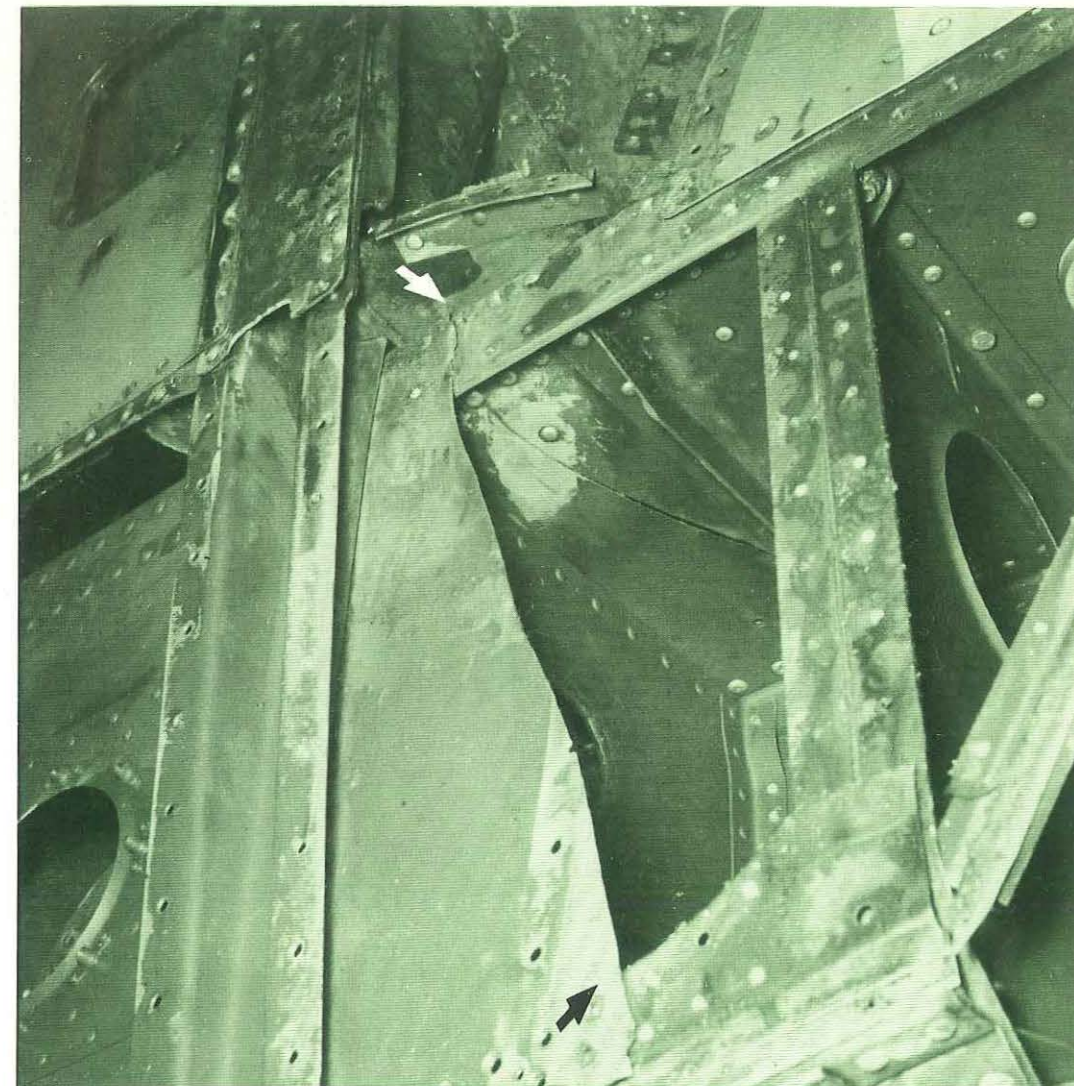
A careful visual inspection of the wing structure through the available access panels, revealed that the web of the main spar was cracked through, close to the inboard side of the engine nacelle. To gain further access to the area of failure, the lower rear engine nacelle skin was removed, and the access panel in the firewall was cut open. It was then discovered that, as well as the cracked spar web, the lower cap of the main spar was cracked completely through, just inboard of the inner support beam for the starboard engine, as was an adjacent wing skin panel previously hidden by the engine nacelle. There were signs of earlier fire damage in the area of the spar failure inside the nacelle. Conductivity tests revealed that the metal of the spar web, the wing skin, and the lower nacelle fairing, was reduced in strength within a radius of three to four inches from the broken spar cap. In this same area the primer paint had been scorched and, in some places, burned away completely.

The starboard wing was subsequently returned to the manufacturers for a detailed strip examination and the photograph at Figure 1 shows the underside of this wing, with the cracked piece of skin indicated by arrows. The position of the spar cap failure is beneath the arrow nearer the leading edge. When the inboard portion of this severed wing skin panel was removed, the spar web crack could be clearly seen, as could the crack in the lower spar cap itself. This is shown in Figure 2. The metal in the areas where the paint had been charred or burnt away, had been adversely affected by heat.

Figure 2 — Left:
Another view from underside of wing showing fractured wing skin panel. Note scorching and charring of skin in vicinity of spar cap failure at top of picture. The engine support beam had been removed before this picture was taken.

Figure 3 — Above:
View of main spar as seen from wing leading edge. The wing is inverted. Note evidence of burning in rectangular wing ducting.
