AVIATION SAFETY DIGEST

Number 89 1974
CONTENTS

Fatal Collision with Ridge	2
Nowhere to Go	8
Jammed Controls	13
Inviting Disaster	14
Carbon Monoxide Poisoning	18
Visibility Lost During Approach	20
Propeller Dangers	23
Wasps!	24
Another Case of Indigestion	26
Aerosol Cans — They Can Explode!	28

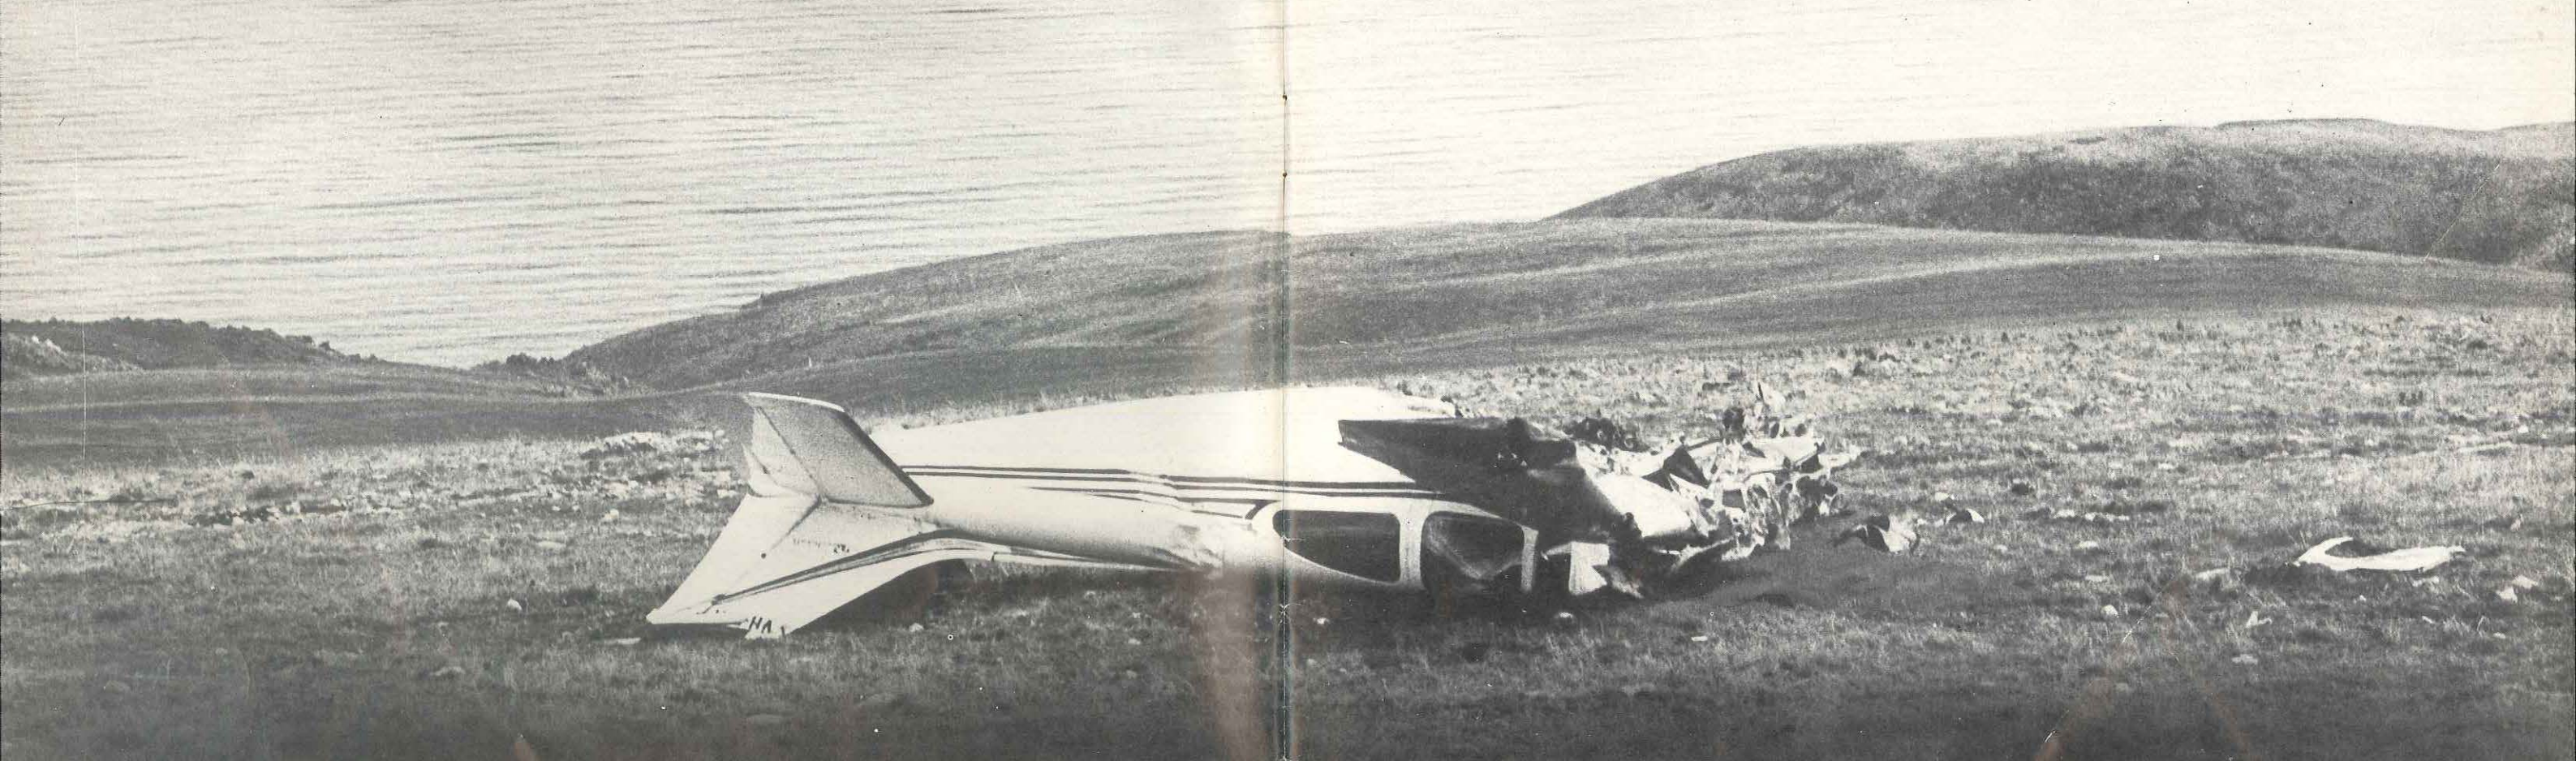
During the final stages of a VFR flight from Moorabbin, Victoria to Adelaide, South Australia, and while apparently descending towards St Vincent's Gulf preparatory to a visual entry to the Adelaide Control Zone at Port Noarlunga, a Beech Debonair struck the top of a ridge 680 feet above sea level, some 40 km south of Adelaide. The pilot and all three passengers were killed instantly. At the time of the accident, fog and low stratus cloud covered the hills south of Adelaide and there was extensive cloud above them.

Examination of the wreckage did not reveal any defect or malfunction which could have contributed to the accident and there was evidence that each fuel tank had contained an adequate quantity of fuel. The current area QNH of 1019 mbs was set on the altimeter and no evidence was found that it was other than serviceable prior to impact. No evidence was found to suggest that the aircraft had at any stage been out of control.

The cause of the accident was that the pilot continued the flight into weather conditions in which he was not able to maintain the visual references necessary to ensure adequate terrain clearance on his selected flight path.

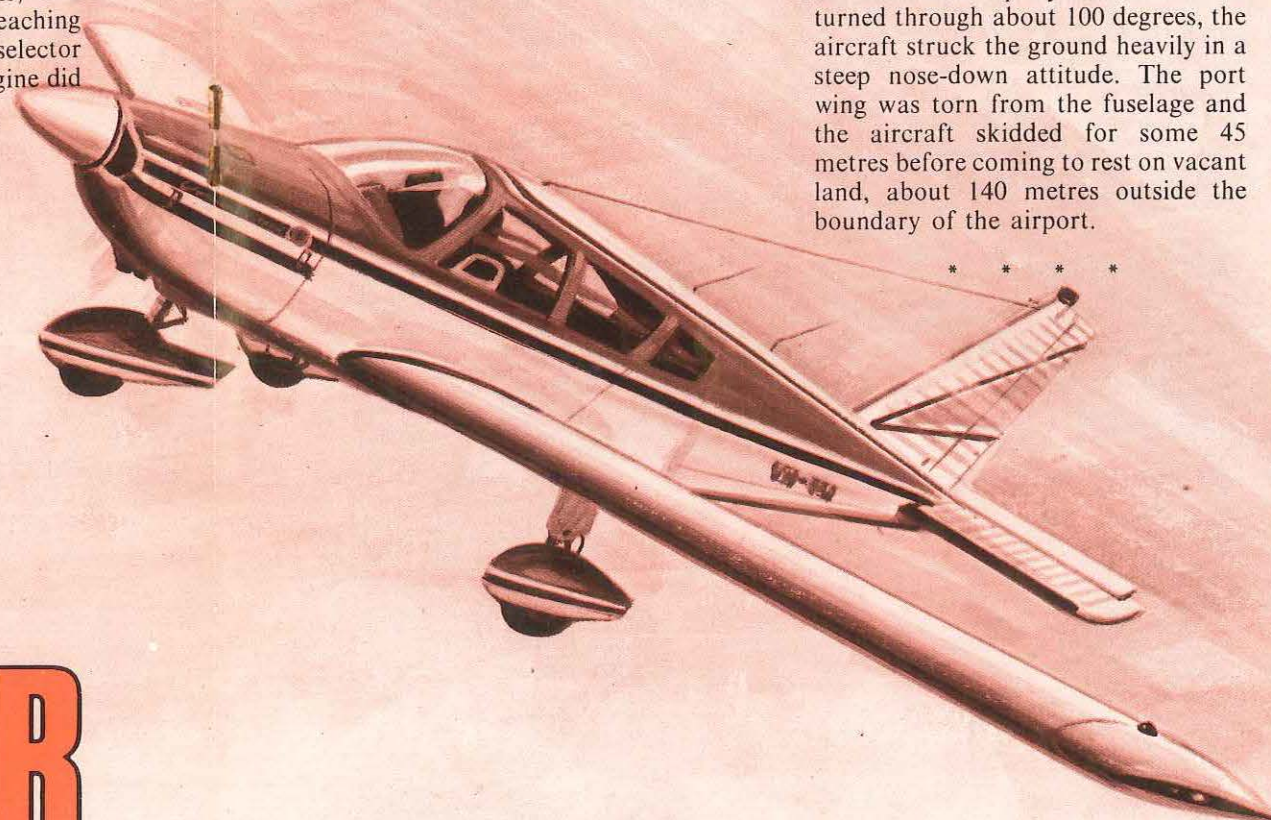
A detailed examination of the aircraft and its systems did not reveal any mechanical cause for the engine malfunction. During the on-site investigation, the fuel selector was found set between the port tip and port main tank detents and it is probable that this was the position selected by the pilot after the engine lost power. The entire fuel system, including the electric and engine driven fuel pumps, the fuel selector, fuel drains and system filters, and the tank vents, were all carefully checked but no defect was found.

The engine was subsequently removed from the wreckage and, after the impact damage sustained by some of the components had been rectified, it was fitted to a test stand to enable an engine-run to be conducted. The fuel selector and electric fuel pump from the aircraft were incorporated in the fuel plumbing to the stand so that the actual conditions in the aircraft at the time of the accident could be simulated as closely as possible. The engine started and ran normally and, apart from some degree of vibration believed to have been induced by a bent crankshaft, its operation could not be faulted throughout the power range. Tests were also conducted with the fuel selector positioned between the port tip and port main tank detents, and an adequate flow of fuel was still available to the engine. Flights were undertaken in a similar aircraft to establish the effect on engine operation of an open fuel drain valve, but the engine continued to run normally and the only result was a loss of fuel from the open drain valve.

No mechanical reason was found for the engine hesitating during the touch and go landing which caused the pilot to abandon his earlier take-off.

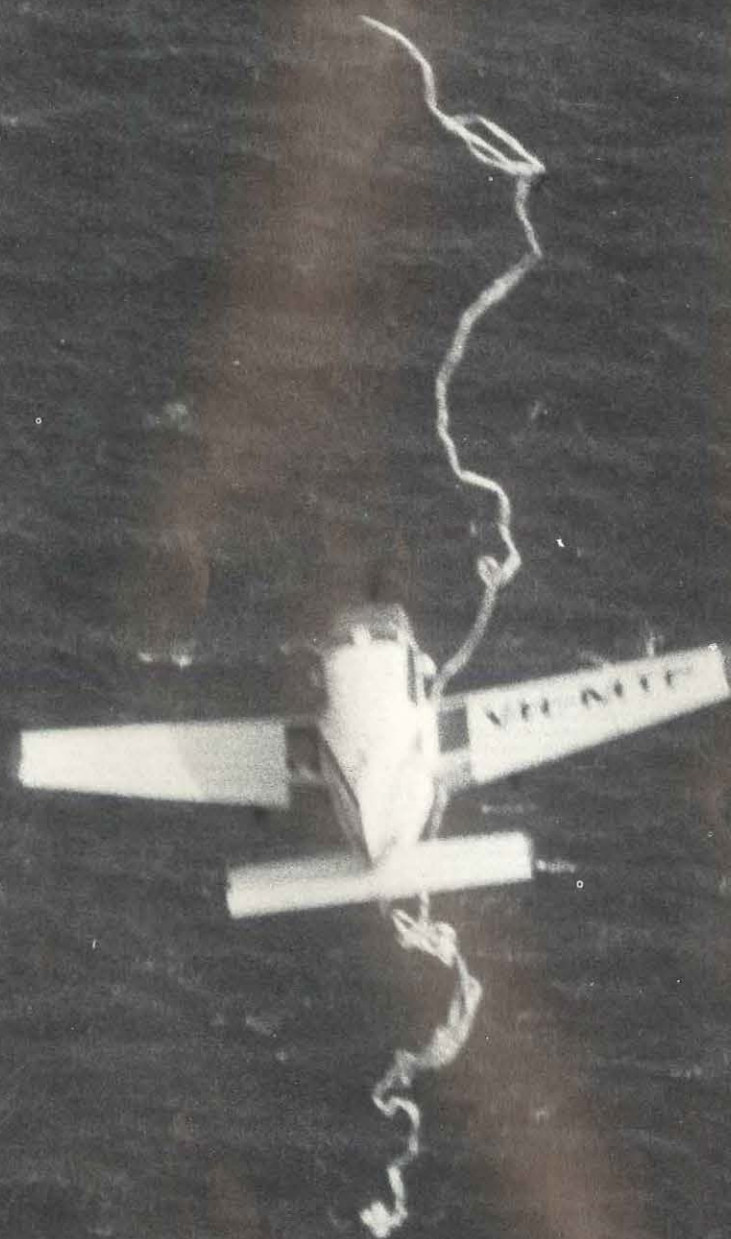
As in the case of the other Airtourer, when the engine was checked later, paper was found lodged in the throat of the carburettor. Although the operator of the aircraft did not recommend that pilots use carburettor heat during streamer cutting, it was learned that this pilot normally selected hot air just before throttling back preparatory to releasing the streamer. Once the streamer was clear of the aircraft, he then locked the canopy and returned the heat control to the cold position before continuing with the exercise.

It was concluded that on this occasion, the pilot had left either full or partial heat applied, with the result that a piece of paper had been sucked in through the hot air intake, passing through the heat exchanger and finally into the carburettor.
