Number 94 1976

AUSTRALIAN DEPARTMENT OF TRANSPORT

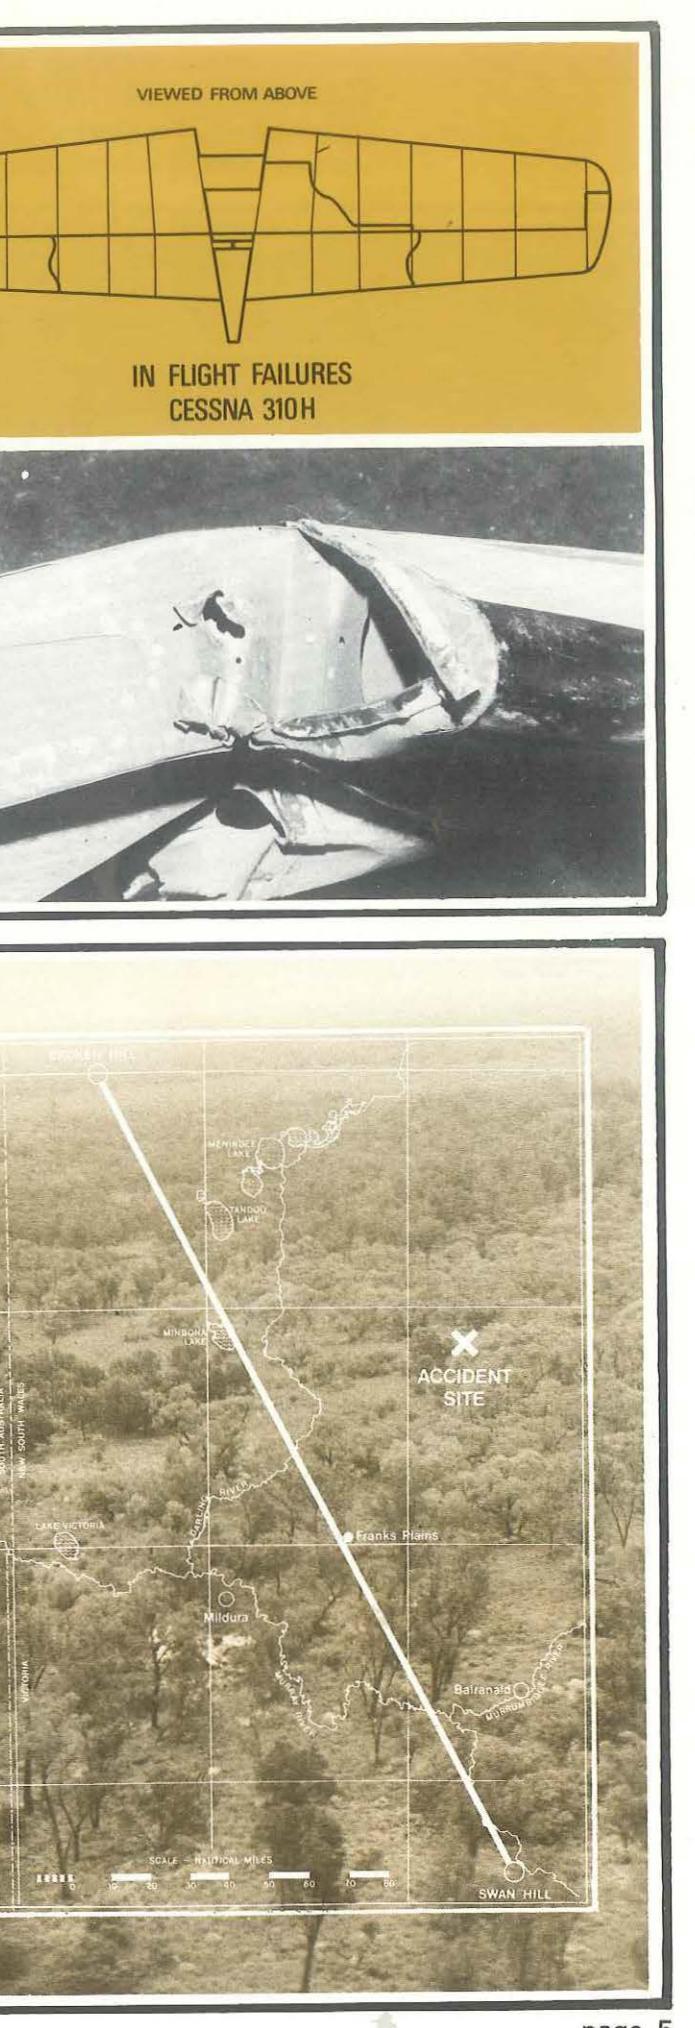
Detailed examination of the separated elevators and tailplane portions, showed that these had failed in flight as a result of aerodynamic overload. The failure had begun with a downward bending collapse of the port tailplane, under the effect of a substantial upelevator control input. There was no evidence of any constructional defect, nor of vibration or flutter having preceded the structural failure.

Top right: Diagram of 310's tailplane and elevators, showing in-flight failures.

Centre: Close up of inboard edge of port tailplane, showing downward-bending failure of front spar.

Bottom: The nature of the country in which the aircraft crashed is shown in this aerial view of the main wreckage. The obviously steep final descent path is evident from the lack of damage to the surrounding scrub.
