AUSTRALIAN DEPARTMENT OF TRANSPORT

Number 98 1977

AVIATION SAFETY DIGEST

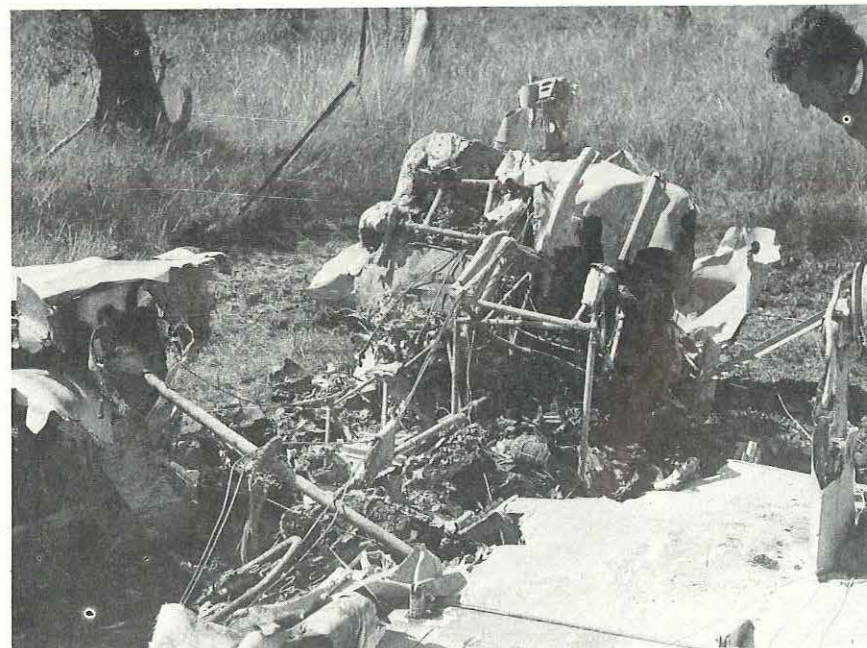
His original decision to track direct from Cessnock to Armidale over a formidable stretch of mountainous country with few clearly recognizable landmarks was unwise.

Navigation would have been much easier if he tracked further inland via a number of towns and roads. In addition, the forecast cloud should have warned him that visibility was likely to be difficult over the mountains. His action in pressing on even after encountering cloud problems was almost sure to contribute to his navigational difficulties. Once lost however, he acted correctly in calling for assistance, and he may well have been able to complete the flight safely by diverting to Tamworth. Yet, once he had sighted the agricultural strip, he apparently became convinced that it was important for him to land as soon as possible. This decision was certainly his to make, but the pilot had never before landed on a one-way agricultural strip. The strip was only 657 metres long and, at a height of 3700 feet above sea level, was a good deal higher than any other strip at which the pilot had operated. There is no doubt that the aircraft could have made a safe landing on the strip in the prevailing conditions, but the pilot misjudged both the wind conditions and his approach to the strip.

The wind, rather than blowing down the strip as the pilot had thought, was evidently a tailwind of moderate strength. Calculations have shown that in this aircraft on such a short strip, the decision to go around from a missed approach would have to be made very early to clear the obstacles at the far end.

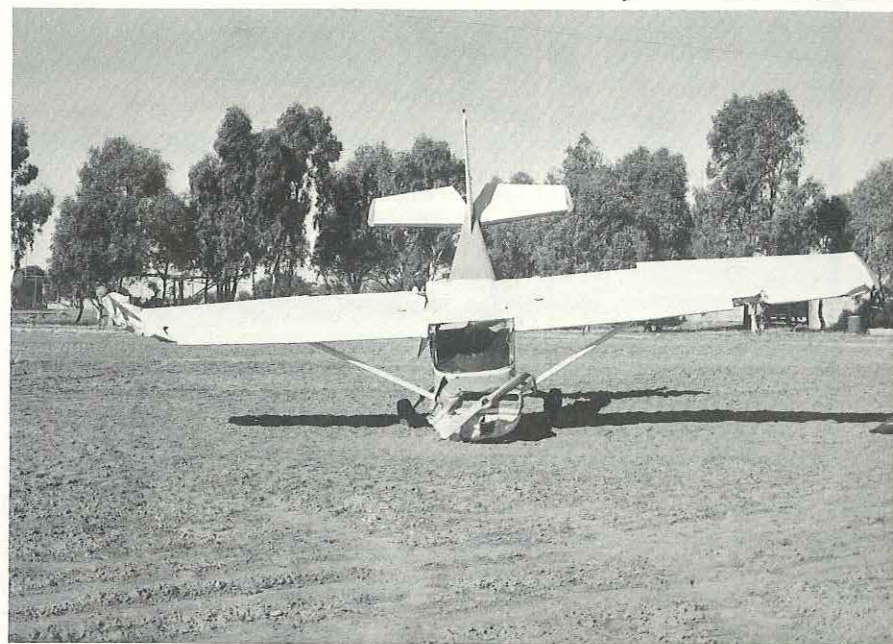
The pilot of this Cessna 150, who was not quite 20, had recently obtained his unrestricted private pilot licence, and had hired the aircraft for an afternoon's local flying from the farming property on which he lived. It was in fact the first time he had flown since his licence test nearly seven weeks before.

Towards the end of his sixth flight late in the afternoon, again with two children as passengers, the pilot was making a long low approach to land. In the glare of the westering sun he failed to notice the proximity of the power line to his approach path, and the aircraft struck the wires with its undercarriage at a speed of about 60

knots. The aircraft swung to the left, sliding sideways along the wires. Stretching them like a bow string, the aircraft quickly decelerated and struck the ground, collapsing the nose leg and compressing the engine mounting structure. The windscreen shattered at the same time and the child in the rear compartment was hurled out on to the ground.

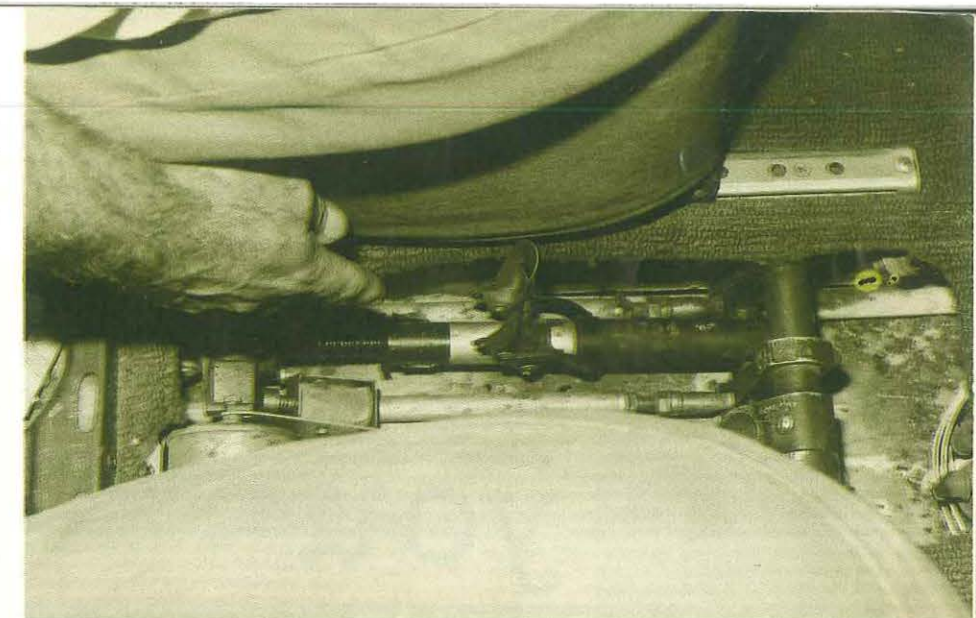
When the aircraft was inspected later, it was found that both voltage regulators had developed separate and unrelated defects. As a result, the aircraft's battery had become discharged and when the aircraft arrived over its destination, there was insufficient electrical power to lower the undercarriage in the normal way.

In the course of the investigation, the pilot twice demonstrated the procedure he had used in his attempts to lower the undercarriage manually. But each time he moved the motor release arm forward only to the vertical position, the point at which excessive force became necessary to obtain any further forward movement. With the lever in this position of course, the undercarriage mechanism was not disconnected from the actuating motor and the emergency operating handle could not be moved. In the conditions of darkness and high work load that existed at the time of the accident, it is clear that the pilot moved the motor release arm only to a point where he felt firm resistance against further movement and was misled into believing it had reached the limit of its forward travel.

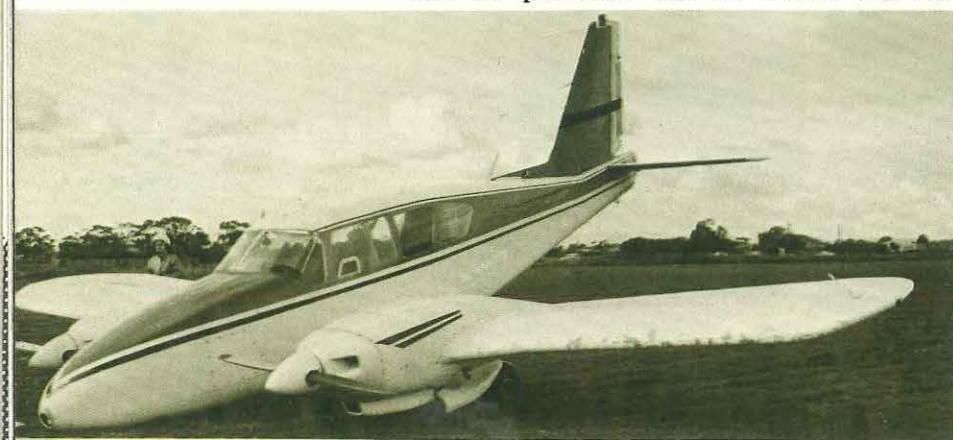
Top: The Aztec after its emergency landing, showing minimal damage which followed collapse of the nose leg.

'I turned the master and magneto switches off and touched down at a slow speed. The landing was smooth and at the last moment the nose dropped, collapsing the nose gear, and the aircraft slid along the grass nose-down. There did not seem to be much damage.'

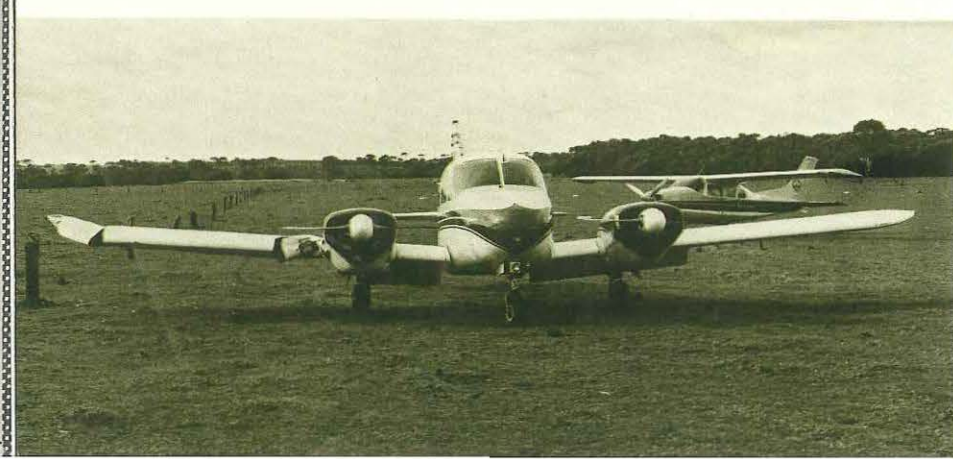
The Apache after striking the boundary fence during approach with both propellers feathered. Note the severe damage incurred by the starboard wing.

Examination of the aircraft after the accident, showed that the nose leg was fully down and locked. The failure of the green 'DOWN' indicator to illuminate was the result of nothing more than a dirty micro-switch.

Even if the worst had then come to the worst and the pilot had been unable to complete these actions in time for the touch-down, he would still have had the satisfaction of saving one propeller. And one bent propeller is surely preferable to the extensive damage which the aircraft actually sustained in this case!
