# Aviation Safety Digest

# Contents

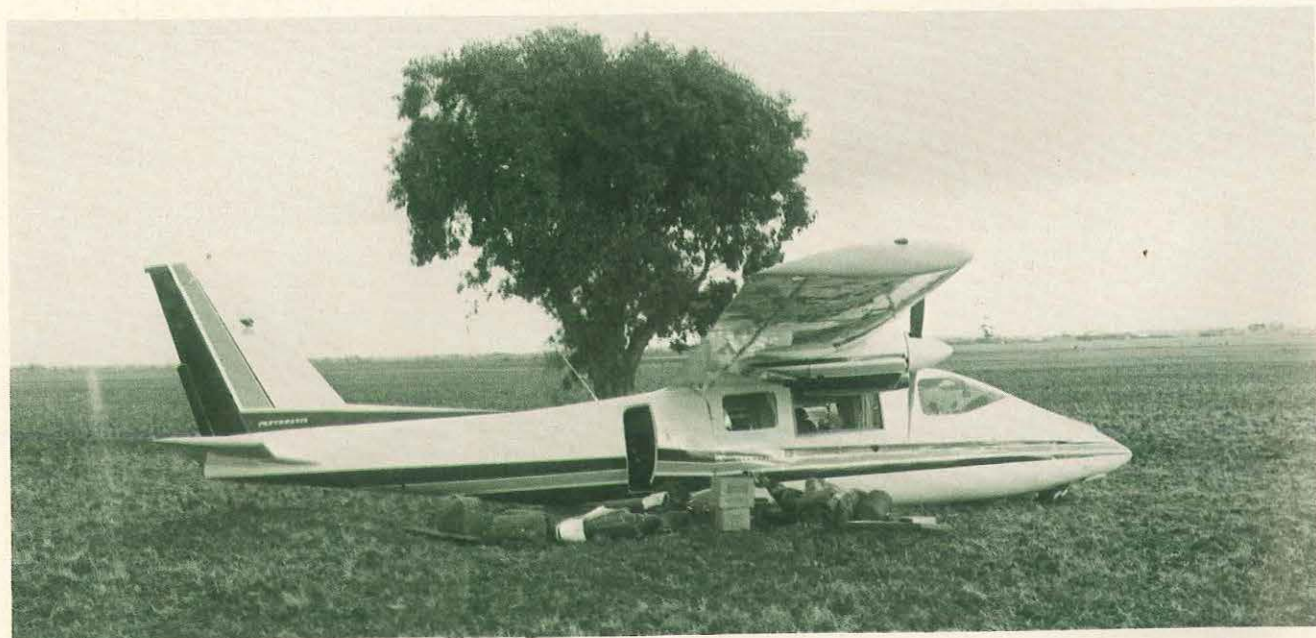
A party of five people, intending to go on a weekend hunting trip to an island in Bass Strait, organised a charter flight from a Victorian country airfield. The group said they would be taking with them three hunting dogs and a small amount of overnight camping baggage.

Because the aircraft was overloaded and the pilot did not select the flap to 15 degrees for take-off, the aircraft's actual take-off distance in the prevailing conditions would have been longer than that shown on the take-off weight chart in the approved flight manual. This chart

The development of this accident can be traced through a succession of hasty and ill-considered decisions. The haste of the pilot and passengers to depart, the inadequate loading procedures and the rushed cockpit checks all played their part in bringing the intended flight to a premature conclusion. It was fortunate that the consequences were not more serious.

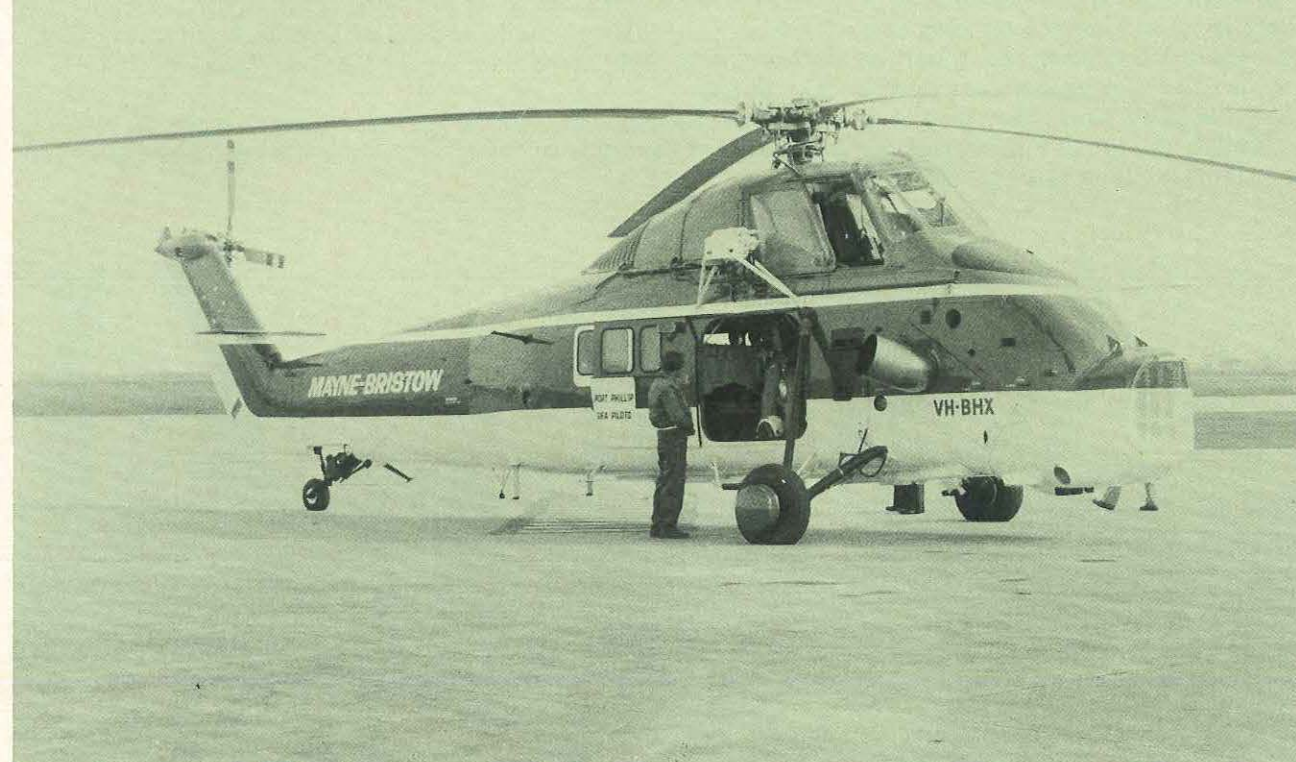
In a north-westerly wind of five to ten knots, a Sikorsky S-61N helicopter had made an approach to runway 35 and subsequently had moved off to the west side of the runway to allow a Chipmunk to land. The helicopter was hovering at an estimated height of 10-20 feet about 100 metres from the runway edge when the Chipmunk, 100 feet above the runway and over the centreline, experienced turbulence of sufficient severity to make control difficult. It was concluded that the Chipmunk was affected by the helicopter's downwash being deflected obliquely from the surface by the wind.

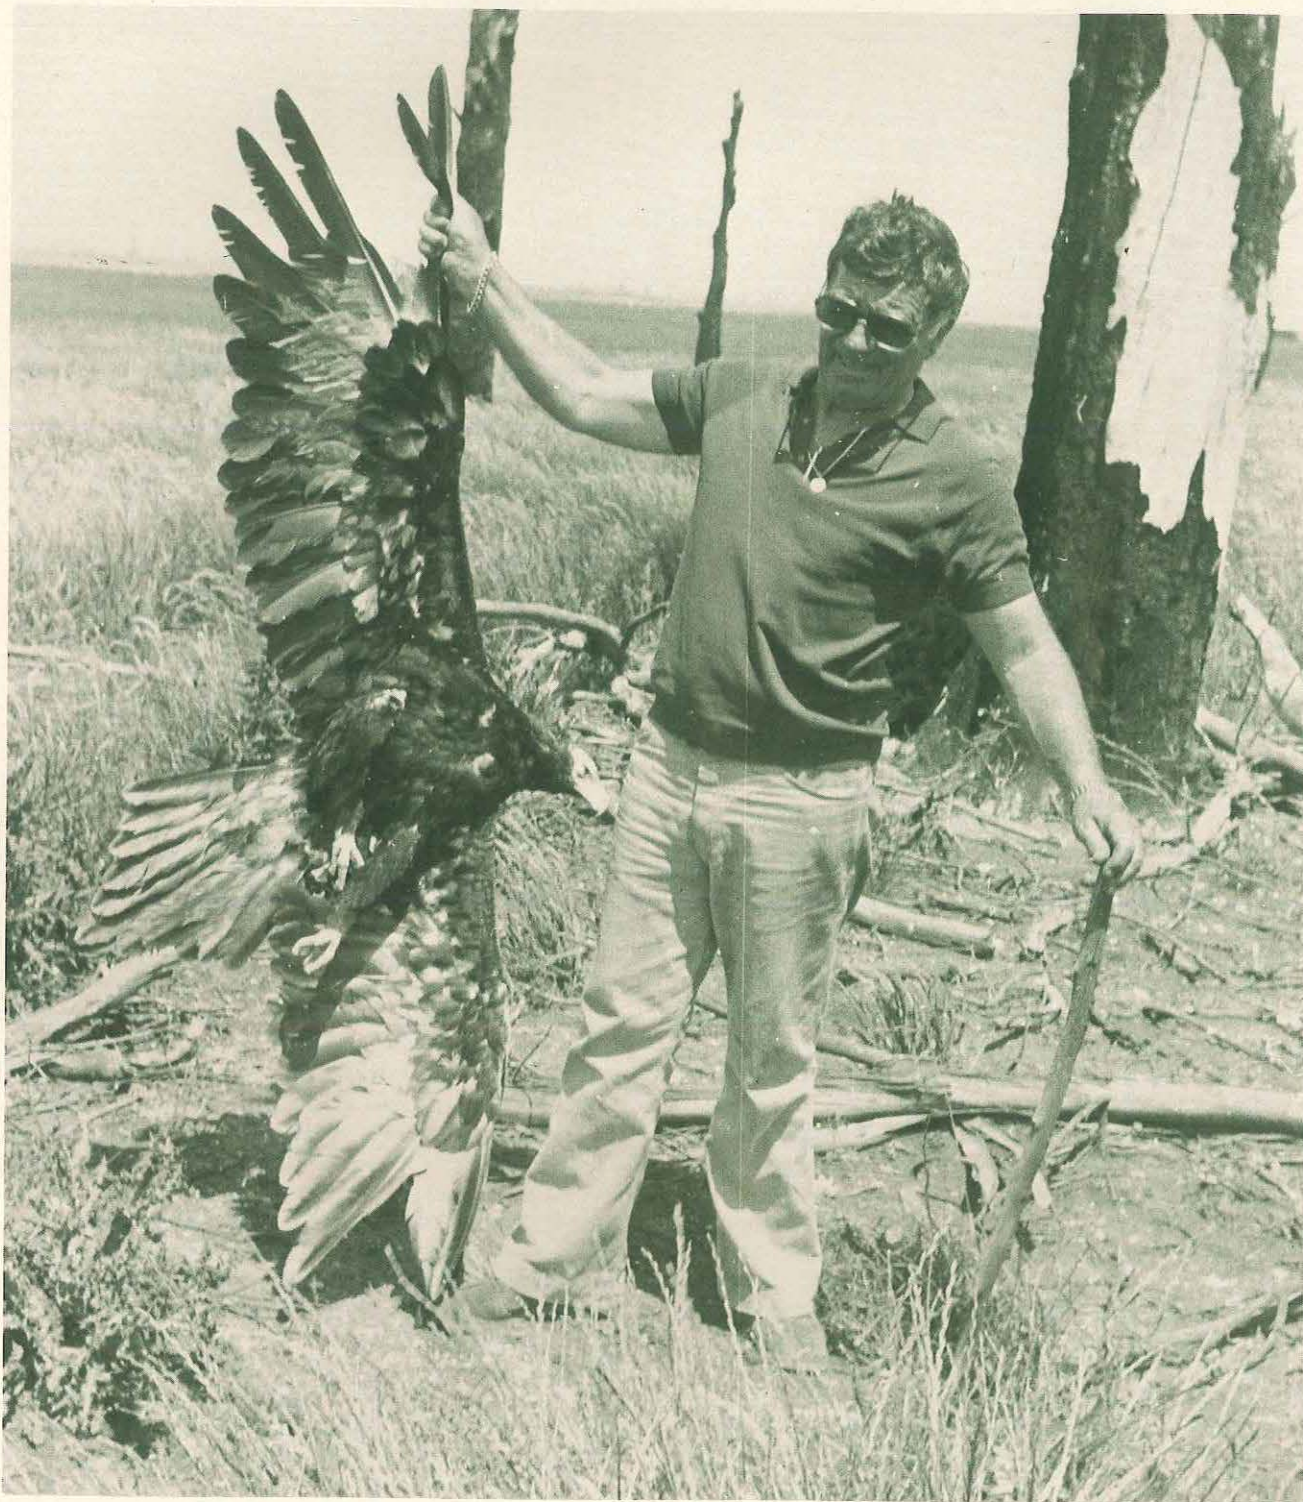
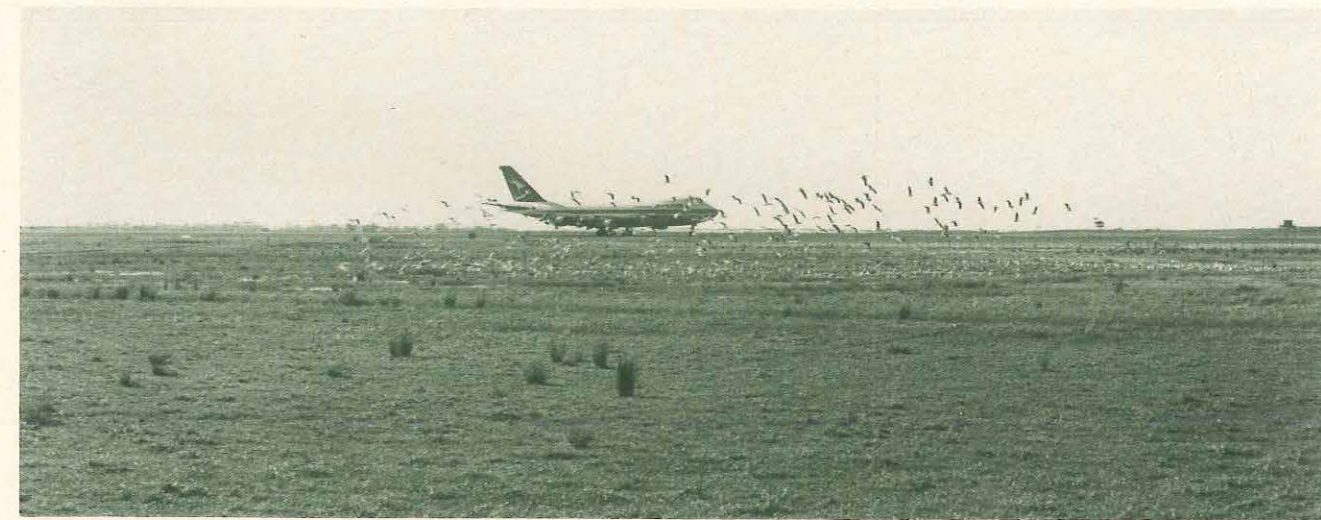
On final approach to Kowanyama, Qld, the captain of a DC3 observed a number of hawks over the end of the runway, apparently a common sight on a warm autumn morning. As the aircraft touched down, a number of birds took flight and one collided with the right hand windscreen which shattered, showering the pilots with glass slivers. The landing was completed normally and one of the pilots received medical aid for a minor cut above his eye.

On descent below 5000 feet, near Wonthaggi, Victoria, the left wing of a Beech 36 struck a large, unidentified bird. Aircraft control was not affected and the flight was terminated at Moorabbin without further incident. The leading edge of the left wing was buckled near the wing root.
