Department of Transport — Australia

106/1979

# Aviation Safety Digest

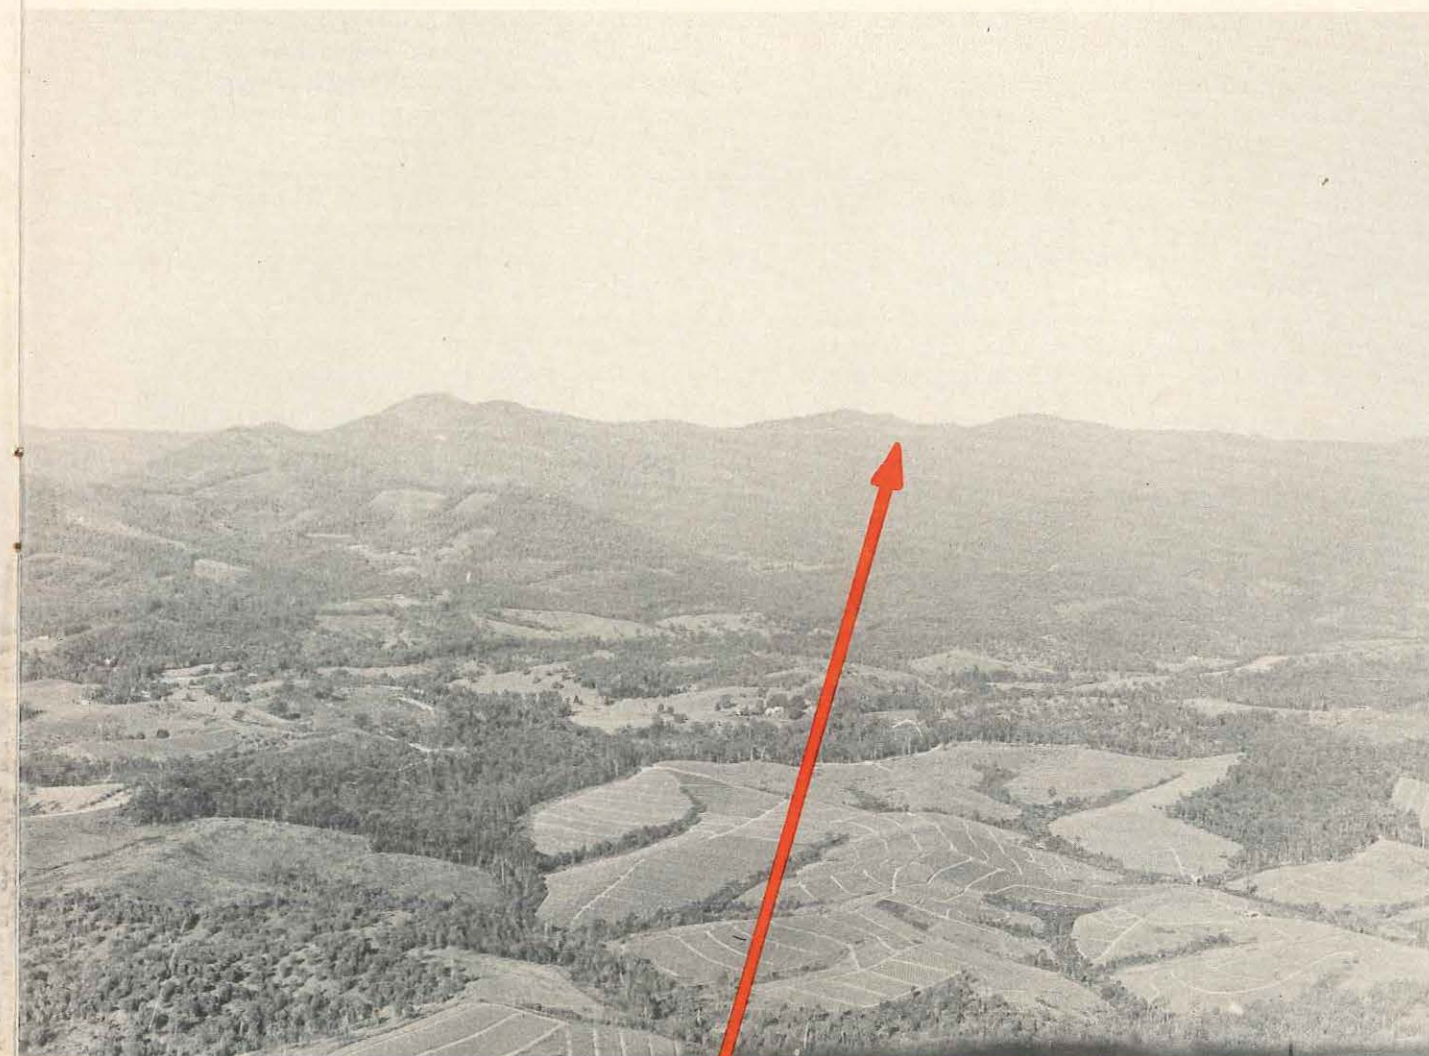
*Pilot's view of the northern entrance to the Archerfield lane of entry. The correct track is shown on the left; the probable flight path of the Comanche is on the right.*

It would appear that for some reason, the pilot flew too far west and turned up the wrong valley. Although the exact reason for his failure to turn is not definitely known, it is likely that in the prevailing conditions and at low level, he would have had difficulty in identifying visual reference points, particularly if diversions around showers were also required. The lane of entry and its northern approaches are difficult areas for map-reading, especially at low level. The countryside consists of undulating ground with a series of small valleys and timbered ridges lying across the lane. There is no clearly defined valley, road, river or railway line leading down the lane towards Archerfield. It has been estimated that the additional distance between the entrance to the lane and the point where the aircraft eventually turned up the valley

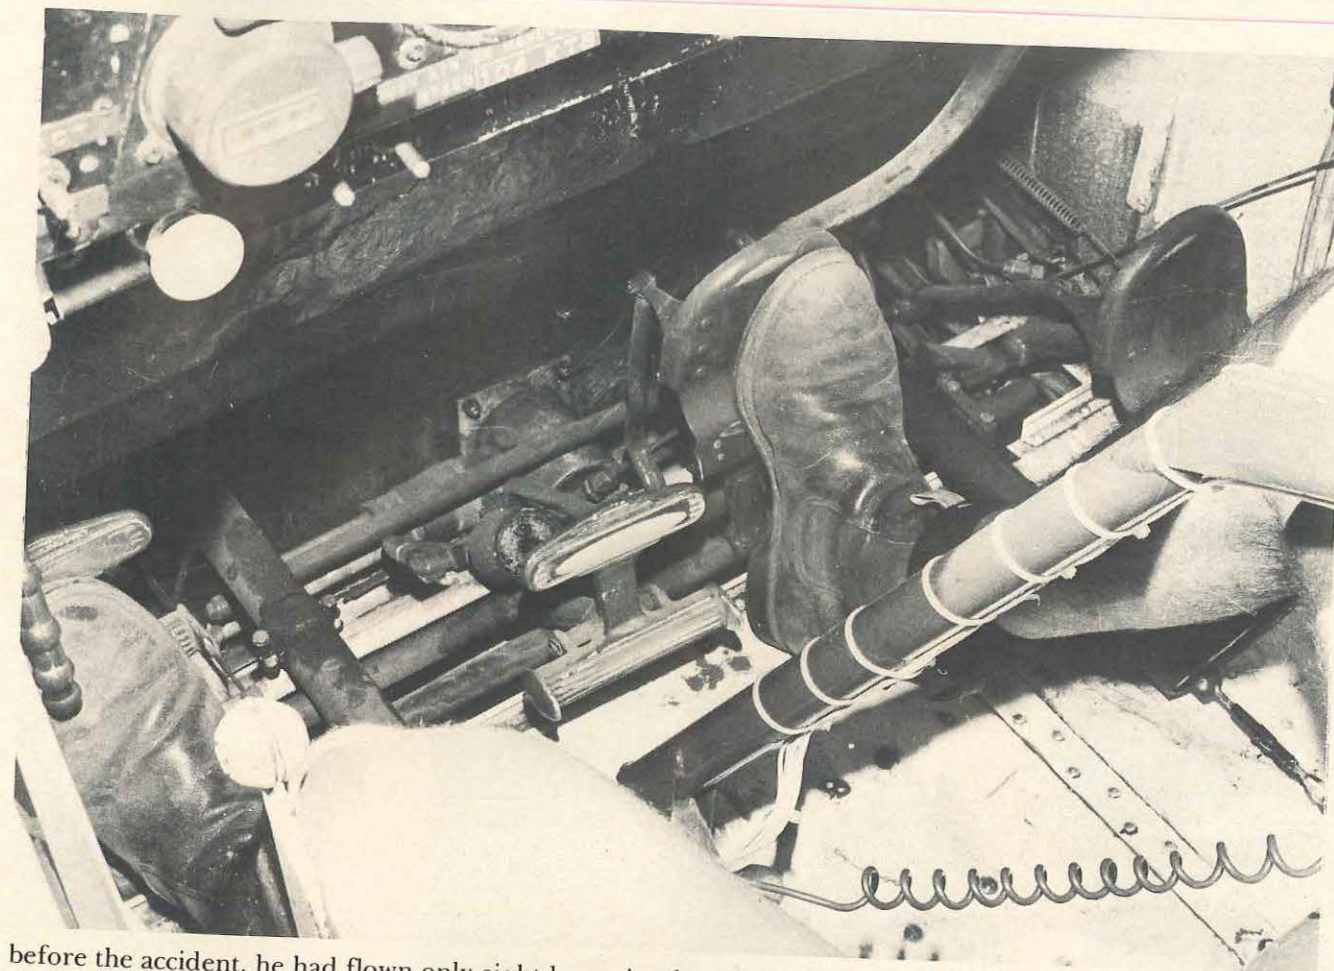
The aircraft was a special dual-training version of the Pawnee with rather restricted side by side seating. It was equipped with two sets of rudder pedals but measurements showed that the distance between the centres of the left and right pedals on the left set of controls was only 28 centimetres, while in the normal Pawnee, with only one set of controls, this distance is 49.5 centimetres. The space between the two sets of pedals in the two-seat aircraft, edge to edge, was only three centimetres. There were no obstructions between those sets.

before the accident, he had flown only eight hours in the dual-control version over the same period. He did not positively recall having shifted his feet off the rudder pedals in flight and then shuffled them back again but it is possible that, had he done so, his right foot could well have taken up a more natural position on the adjacent left pedal of the right side set. The pilot remembered that on an earlier occasion, when taxiing the aircraft, he had momentarily lost directional control and he concluded at the time he had inadvertently placed his right foot on the wrong pedal. In the absence of any other explanation for the

loss of control which led to this accident, and in view of his previous experience, the pilot thought it likely he had done the same thing on this occasion.
