Aviation Safety Digest

Department of Transport

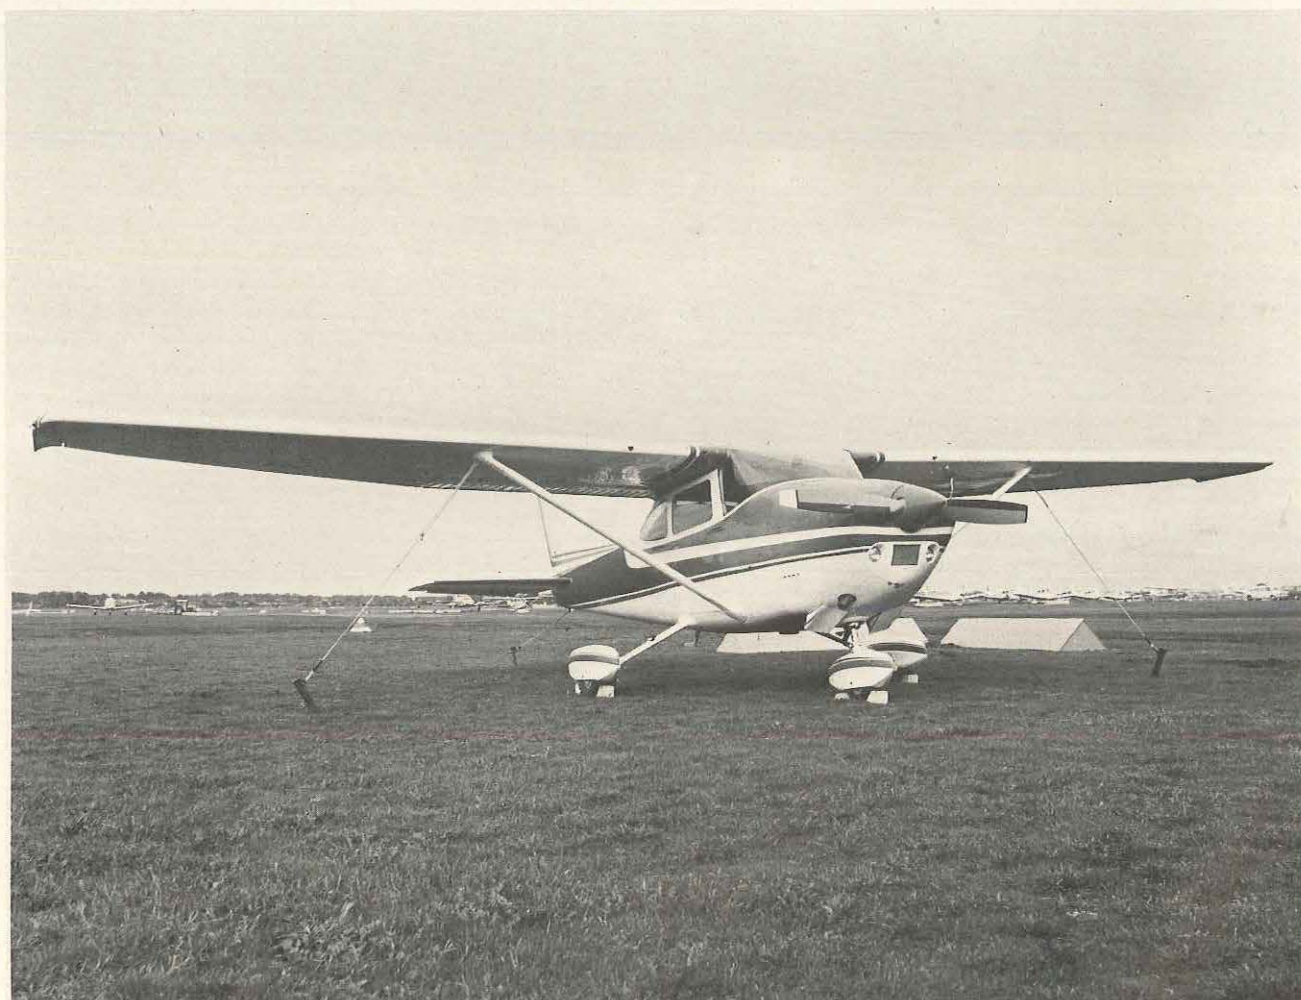
In order to obtain a positive illustration for the points made in this article, staff of the Digest went to Moorabbin Airport to photograph a properly secured aircraft. They were not able to locate such an example, but were able to borrow wheel chocks and a pitot cover to add to the aircraft illustrated above which was well tied down. Although this aircraft provided the most suitable subject, the elevator trim tab had not been set in the neutral position. To satisfy the manufacturer's recommendations it should also have had the cowl flaps closed, a surface control lock installed over the fin and rudder, and a tie-down rope securing the nose gear torque link. It was also noted that wheel spats preclude the use of wheel chocks of an effective size. ●

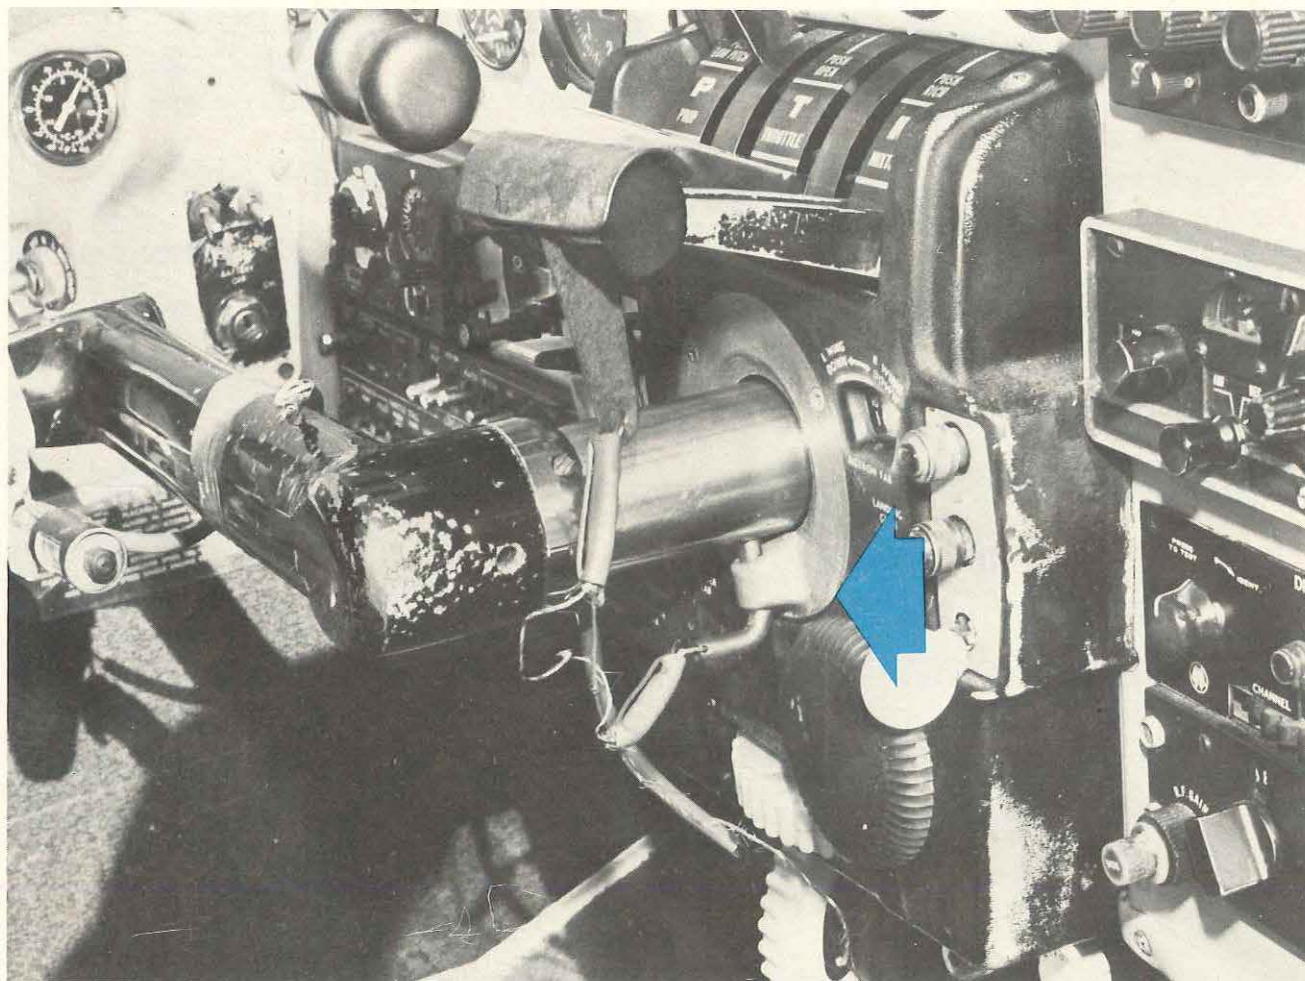
possible to determine if the pin had been inserted through it; however, the pin was in place in the control column. Nevertheless, with the pin inserted in either manner, the pilot would have been denied aileron and at least partial elevator control, during both ground and air operation of the aircraft. The flight path of the aircraft as described by witnesses to the accident was consistent with the controls being locked by either of the two methods described.

The restriction to control surface operation should have been obvious if preflight, vital actions had been performed. The cause of the accident was therefore considered to be that the pilot did not perform adequate preflight procedures.

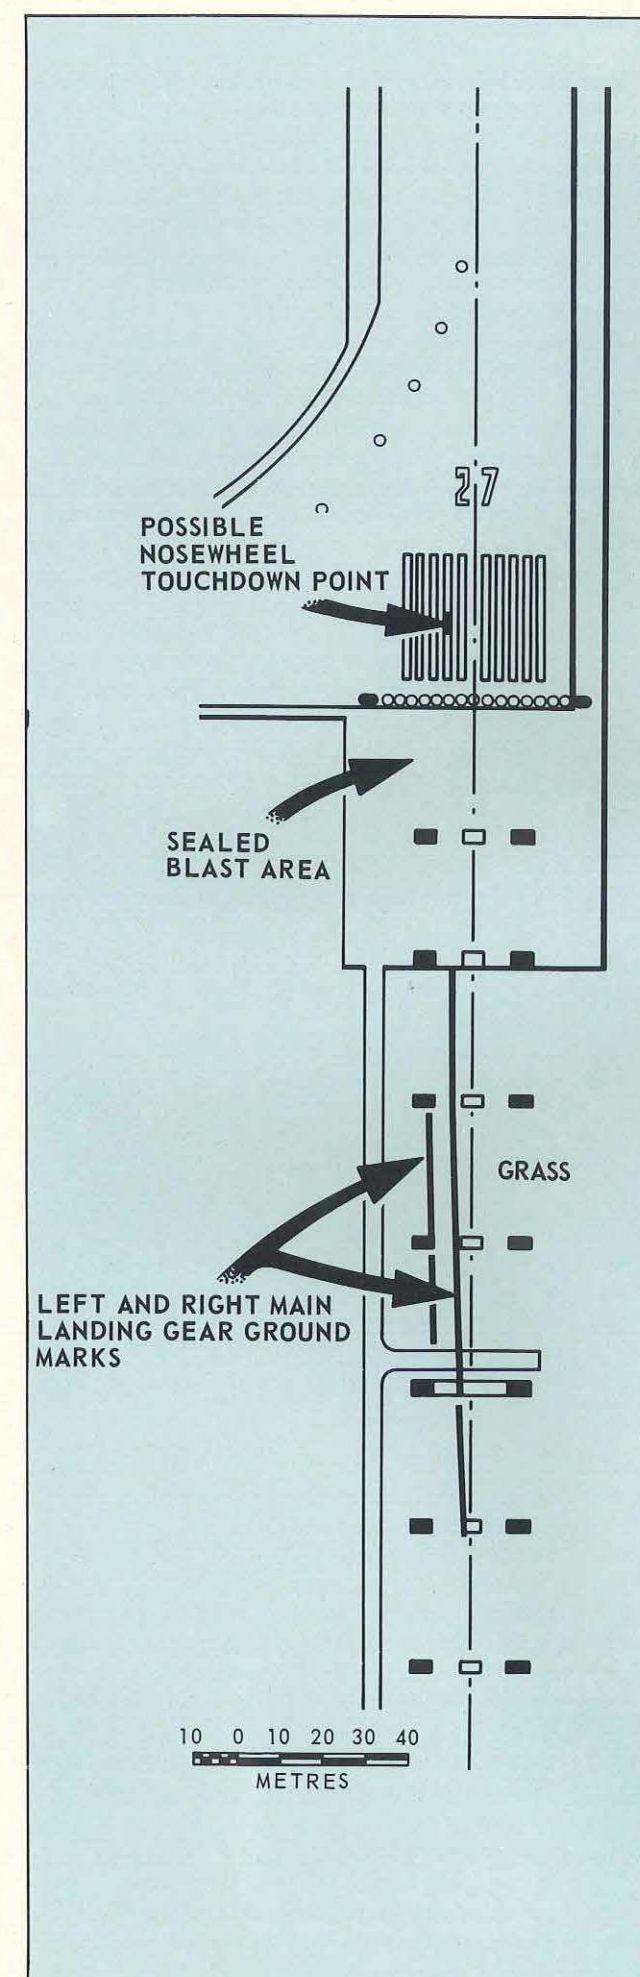
As the Captain rotated the aircraft the F/O sighted the right hand threshold lights and commented they were 'looking a bit low'. He could not remember making any further comment but the Captain recalled that, just before impact, the F/O said 'You are going to hit the lights'. Both pilots then felt the landing gear strike the ground and the approach lighting.

Touchdown was in a near normal landing attitude, 192 metres short of the runway threshold. Six approach lights, in the last four rows leading to the threshold, were struck by the main wheels as the aircraft rolled across the grassed area. The nosewheel probably touched down on the runway just beyond the threshold. The aircraft remained on the runway as it slowed down and taxied to the terminal under its own power. The passengers disembarked by normal means.
