Aviation Safety Digest

Contents

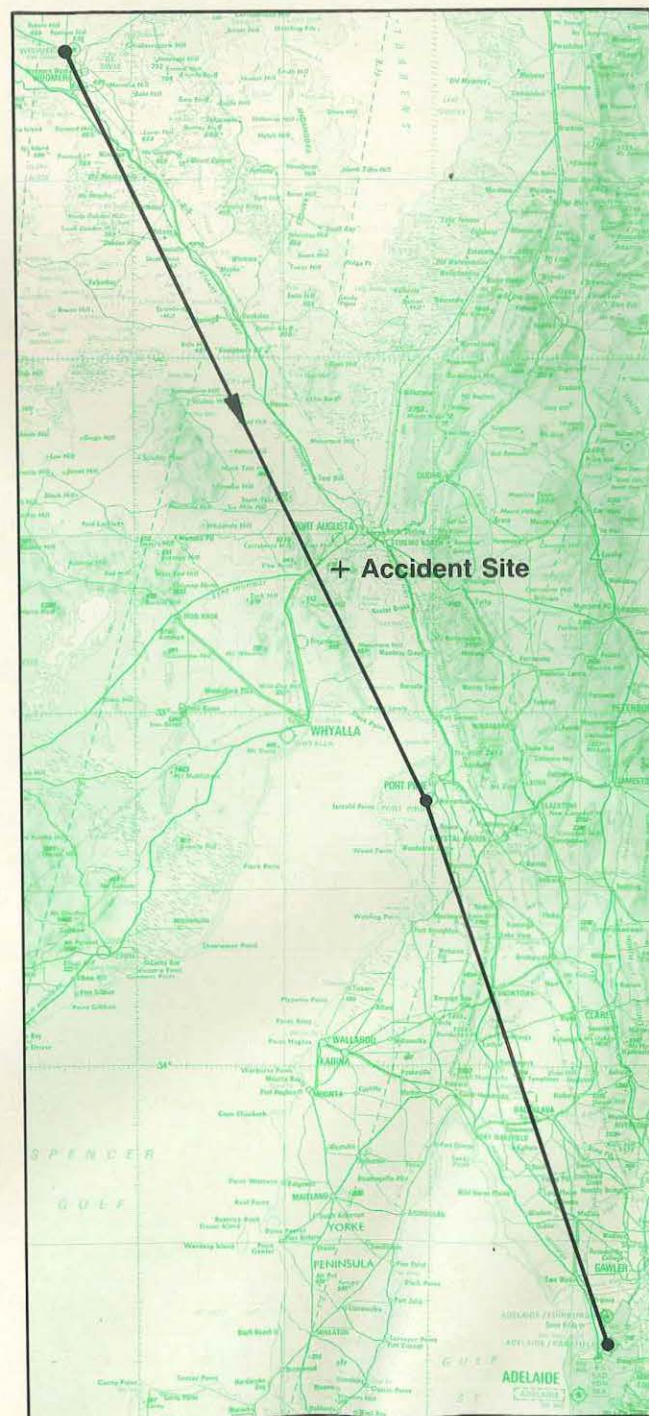
Detailed examination of the wreckage did not reveal evidence of any defect or malfunction which might have contributed to the accident. The damage to the aircraft, together with ground impact

marks, indicated that the aircraft struck the ground at high speed in a steep nose-down, right wing-down attitude, consistent with it being in a spiral dive.

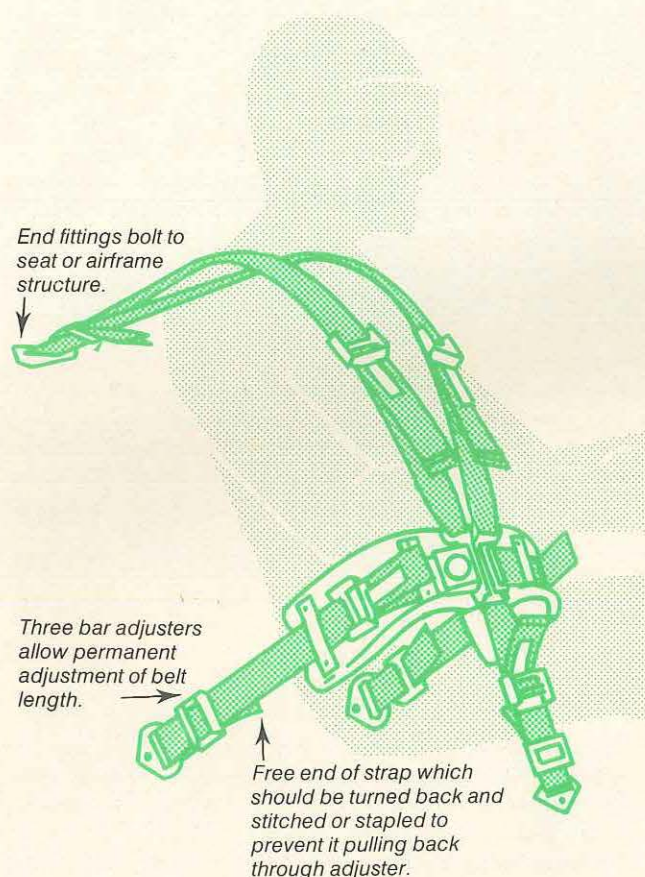
'While adjusting my harness before taxiing for an aerobatic training flight, I found that I could not tighten the lap strap sufficiently. I shut down the engine and inspected the strap where it was attached to the airframe. A comparison with the front harness showed that the rear one was incorrectly secured and I found that I could work the strap loose by pulling it upwards. The strap had either been incorrectly attached to the aircraft or it had worked loose since its attachment. The other lap strap for the rear seat was similarly faulty. I attached the rear straps correctly, checked the front straps thoroughly and proceeded with the flight. I have since notified the operator and club instructors about the incident because the consequences of a similar, future occurrence in an aerobatic aeroplane could be somewhat embarrassing.'

The photograph above shows the harness as found on a Bellanca. Note the limited accessibility, and the fact that this is on the more accessible side, adjacent to the large entry door. The free end of the strap should be passed back through the adjuster, which is too far up from the end fitting.

Occasionally it may be necessary to make a small adjustment on the buckle side when the seat is shifted to extreme positions. This again introduces, by itself, no special hazard in view of the free length of webbing normally available. However, the free ends of many of these straps are not sewn over, and if repeated and incorrect personal adjustments have been carried out on the buckle side the webbing may require only a small amount of slip before the end will pass through the adjuster and render the restraint system ineffective. It is therefore advisable to check, before buckling up, that the buckle is located at the side of the occupant and that a safe free length of webbing protrudes through the adjuster' ●

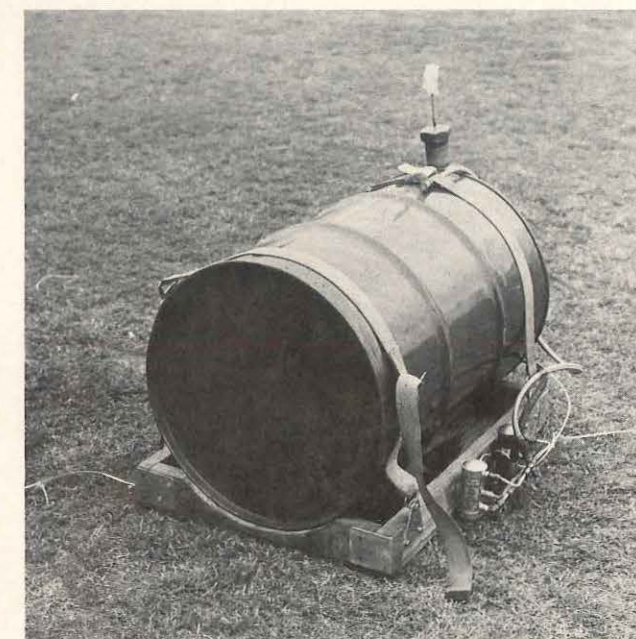
The auxiliary fuel system which was fitted to the helicopter

modification which adds another vent below the right hand door. This modification is not mandatory and was not fitted to any of the three aircraft involved in accidents in Australia.
