Contents

Aviation Safety Digest 112 / 3

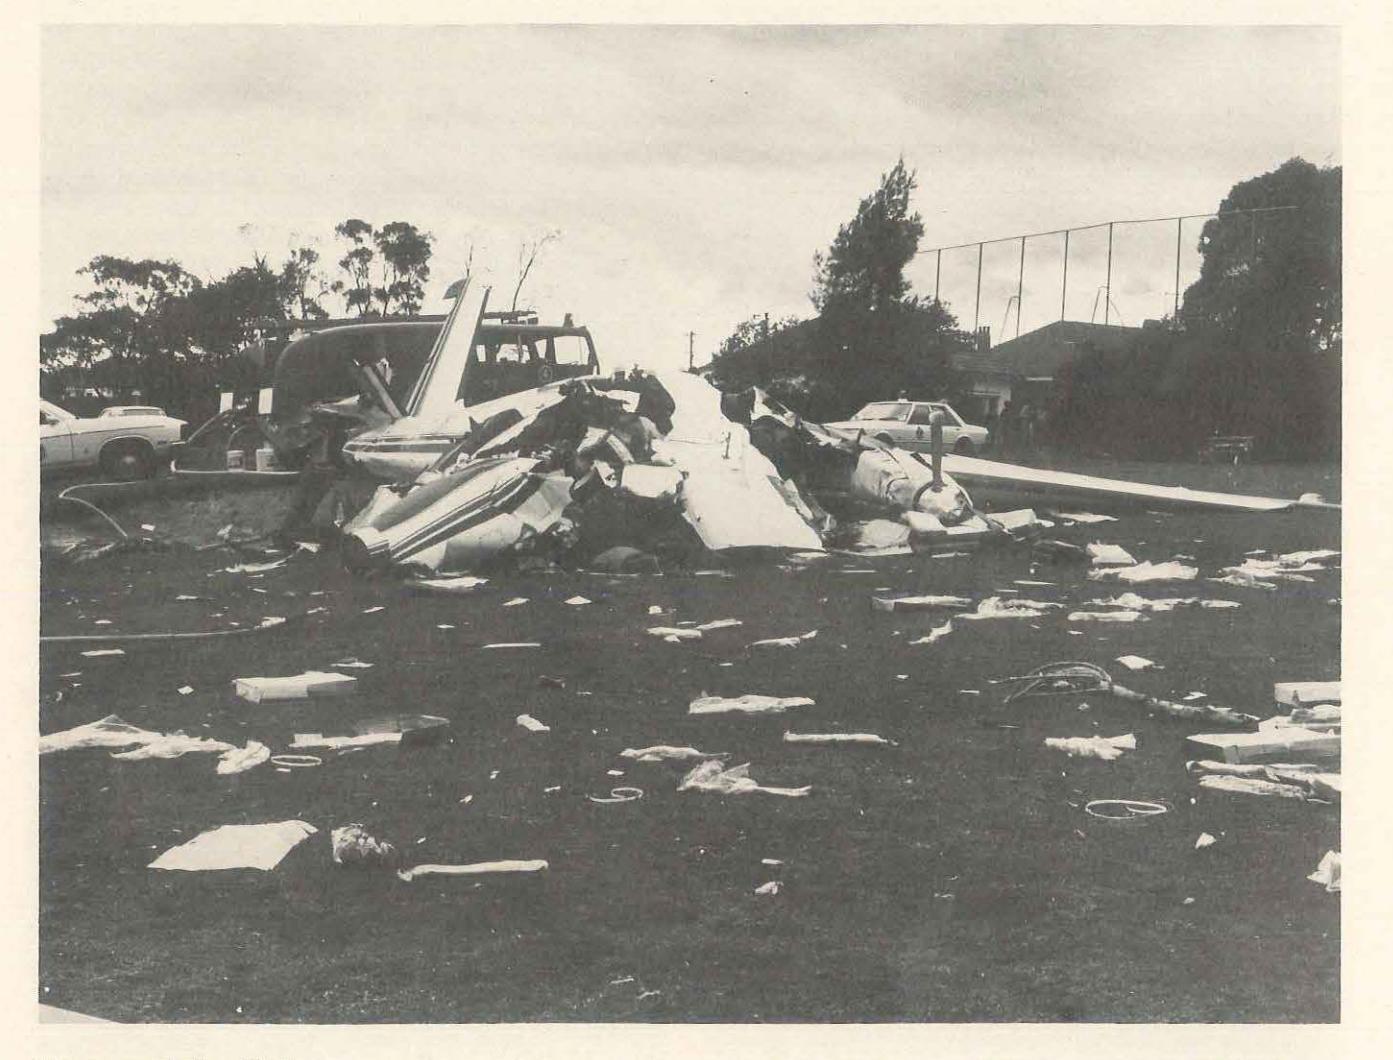
At 1508 hours a Rockwell Shrike Commander 500S with one pilot, a passenger and a load of freight crashed onto a golf course near Essendon Airport, Victoria, following fuel exhaustion on a flight from Flinders Island to Essendon. Both occupants were killed, and the aircraft was destroyed by impact forces.

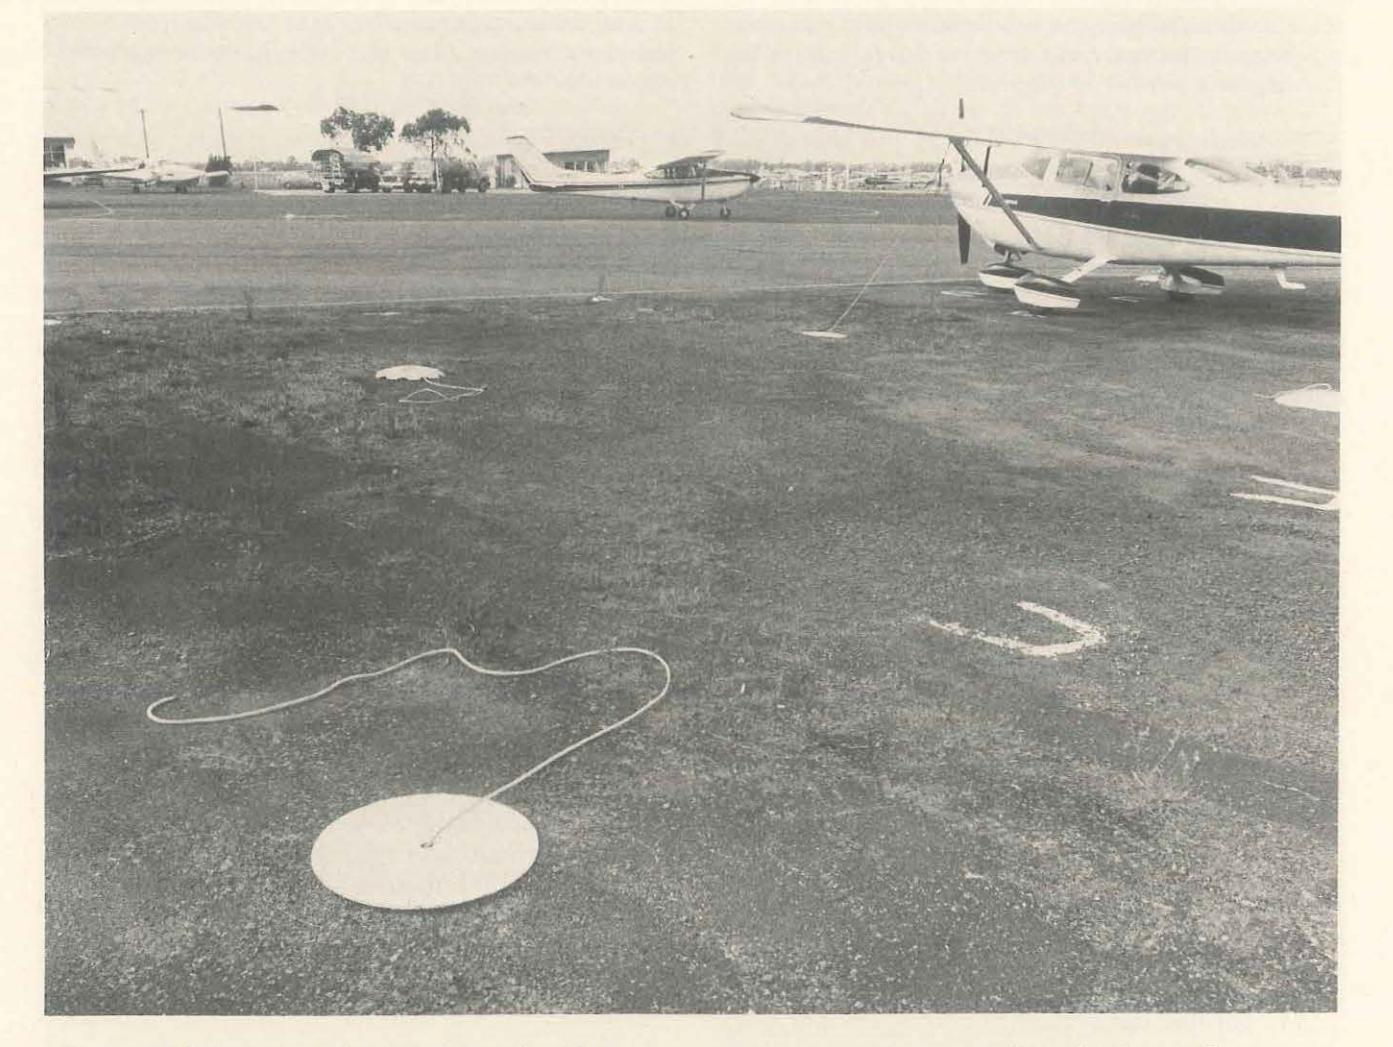
After completing his daily inspection the pilot found that the battery was flat, so he decided to hand start the engine of his Cessna. He applied the hand brake and, as an additional precaution, tied the tail of the aircraft down with a 10mm diameter synthetic tie-down rope. When the engine started the brakes proved to be ineffective. Furthermore, the tie-down rope broke with little apparent strain and the aircraft was damaged in a collision with a parked vehicle. The reason for the failure of the brakes to restrain the aircraft was not determined.

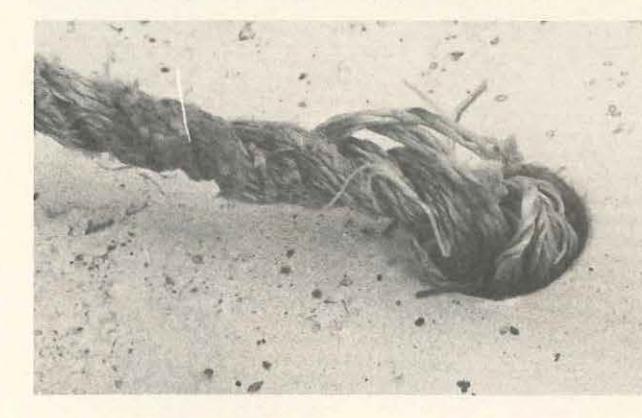
Local abrasion as distinct from general wear may be caused by the passage of the rope over sharp edges whilst under tension and may cause serious loss of strength. Slight damage to the outer fibres and an occasional torn yarn may be considered harmless, but serious reduction in the area of one strand, or somewhat less serious damage to more than one strand, should warrant rejection. Protection at points where excessive abrasion may occur is economic.

Cuts, contusions, etc., or careless use may cause internal as well as external damage. They may be indicated by local rupturing or loosening of the yarns or strands.

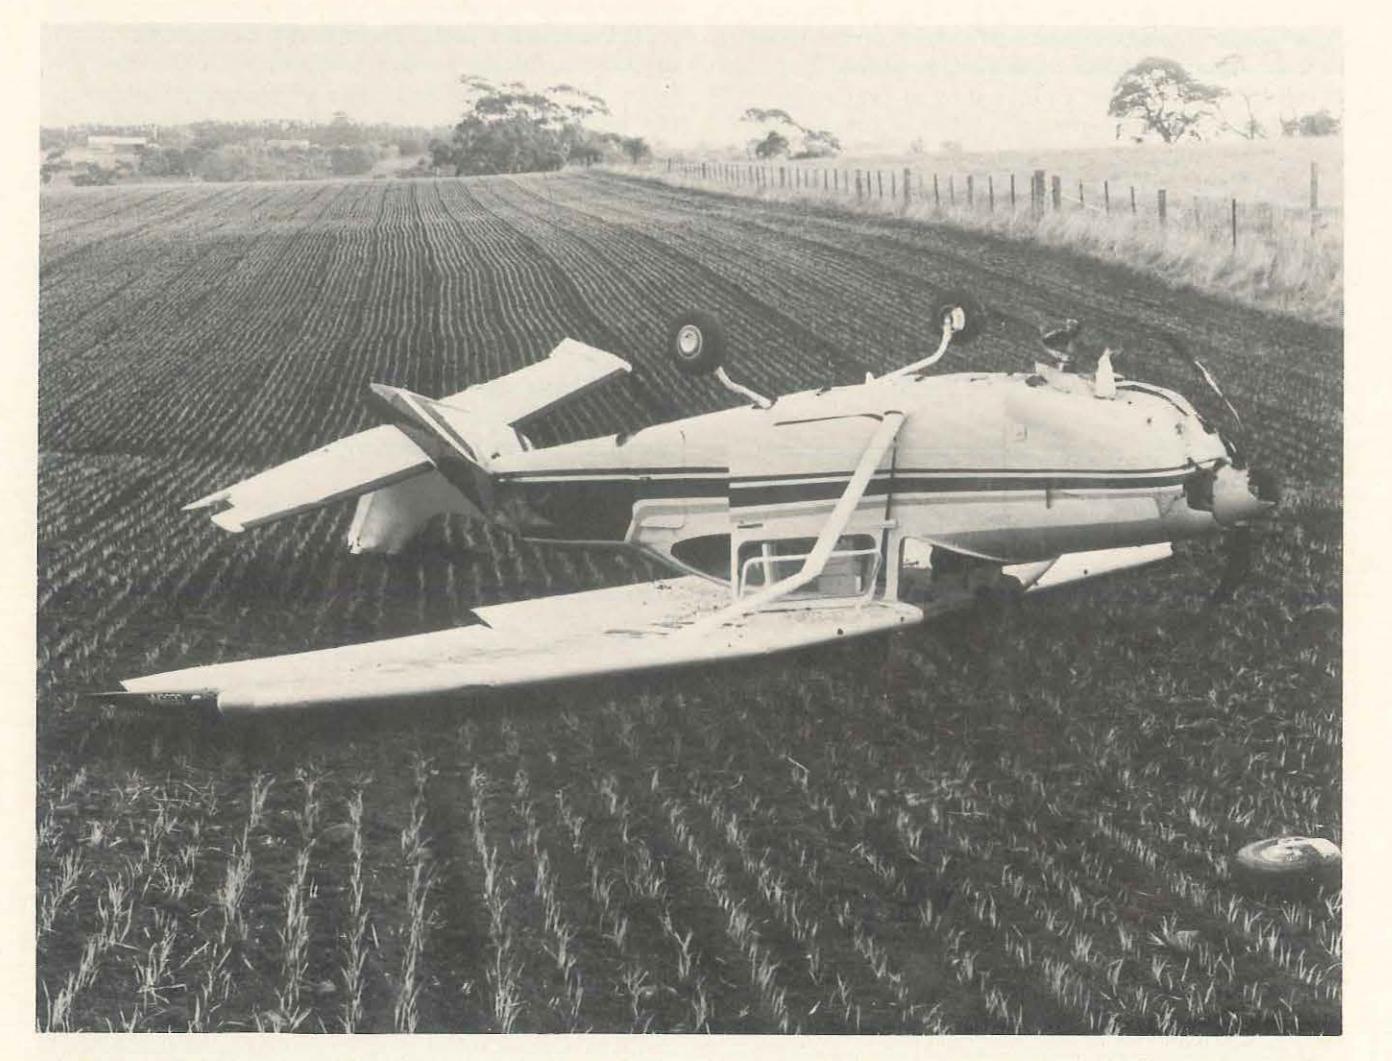
After a one hour delay due to fog the pilot started the engine and prepared for take-off with three passengers in his Cessna R182. By then most of the fog had cleared; only small patches remained in the gullies and valleys around the strip. The temperature was 8°C with a relative humidity of about 93 per cent. The pilot completed an engine run-up, which included a check on the operation of the carburettor hot air system, but he did not specifically check for the presence of induction ice. After completing the before-take-off checks the pilot closed the throttle and got out of the aircraft to remove condensation that had formed on the outside of the windshield. This completed, he strapped in, re-checked hatches and harnesses, then taxied a short distance to the strip and started the take-off roll.

The investigation did not reveal any mechanical defect in the engine or airframe to explain the lack of performance; but atmospheric conditions at the time of the accident were certainly conducive to the formation of induction icing. With a dry bulb temperature of 8°C and a relative humidity of about 93 per cent, the probability of serious induction ice formation would be high at any power setting. (Refer to Aviation Safety Digest 108 lift-out chart). The formation of ice at low or idle power would then almost be assured.

Most owner's handbooks and operations manuals warn against prolonged engine operation on the ground with alternate or hot air selected as the air source is unfiltered. However, during run-up (and in icing conditions immediately before take-off) hot air must be applied for sufficient time to ensure that any ice that may have formed is removed. The technique will vary with different aircraft types so check your owner's handbook for the correct procedure for your aircraft. Generally, application of hot air will cause an RPM drop. If no ice is present the RPM will remain steady at the lower figure. If ice is present the RPM will initially decrease, then increase as the ice is removed, and stabilize at a higher reading. The RPM will then increase further when cold air is again selected. This is a worthwhile check following any prolonged period of operation on the ground in possible icing conditions. Make it your habit to check for the presence of ice as well as checking the serviceability of the carburettor hot air system
