Aviation Safety Digest

BUREAU OF AIR SAFETY INVESTIGATION

115/1983

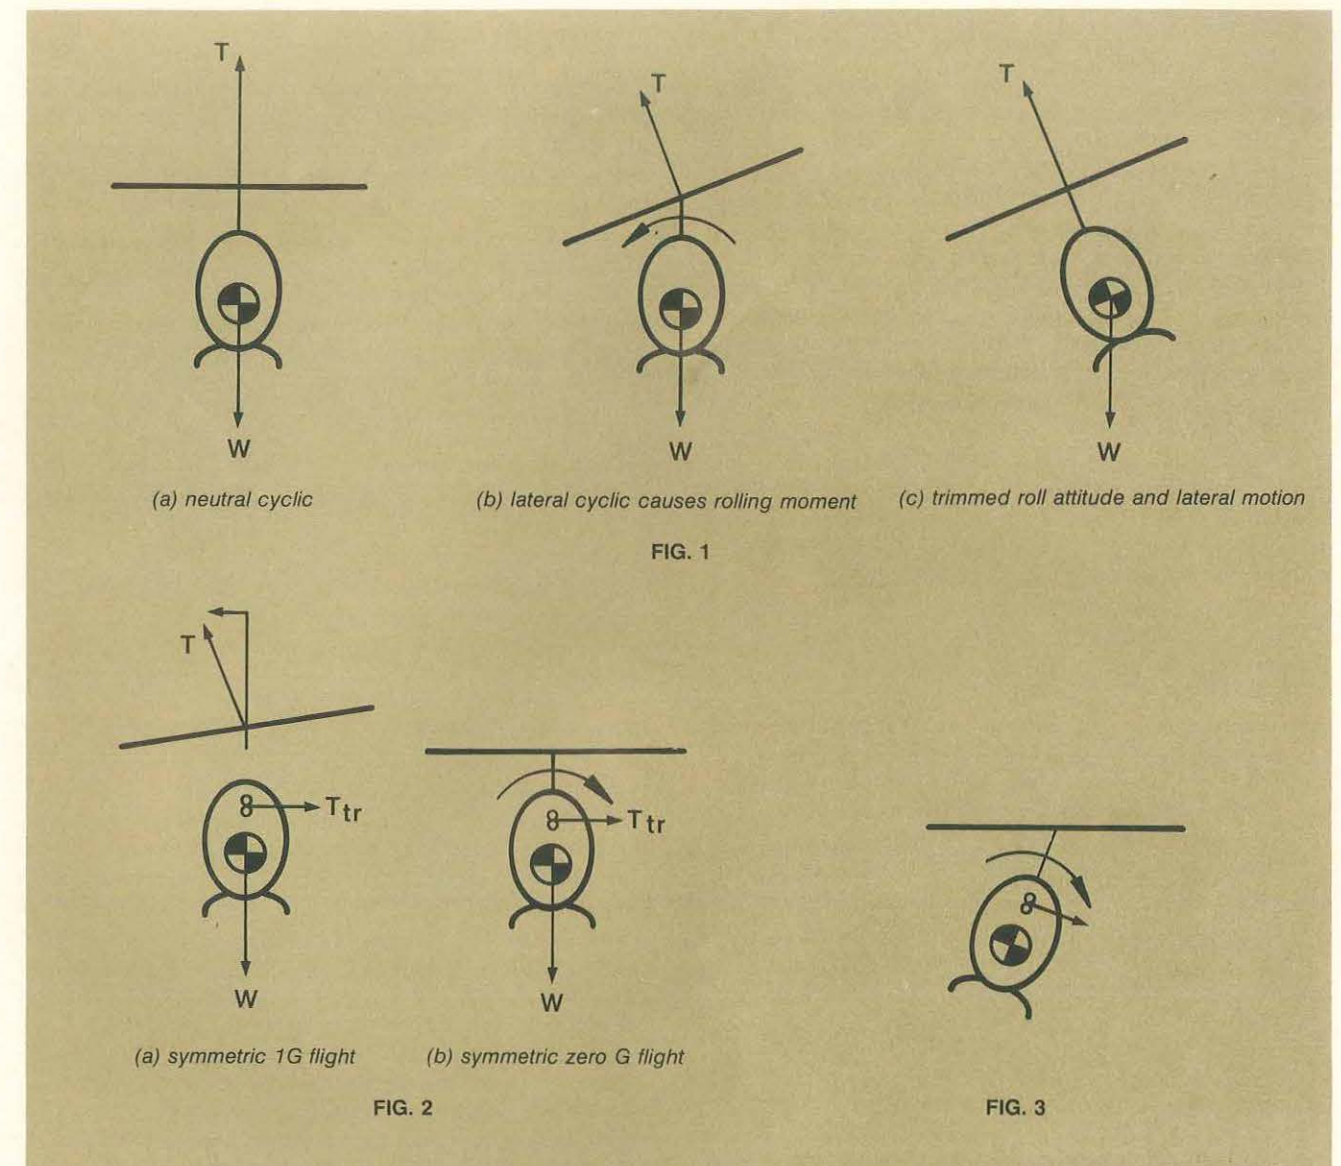
weights and density altitudes result in flapping angles of approximately 15 per cent or less of the maximum allowable for a typical semi-rigid system. Assuming centre of gravity limitations (forward centre of gravity limits in particular) are not exceeded, gusty conditions can increase rotor flapping by a similar amount. Sudden changes in attitude, as induced by abrupt cyclic input or by mechanical failure, e.g. loss of the tail rotor or engine power loss, can also increase flapping values to as much as 60 to 70 per cent of the limit, and sideways flight to the right at maximum permissible speed will increase flapping similarly. The reason for the last item is that the direction of rotation of the main rotor on these helicopters is clockwise when looking up through the rotor. The most critical manoeuvre in regard to mast bumping, however, is one that generates low g, such as the pushover at the top of a zoom climb. To understand why, think back on your knowledge of helicopter control. If the pilot desires a change in pitch or roll attitude, the primary control is cyclic, which allows tilting of the rotor thrust vector with respect to the mast. As a result, an unbalanced moment is generated about the aircraft centre of gravity and fuselage attitude is changed (see Fig. 1).

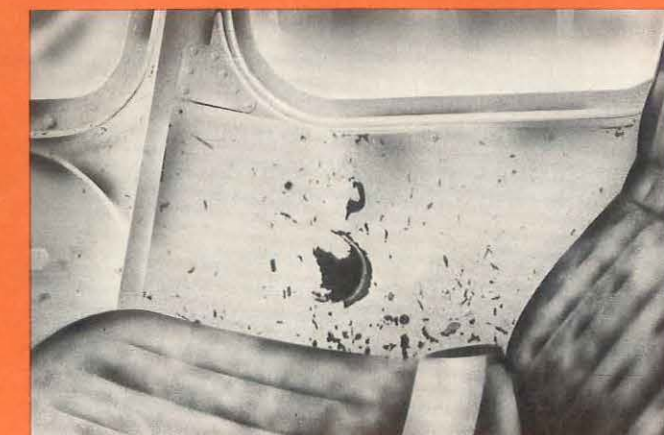
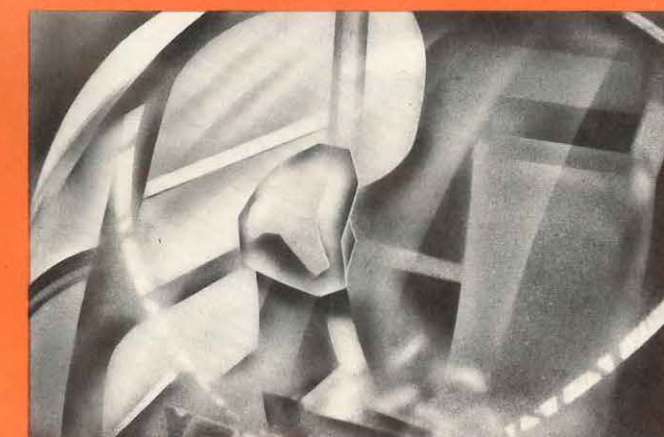
The ruptured can made a deep imprint in the metal liner of one of the aircraft's doors before it punched a hole in the windscreen.

WARNING: The temperature in a closed aircraft cabin can easily reach and exceed the 50° Celsius temperature limitation prescribed to ensure pressure can safety. Temperatures as high as 80° Celsius have been recorded.

CAUTION: Do not expose to heat exceeding 50° Celsius. Do not puncture or incinerate can.
