Aviation Safety Digest

Contents

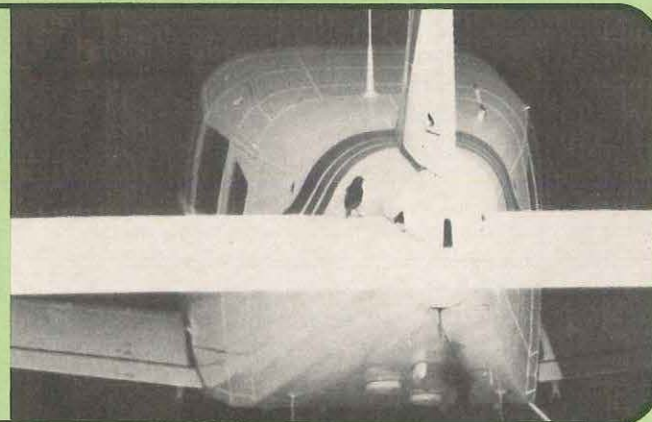
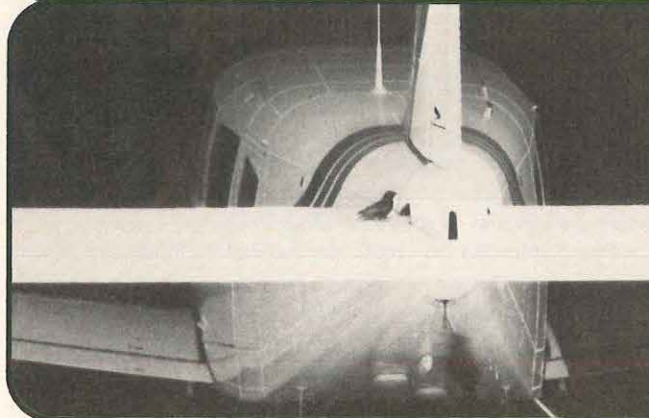
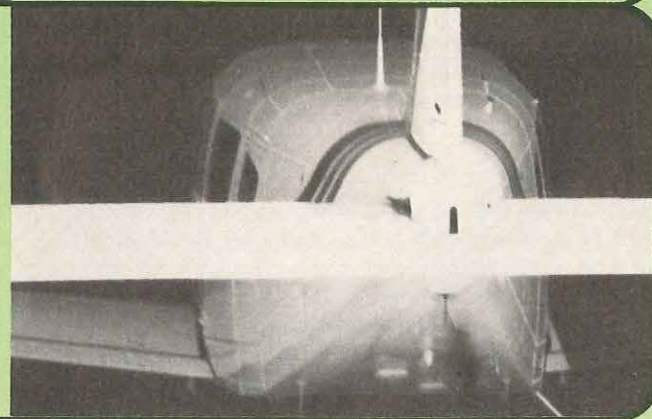
Birds building nests in the various nooks and crannies of aircraft remain a persistent problem. While the accompanying photographs of a prospective tenant checking out its new home may appear amusing, the pilot who finds his controls jammed inflight is anything but amused (see *Aviation Safety Digest* 107, page 28).

Obviously, it is impossible to block off all available nesting sites, but the Latrobe Valley Aero Club, for one, has taken a positive measure to deny birds entry to the engine area — one of the most popular places for nests. This consists of using blanks which fit into the engine cooling openings in the engine cowls. Details of the blanks are as follows:

- made from low-density polyurethane foam
- cut out with the aid of a template and an electric carving knife
- red ribbons attached as warning flags.

The blanks can be inserted after allowing a few minutes for the engine to cool and are especially useful during the spring and early summer when starlings are nesting. The use of such blanks or covers would never, of course, obviate the need for a detailed visual check of possible nesting sites ●

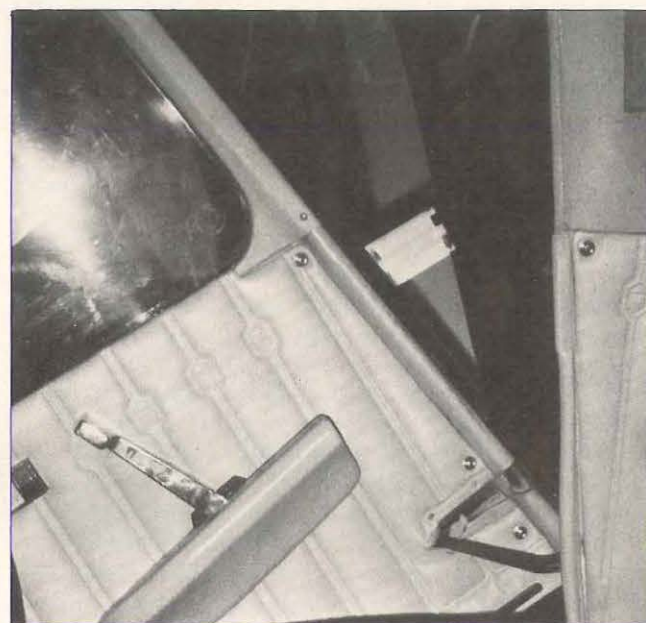
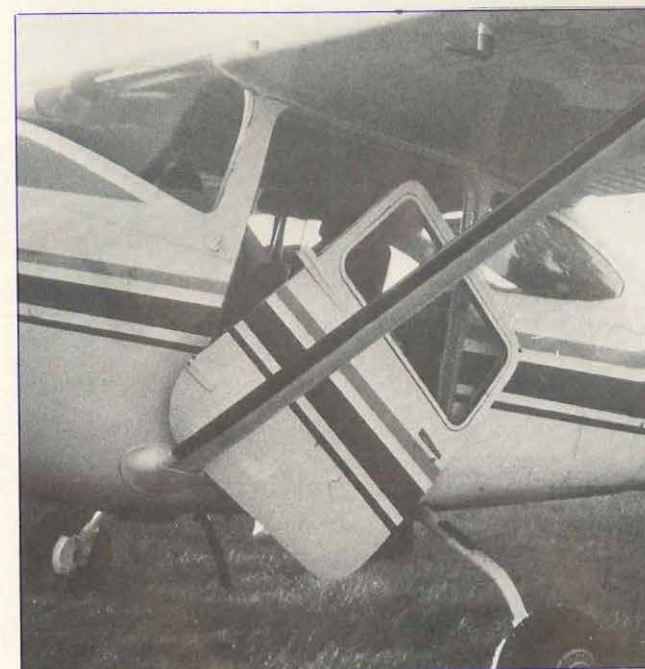
'Post-flight inspection revealed that the hinge pin on the upper door hinge had sheared, allowing the leading edge of the door to protrude into the airflow; the 140 knot slipstream had then "peeled" the door open. The restraining scrap stopped the aft movement of the door, while the wing strut stopped it dropping downwards. It was also interesting to note that in its final position, the door was acting to "scoop" air into the cabin.
