Aviation Safety Digest

AIR SAFETY

119/1984

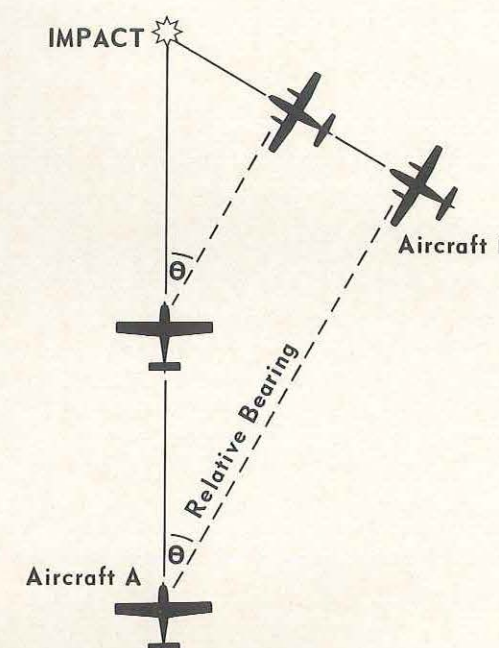
Figure 1. Constant relative bearing equals collision risk.

If two aircraft are on a collision course and these aircraft are flying on constant headings at constant horizontal and vertical speeds, then each aircraft has a constant relative bearing to the other right up until the moment of impact. Figure 1 makes this clear. Even though aircraft A is going twice as fast as aircraft B, their relative bearings are constant. The effect of this, of course, is that if you are going to collide with another aircraft, then that aircraft has no apparent motion with respect to you and will stay at exactly the same point on your windscreen until you hit it; in other words, it will in many respects behave in the same way as a fly squashed on the outside of the windscreen.

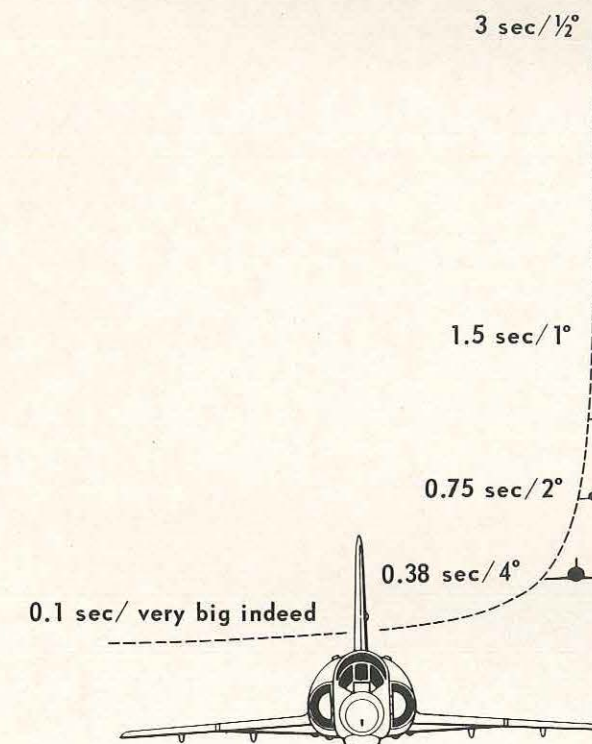
Figure 2. Time to impact and angular size of oncoming aircraft.

To answer this point, look at Figure 2 to see just how an oncoming aircraft appears to get larger as it gets closer. It is roughly true to say that the apparent size of an oncoming aircraft (i.e. the angle which it subtends at your eye) doubles with each halving of that aircraft's

range. Imagine the case in which a GA aircraft and a military jet are approaching each other head-on at speeds of 150 knots and 450 knots respectively — a closing speed of 600 knots. At about twenty seconds before impact the two aircraft might be about 6000 metres apart and each will present a target to the other of only around a sixteenth of a degree. Ten seconds from impact the distance will have halved and the target size will have increased to all of an eighth of a degree; at five seconds the size will have again doubled but is still only about a quarter of a degree.

In other words, the oncoming aircraft remains extremely small until very, very late, and then it suddenly expands into something that fills the windscreen. These abstract calculations match up with the accounts of many pilots who have had mid-air or near misses: they often describe themselves as having maintained a good lookout, then diverted their attention inside the cockpit for two or three seconds to complete some checks, only to look up and be horrified to find that the way ahead was full of aeroplane. As reaction time is usually two seconds or more this amounts to a situation pregnant with danger.

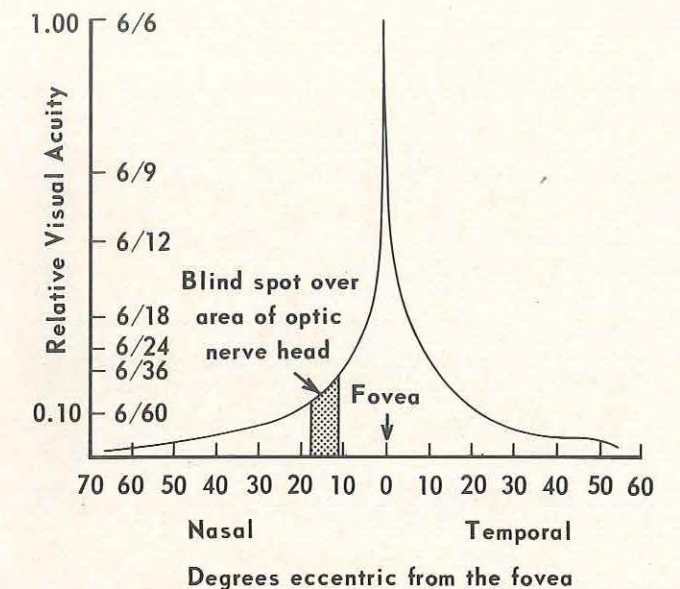
Figure 3. The variation of visual acuity at retinal sites eccentric to the fovea. The acuity at 5 degrees to the fovea is only one-quarter that at the fovea.

The first point to be made is that the retina is not equally sensitive over all its surface. Figure 3 shows that it is only in a small, central area of retina (the fovea) that visual acuity is good. Even at very small angular departures from this central area acuity drops off alarmingly to a small fraction of the central acuity. This does not cause any problems in everyday life because we can always use the central part of the retina to investigate anything that we are interested in and use the rest of the retina to 'fill in' the rest of the world (and attract our attention to anything interesting out there), but it does mean that if we are conducting a visual search for a small target, and the object of our search does not happen ever to fall on the foveal area, then we are extremely unlikely to see it. This is especially true, as noted at the beginning of this article, if the target has no relative movement. It is, of course, this unequal distribution of acuity over the retina which produces results such as those shown in Figure 4. In this experiment subjects were required to detect the presence of a Douglas DC3 (not a small target) at three different ranges and at differing locations on the retina. It is clear that the subjects' chances of spotting the aircraft dramatically mirror the sensitivity of the retina.
