# Aviation Safety Digest

# Helicopter wake turbulence

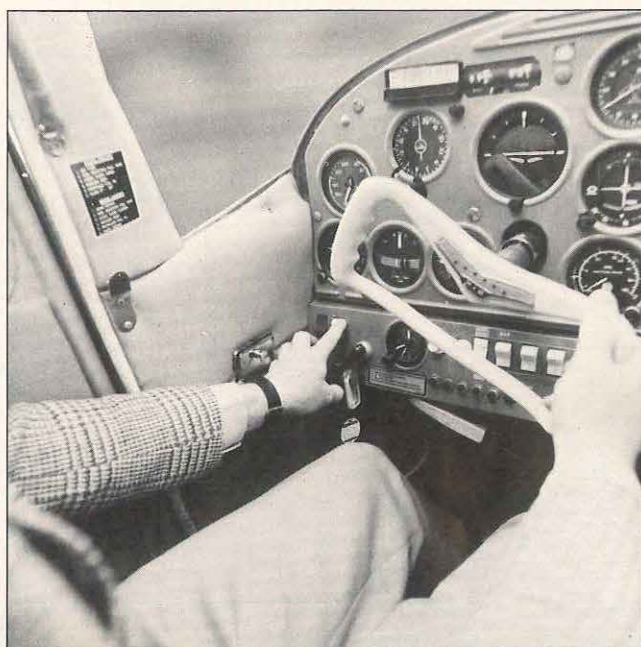
'... The probable cause of the loss of power was fuel vapour accumulation in the fuel system — a vapour lock — which could have resulted in some degree of interruption to engine power output. Turning on the auxiliary fuel pump most probably would have cleared the vapour lock and remedied the situation.'

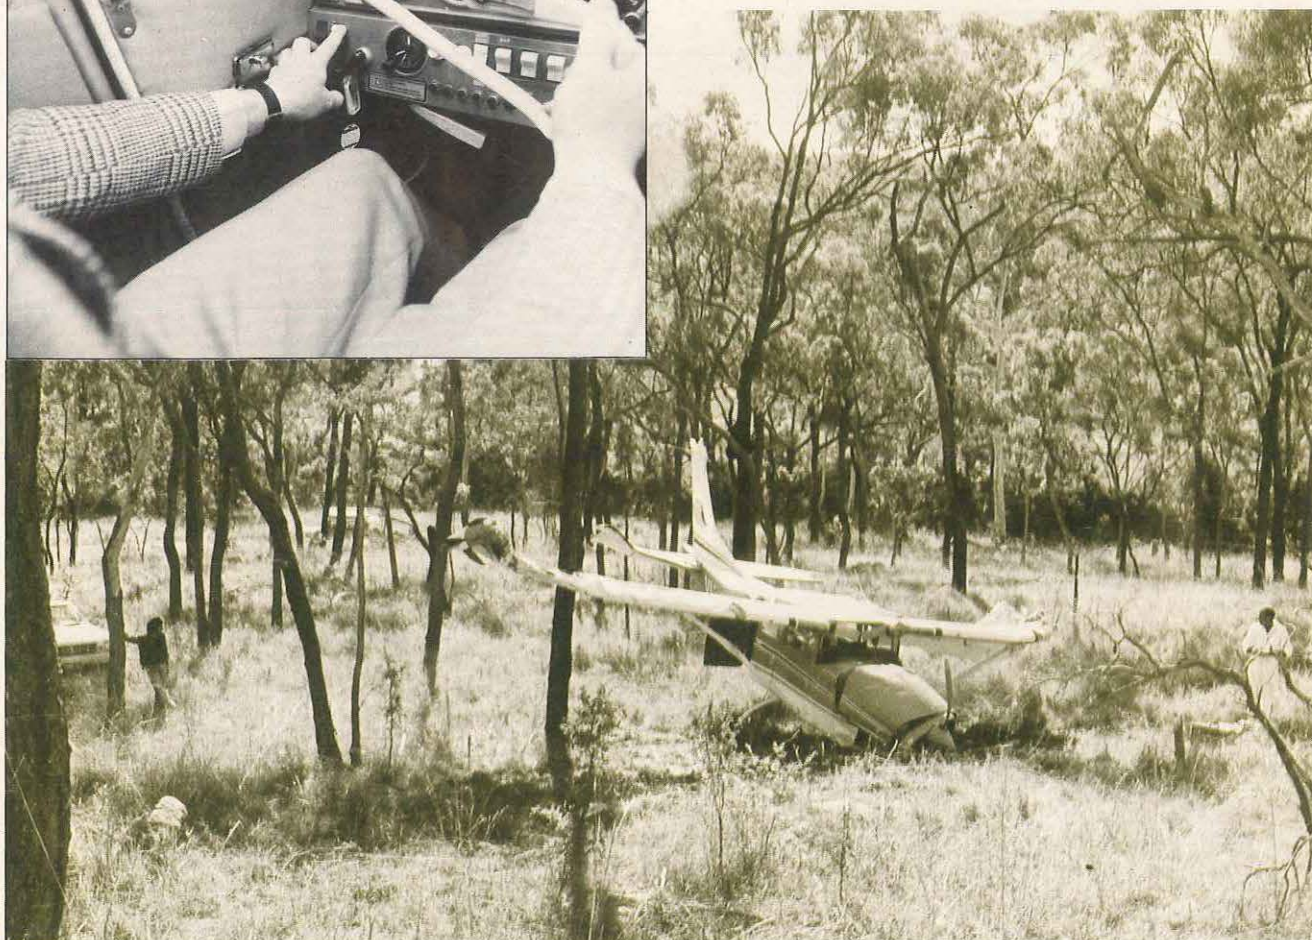
'The pilot ... energised the EMERG half of the auxiliary fuel pump switch ... The resulting grossly over-rich mixture would have adversely affected the performance of the aircraft ...'

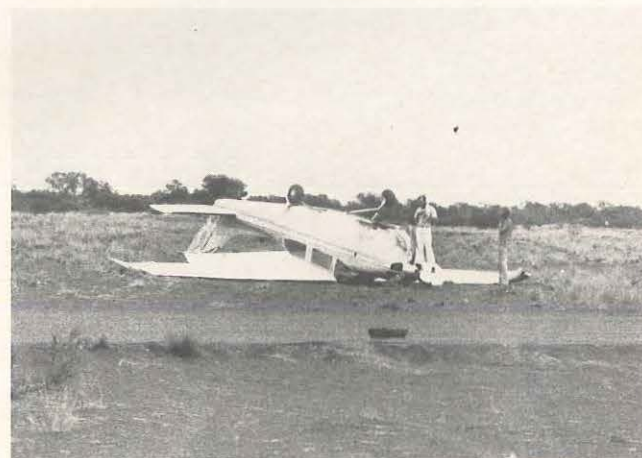
the prevailing conditions and at the Cessna's landing weight, an accurately flown approach was necessary. Instead, the pilot failed to complete his pre-landing checks and did not lower full flap, used too high an approach speed for the aircraft's weight, and landed with a strong tail wind. Although he recognised during the final approach that his groundspeed was excessive, he did not take any corrective action. To complete his litany of woes he misjudged his landing speed and flare. Touchdown was made 300 metres into the strip and the aircraft bounced several times before settling properly with only 200 metres to run. Heavy braking failed to stop the aircraft, which overturned and sustained substantial damage after it ran off the ALA.

In addition to the pilot's fatigued state, several other significant factors emerged. First, it became apparent that, during his lengthy period of unsupervised operations, this young pilot's skill level had deteriorated to the extent that it was no longer adequate for the tasks he was expected to complete. Subsequent flight testing showed that his general flying skills were below the standard required for commercial operations: a short session of retraining was necessary before the satisfactory standard was regained. It does not seem unreasonable to question the wisdom of the operations manager/senior pilot who sent this inexperienced pilot off by himself for a protracted period of commercial operations without taking positive action to ensure that the pilot did not neglect the need to remain proficient in all relevant flying and operational procedures.
