BUREAU OF AIR SAFETY INVESTIGATION

tion Safety Digest

122/1984

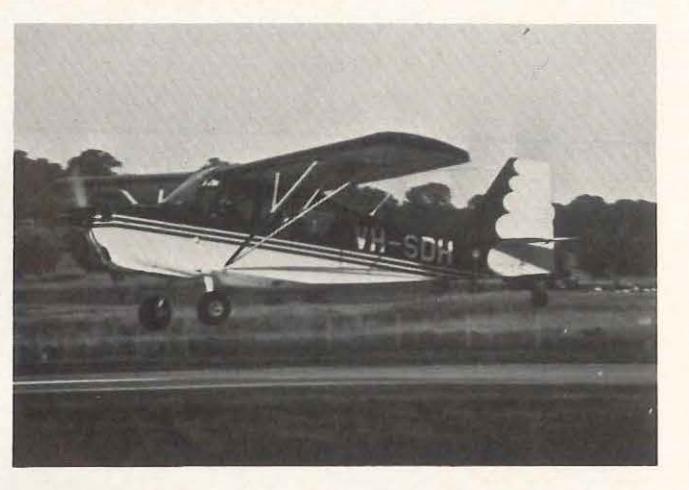
Tail wheel aircraft are generally more prone to groundloop accidents than are nose wheel types primarily because the centre of gravity is located aft of the main wheels. Figure 1 (page 4) depicts the forces which would apply if, for example, an aircraft began to swing during a takeoff or landing ground roll.

In this situation, the tendency for the aircraft to move sideways is opposed by another sideways-acting force at the main wheels which is generated by friction between the tyres and the runway surface. The fact that the centre of gravity is behind the main wheels gives rise to a yawing moment which tends to pivot the aircraft about the main wheels.

Given the distribution of forces shown in the diagram, instability exists, and so the tighter the turn the more powerful the yawing moment causing the turn becomes. Similarly, as the distance between the main wheels and the centre of gravity increases, the effect of

this adverse yawing moment will also increase, further adding to the severity of the swing in some aircraft. If the runway surface is slippery, the tyres will rapidly lose their grip and the aircraft may slide backwards; if it is dry, the spiral may continue to tighten until eventually the inside main wheel lifts and the propeller and outer wingtip strike the ground.

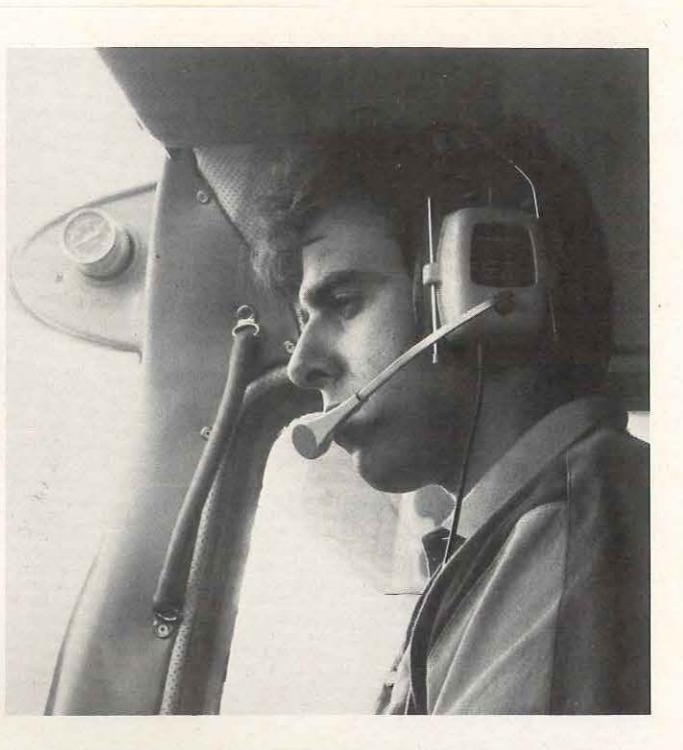
Clearly, certain aspects of the pilot's flying technique were deficient at this early stage of his training and this matter was addressed during the investigation. What is of interest here, however, is the fact that at no stage during the occurrence did the pilot hear the stall warning horn blowing. If he had, then doubtless corrective action would have been initiated before the stall was allowed to develop.

It transpired that the pilot was wearing a headset over both ears. This headset was particularly effective in reducing unwanted cabin noises. Unfortunately, it also suppressed the sound of the stall warning horn.

However, if a headset suppresses external sounds that need to be heard, then something needs to be done about it.

Accordingly, the need to react to sounds emanating from discrete sources has been addressed by wearing headphones over one ear. For example, the

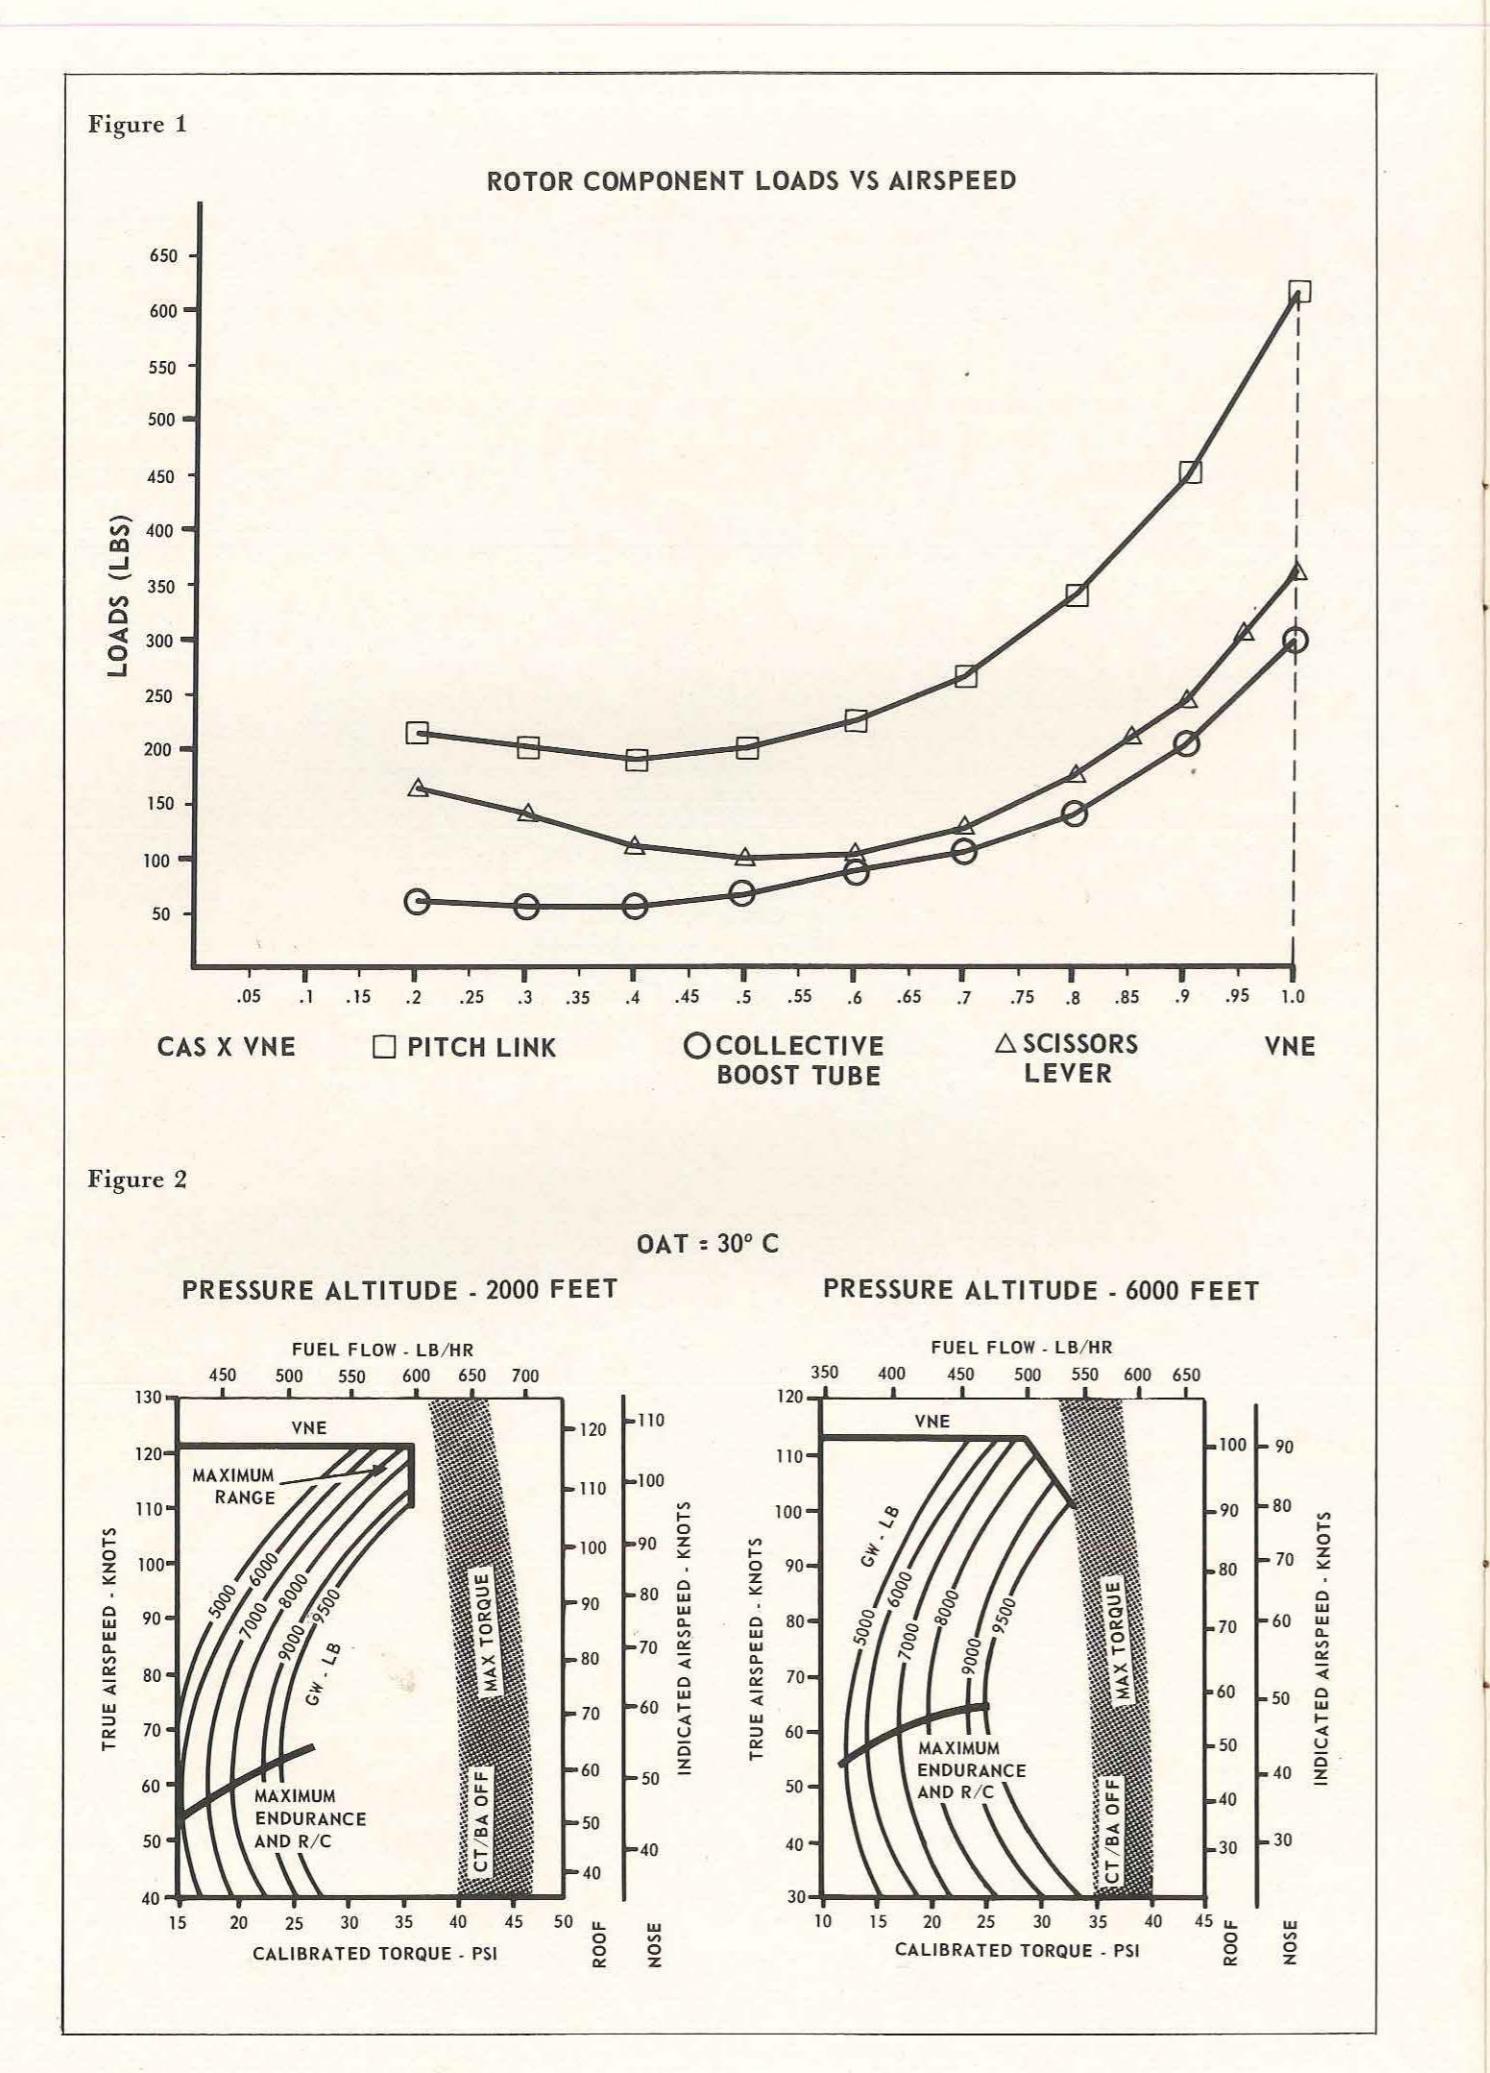
Stress levels of critical rotor head and rotor blade components are the main reason for limiting Vne in modern helicopters. In the UH-lH, for example, the loads on rotor head components rise dramatically as Vne is approached. Figure 1 shows how a small increase in indicated airspeed (near Vne) results in a very steep rise in pitch link, scissors lever and collective boost tube loads. Even exceeding the Vne by a small amount in such stress-limited aircraft (as you can see by extrapolating the curves upward) results in sharply higher loads which will almost certainly reduce nominal component life. A system safety engineer for a major helicopter manufacturer put it this way: 'This damage may not be evident until a crack or other defect develops considerably below the retirement or overhaul flight hour level'. It is important to remember that each revolution of the critical part, whatever it is, constitutes one overstress cycle. In the extreme, the engineer said, the service life of a component designed for many hundreds of hours could be reduced to the point where only a few hours of safe operation remain. For this reason, whenever Vne is exceeded, it should be regarded very seriously and pilots should take pains to record the duration of such events, along with indicated airspeed, gross weight, rotor RPM, engine power settings, pressure altitude and even outside air temperature. From this data, the maintenance department will determine (sometimes with the help of the manufacturer) to what degree component life was reduced and if further checks are required before the helicopter can be flown again.
