# Aviation Safety Digest

# Hand portable fire extinguishers

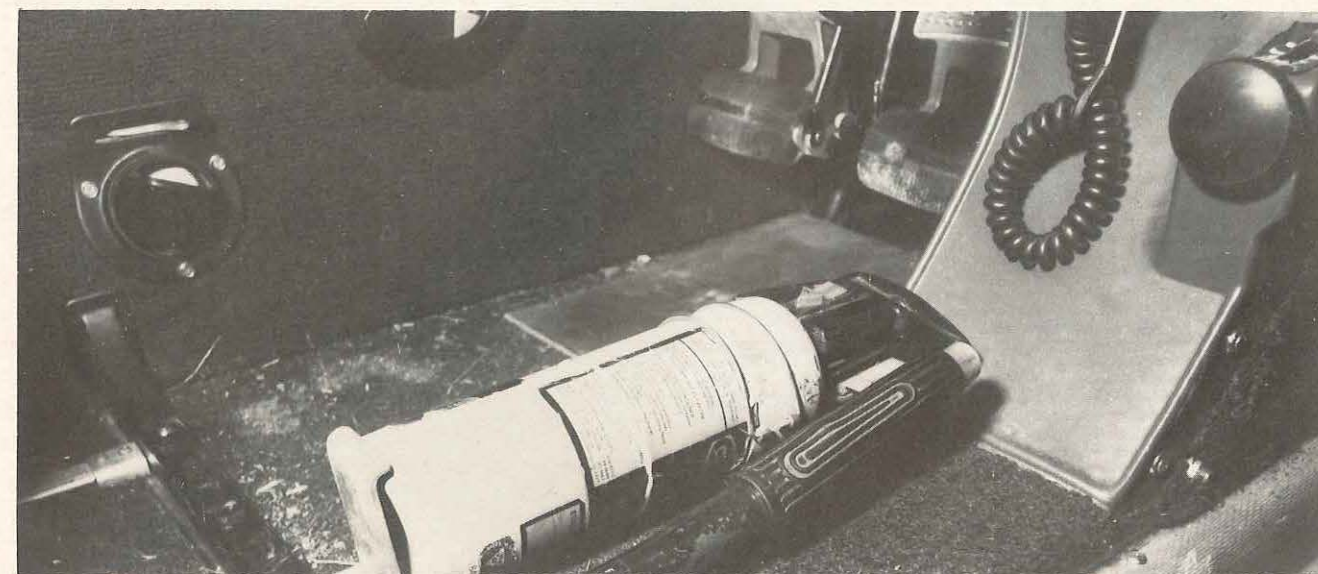
A light twin was cruising at 7500 feet when the pilot became aware of a fire behind the throttle quadrant. A descent was commenced immediately and the pilot began to run through emergency checks and procedures. The fire continued to burn. Shortly after starting the descent the pilot sighted a disused sealed strip and started an approach to land there.

With the fire still burning the pilot took the portable fire extinguisher, intending to discharge it into the throttle quadrant. The extinguisher would not work. By this time the pilot had to concentrate on getting the aircraft safely onto the ground, so the extinguisher was passed to one of the passengers to try to get it to operate. In his words: 'I read the instructions on the fire extinguisher — followed the instructions but nothing happened. I then shook the extinguisher and heard what I believed to be a liquid slosh around in the canister.'

In the event the aircraft was landed and the passengers safely evacuated. The fire, however, continued to burn, the eventual outcome of which can be seen in the accompanying photograph. (overleaf)

This light twin was destroyed by fire after the extinguisher was found to be unserviceable.

For those operators not involved in RPT or Charter work but who take the sensible precaution of fitting an extinguisher, their safety initiative may come to naught if they do not also ensure that the extinguisher remains serviceable. Note that any overhaul on an extinguisher must be performed in accordance with the manufacturer's recommendations.

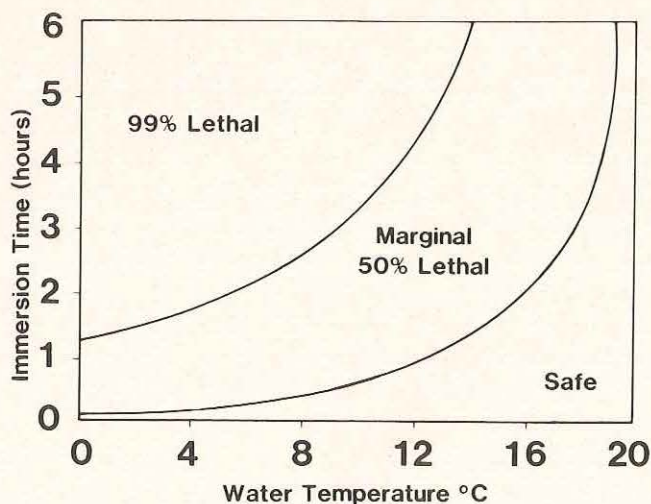
Fig. 2. Effect of water temperature on survival prospects.

Related intimately with water temperature is the duration of exposure. A short time-exposure to very cold water may be tolerated, whereas a longer period of time in warmer water may be fatal. The relationship between duration of exposure and water temperature is well shown in Figure 2. The lines of the graph are drawn for 'average' persons without an anti-exposure suit.
