# Aviation Safety Digest

ASD 130 SPRING 1986

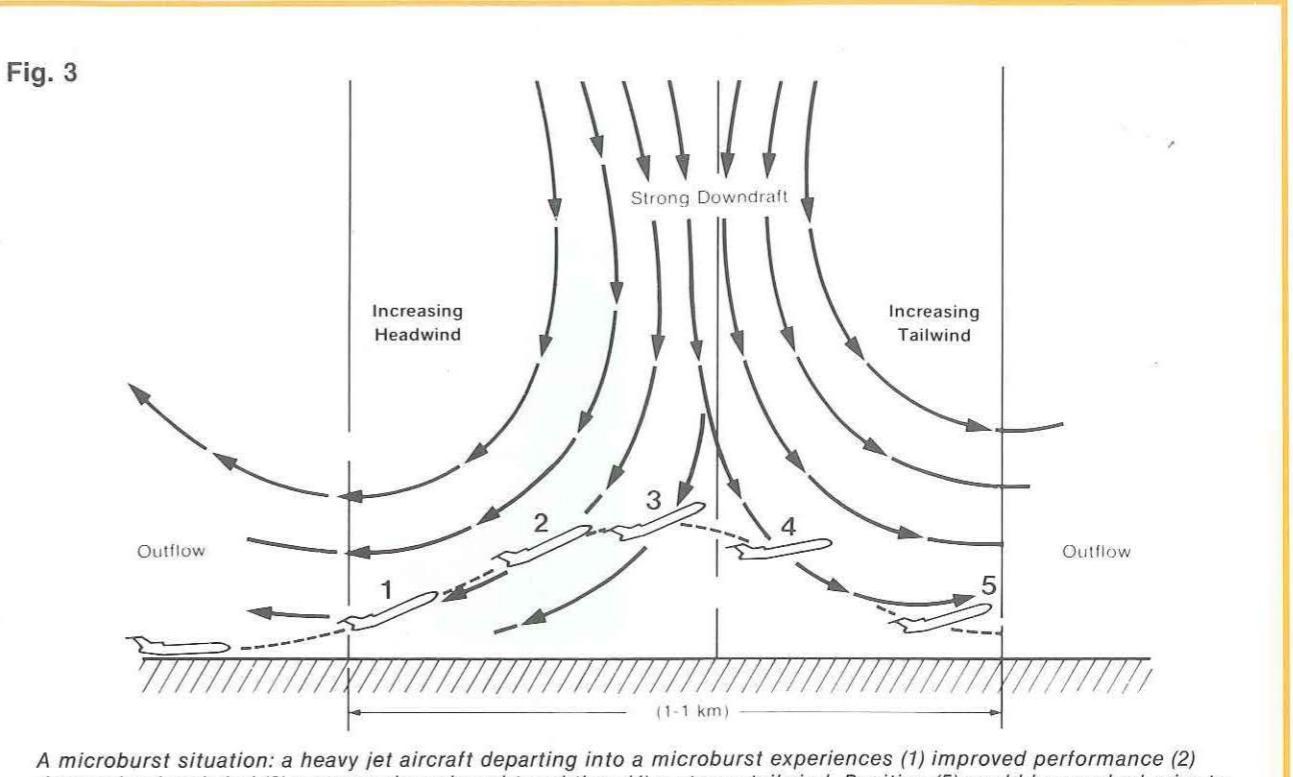
decreasing headwind (3) a strong downdraught and then (4) a strong tailwind. Position (5) could be reached prior to impact in a strong microburst. Since 1970 the U.S. National Transportation Safety Board has identified 15 airline accidents where windshear was a cause or contributing factor. In 12 of the cases the aircraft encountered a downdraught or microburst.

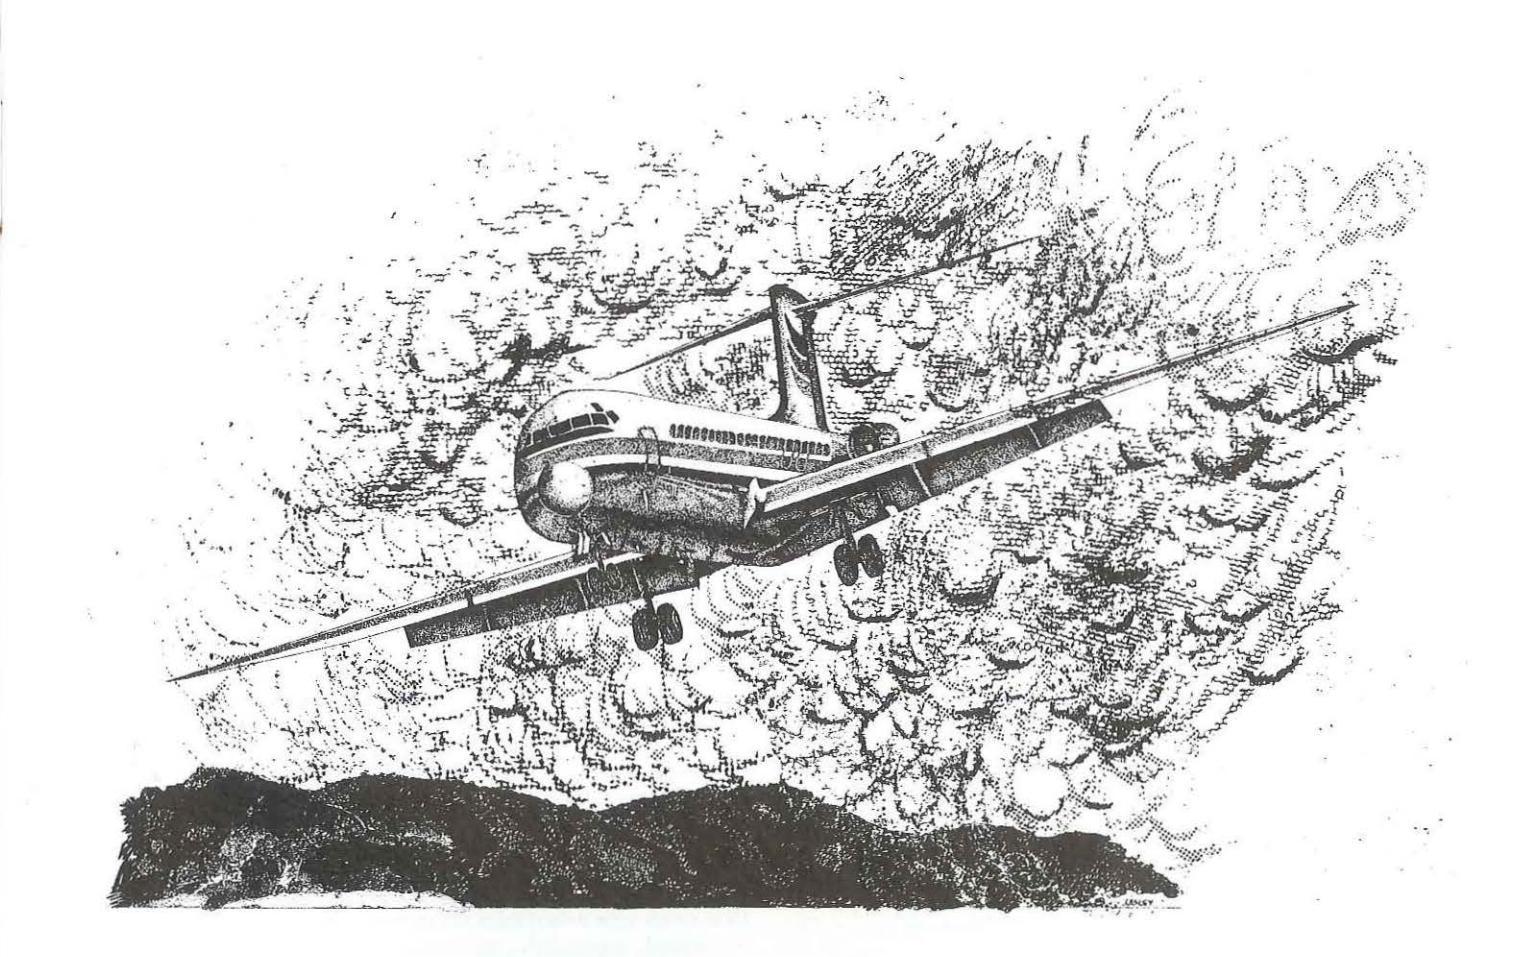
# Cockpit communication breakdown

A DC-9 designated Flight 183, operated by an American company, took off in the mid-afternoon with 51 passengers, bound for the Detroit Metropolitan Airport. The weather forecast was typical for summer, including a prediction for 'quite a few scattered afternoon and evening thunderstorms, possibly severe'. En route weather verified this forecast. About 90 miles from Detroit the crew detected scattered thunderstorms, most of them west of the airport.

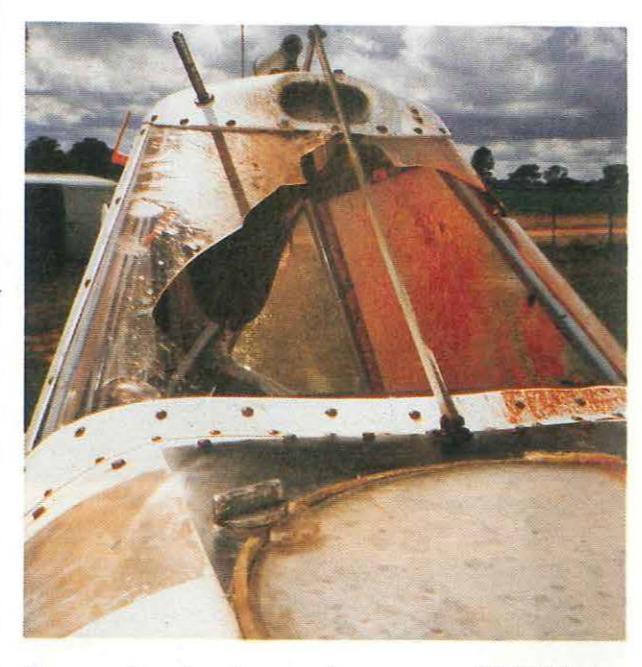
# **Protective clothing**

The pilot was spraying a small crop of wheat and had completed the first run. He began the second run and was side-slipping around a large tree and between telephone lines at a height of about 6-7 feet AGL when, in his words, 'the windscreen shattered and the inside of the cockpit was showered with blood and guts'. Pulling his PA25 up and away from the paddock, he determined that the aircraft's windscreen had sustained a severe birdstrike. He was able to fly back to his airstrip and spent the rest of the morning cleaning the remains of a large Cormorant from the Piper's cockpit. (The bird's weight was later assessed at about  $3\frac{1}{2}$  kg.) There is, however, more to this incident than that. At the time of the birdstrike the pilot had been wearing a helicopter-type SPH helmet, with visors. that he had acquired ten days earlier. Again to use the pilot's words '. . . but for the fact that I had the helmet on and the visor down the story would have ended differently, as the bird came through the perspex relatively intact and hit the visor with considerable force'. The helmet which almost certainly saved this
