Loss of control and collision with terrain involving B200 King Air, VH-ZCR

Essendon Airport, Victoria | 21 February 2017

ATSB Transport Safety Report
Aviation Occurrence Investigation
AO-2017-024
Final – 24 September 2018

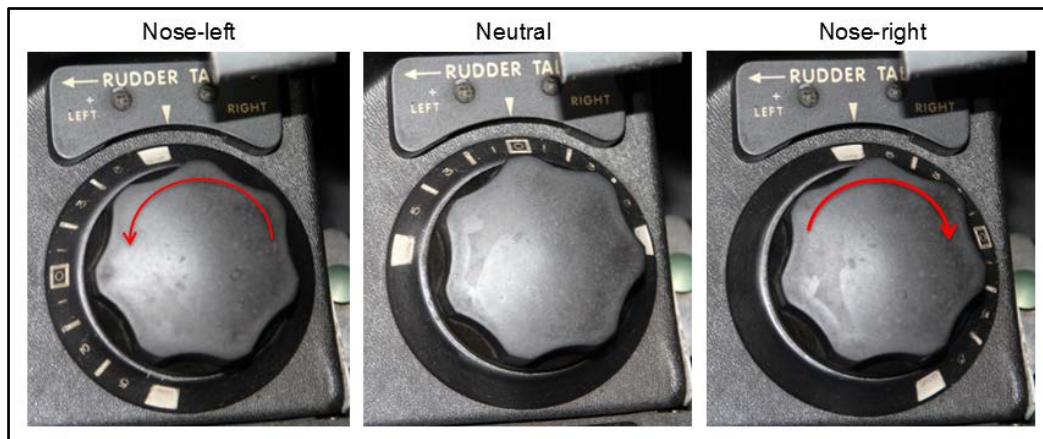
Figure 5: Rudder trim indicator in the full nose-left, neutral and nose-right positions

The rudder trim was manually controlled using a trim wheel located on the right side of the centre pedestal (Figure 5). Cables extend rearward from the wheel, through the airframe, to the rudder trim tab actuator. Rotating the wheel to the left moved the trim tab to the right, which in turn moved the rudder to the left, resulting in nose-left movement about the aircraft's yaw axis. Rotating the wheel to the right results in yaw to the right. Operation of the rudder trim control showed that three turns through about 180 degrees were required in order to achieve full deflection either side of neutral.

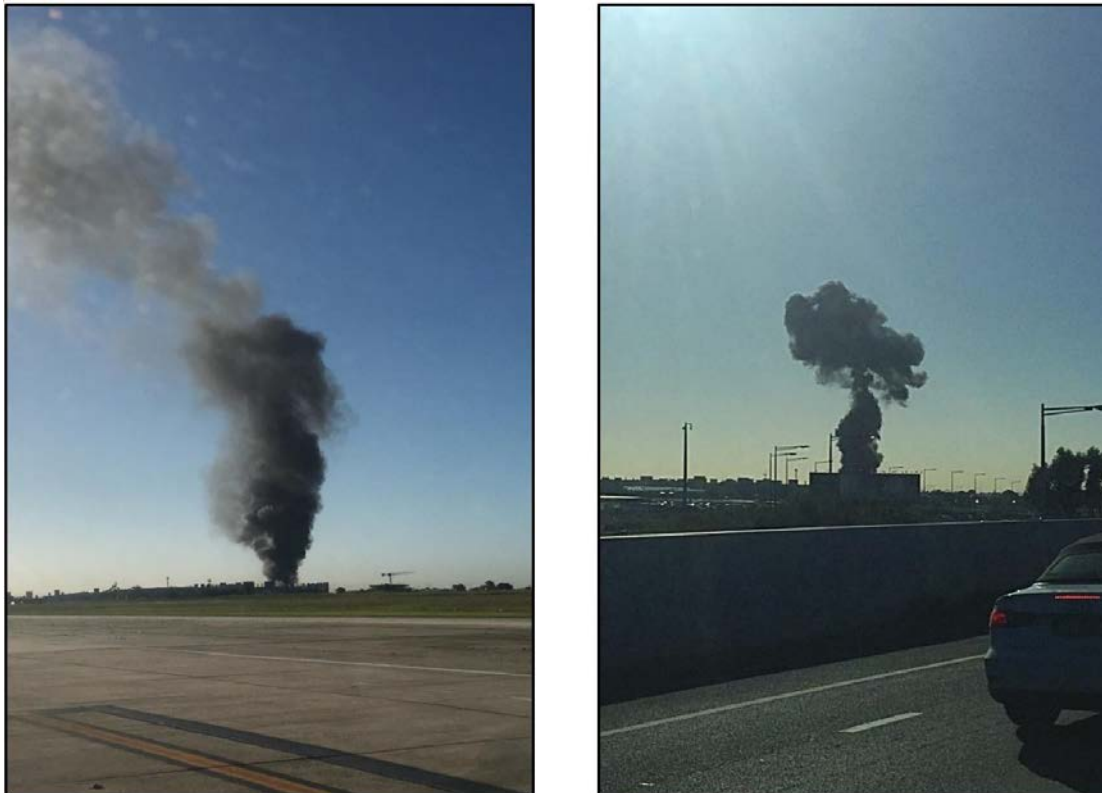
Figure 9: Photographs of the smoke plume that provided an indication of the wind conditions

Two witnesses, both of whom were pilots familiar with the B200 aircraft type, were positioned on the eastern side of runway 17/35 at the time of ZCR's departure. They recalled that the wind was 'fairly calm' and there was no adverse weather present at the time. Images of the smoke plume and video footage of the windsock adjacent to the northern end of runway 17/35 taken shortly after the accident also showed that the wind at ground level was negligible (Figure 9 and Figure 10).

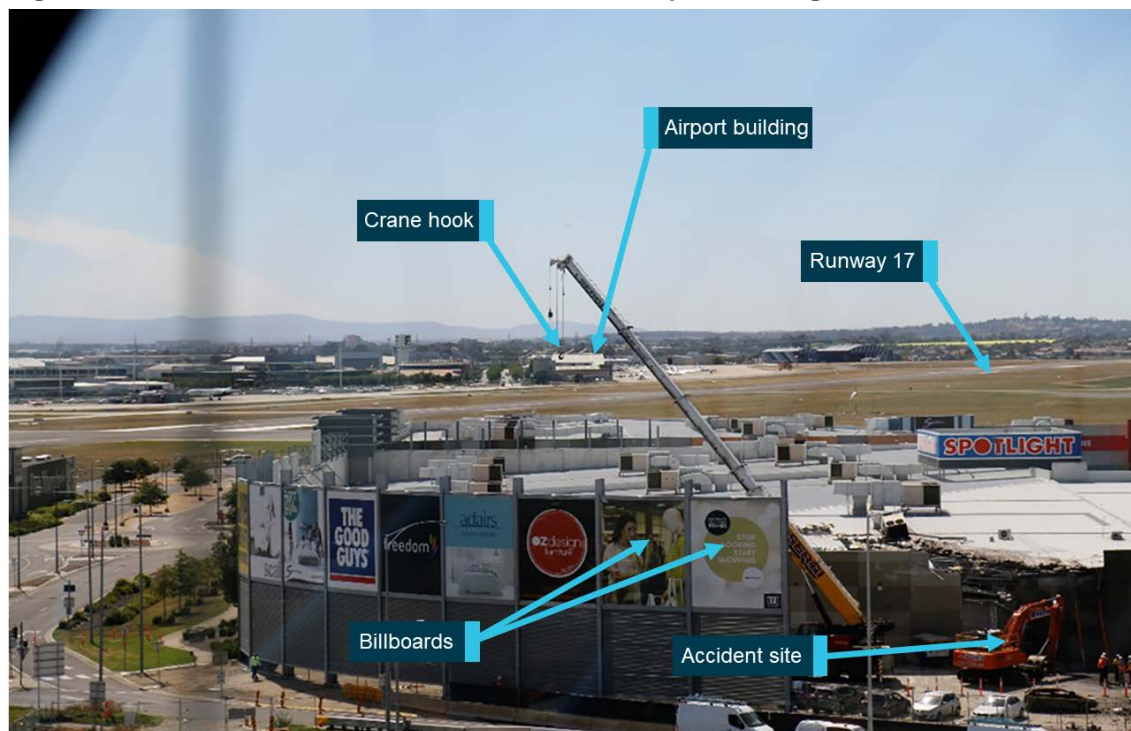
Figure 15: View of the accident site from the crane operator's right cabin window

After this, the aircraft descended to the right over the billboard second from the right. The aircraft yawed further left, possibly an angle of 30-40°, before momentarily disappearing behind the billboard on the far right. The aircraft impacted the roof and parapet wall, and flames ensued immediately after. The aircraft continued moving forward and came to rest in the loading area at the rear of the building.

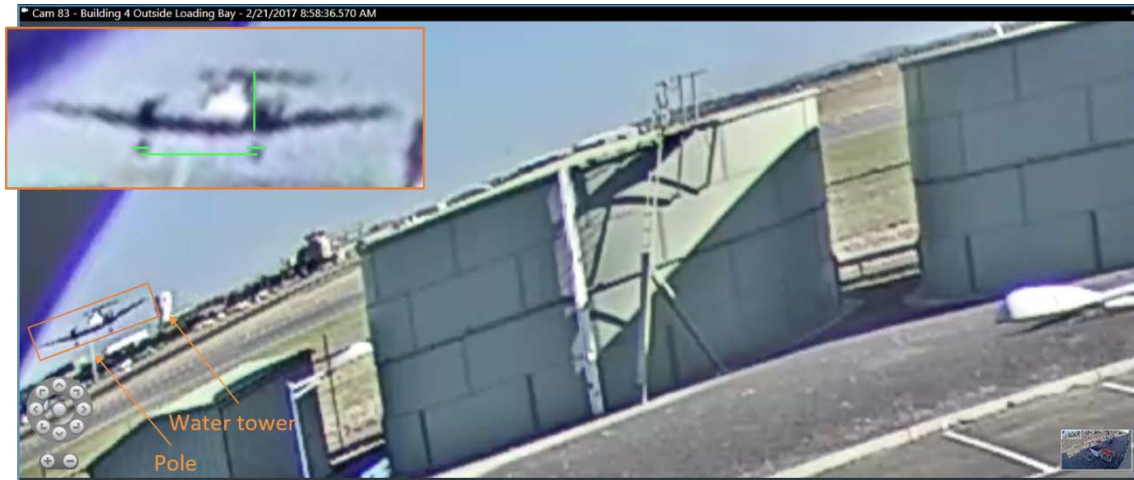
Figure 19: Outlet centre camera 83 still used for analysis, showing significant fisheye distortion in the image

- The images were examined to determine the amount of distortion from the lens, in particular fisheye distortion. The outlet centre camera had substantial fisheye distortion and therefore some analysis, roll angle in particular, was limited (Figure 19). The 'Level 1 main apron' camera appeared to have minimal distortion, despite having a wide-angle lens (Figure 20).

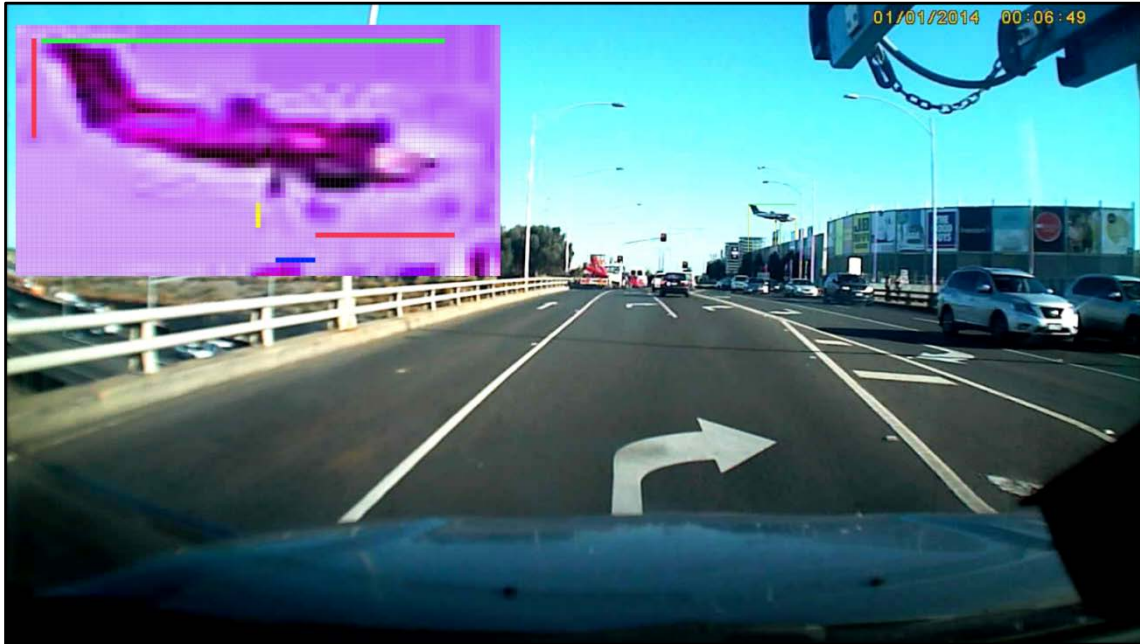
Figure 21: Bulla Road dashboard camera footage with zoomed inset depicting measurements used for sideslip and roll calculations

In summary, the results below demonstrate a substantial left sideslip between points D and G with minimal left roll. These results were consistent with witness observations and analysis of the accident site roof impact marks.

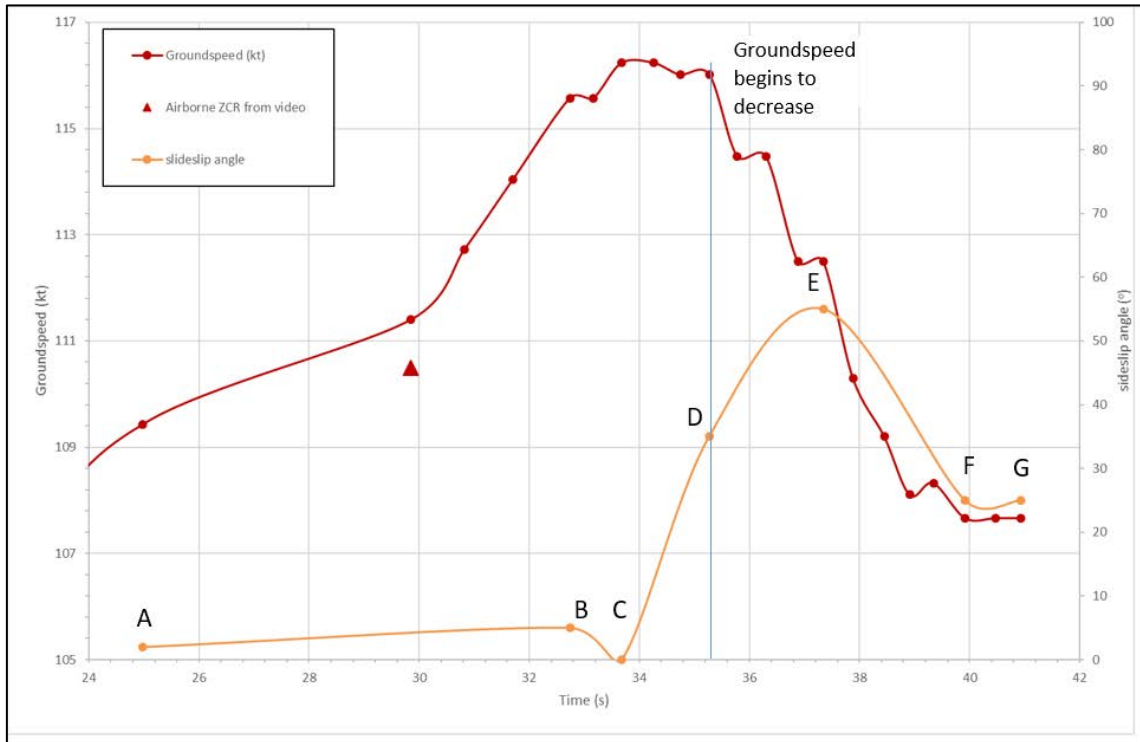
Figure 22: Comparison of groundspeed and sideslip angle against time measured from the beginning of the take-off roll

Sideslip information was correlated with Airservices ADS-B data to determine the relationship between the aircraft's sideslip and performance. This comparison found that the reduction in ZCR's airspeed, identified by the ADS-B data, correlated with the onset of the sideslip. This was most likely due to the increase in drag from the sideslip (Figure 22).

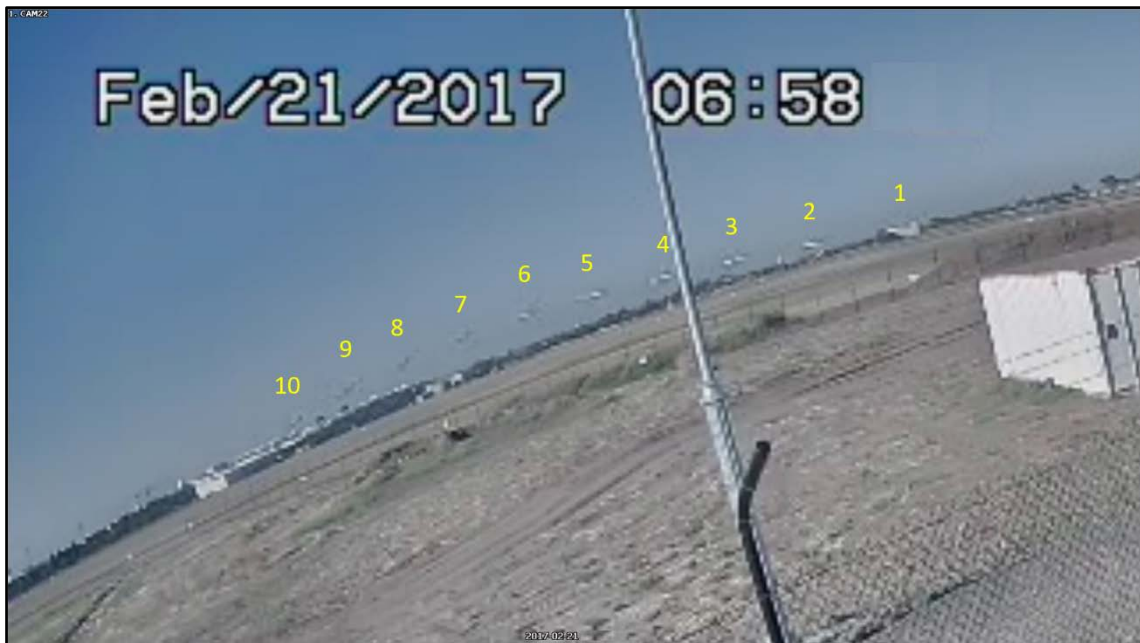
Figure 23: Time-lapse CCTV image of the ZCR's flight path, with images taken every second

Similarly, the aircraft's climb performance also reduced at the same time as the onset of the sideslip. As the ADS-B barometric data was considered unreliable while the aircraft was in a substantial sideslip, a time-lapse image was produced to provide an indicative depiction of the aircraft's vertical flight path (Figure 23). The substantial sideslip was first observed at point 6 in Figure 23, at this point the image shows the aircraft transitioning from a climb to a descent.

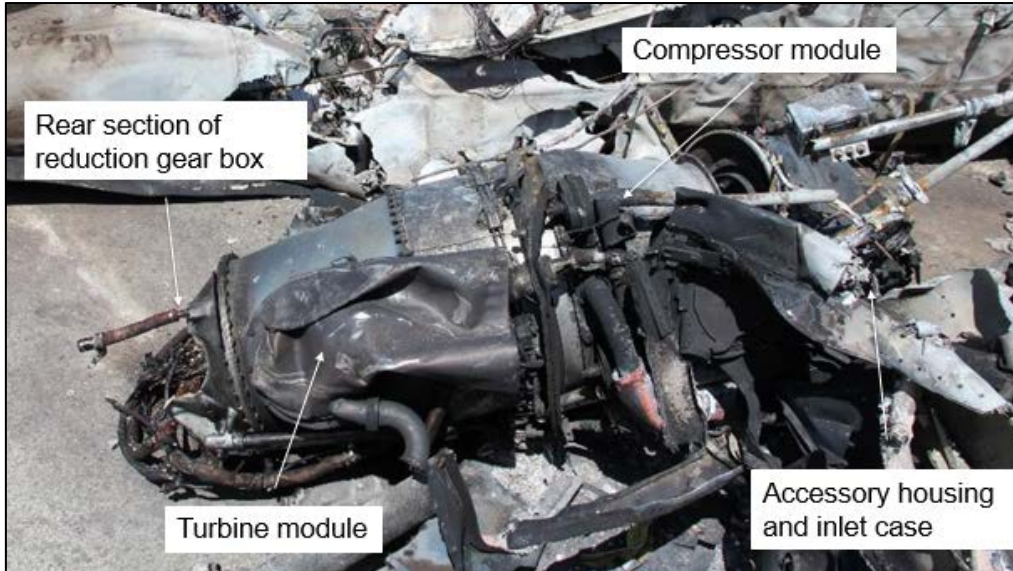
Figure 34: Right engine assembly, shown upside down and viewed from its left side

The left engine had separated from the aircraft and broken into three sections: the accessory drive with the compressor inlet, the compressor and turbine modules, and a forward section of the reduction gearbox which remained attached to the propeller (Figure 34). The engine had sustained significant impact and fire damage. An external inspection did not identify any pre-impact defects.

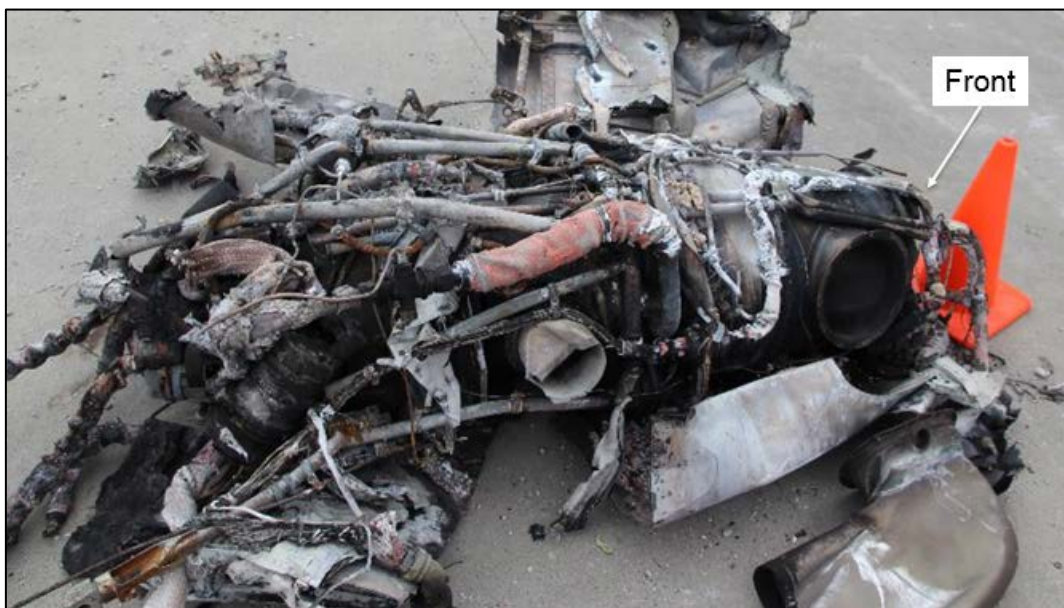
Figure 35: Right engine assembly, shown upside down and viewed from its left side

The right engine had detached from the aircraft and separated into two sections at the reduction gearbox. It sustained significant impact and fire damage (Figure 35). An external inspection of the engine was conducted with no pre-impact defects identified.

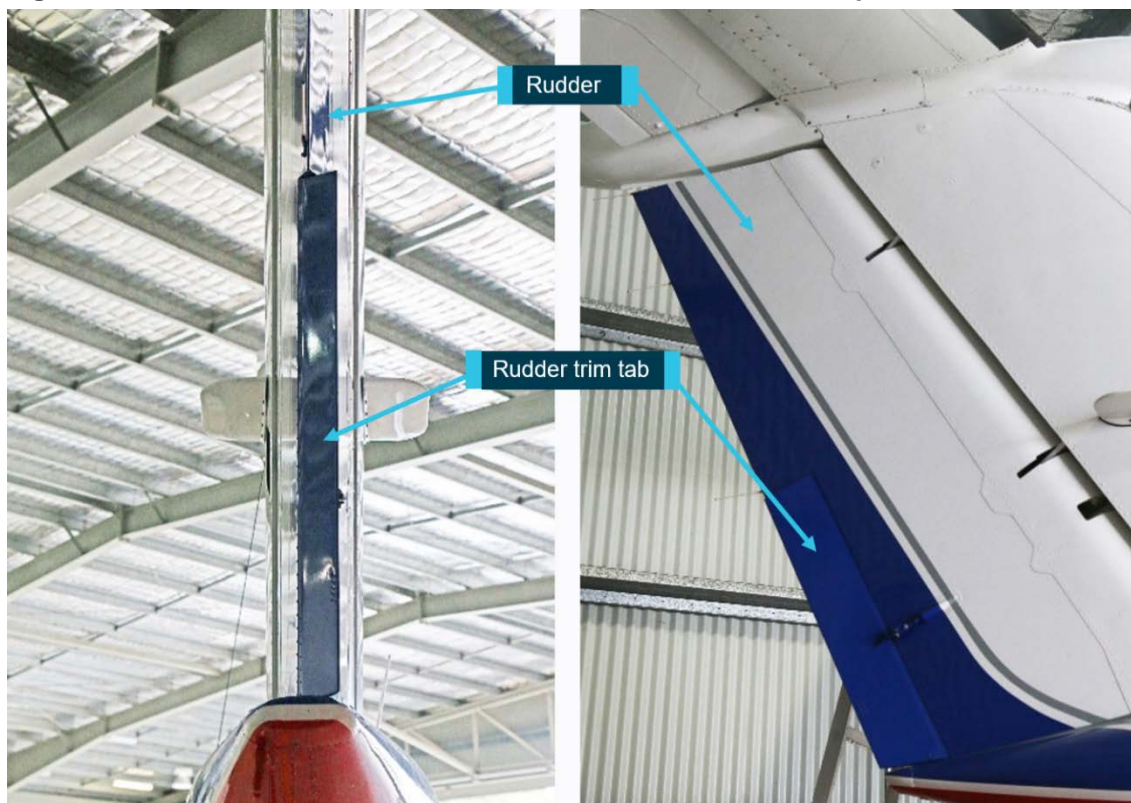
Figure 42: B200 rudder with rudder trim tab set to the full nose-left position

The *PREFLIGHT INSPECTION* checklist included setting the trim tabs in the cockpit to '0' units then visually checking the rudder and rudder tab when conducting the external walk-around (Figure 42). An example of a B200 checklist used by an Australian operator called for a 'function check' of the manual trim system to be performed, which included the rudder trim. A previous employee of this operator indicated that the function check for the rudder trim involved moving the trim wheel from full left to full right deflection and then back to the centre position. Any subsequent checks of the trim were to confirm that they were correctly set. Another pilot who had operated ZCR also indicated that he would exercise the limits of the trim systems during the pre-flight inspection. The ATSB was unable to determine the accident pilot's practices with regard to checking the trim positions during the pre-flight inspection.

A periodic maintenance inspection carried out in the days before the flight resulted in the rudder trim tab being set at the full right position and possibly aileron and elevator trim tabs being set at non-neutral positions prior to the flight. There were indications that the pilot was rushed and probably overlooked the rudder and aileron trim tab settings prior to takeoff. The aircraft flight path reported by witnesses was found to be consistent with the effect of abnormal rudder and/or aileron trim tab settings.

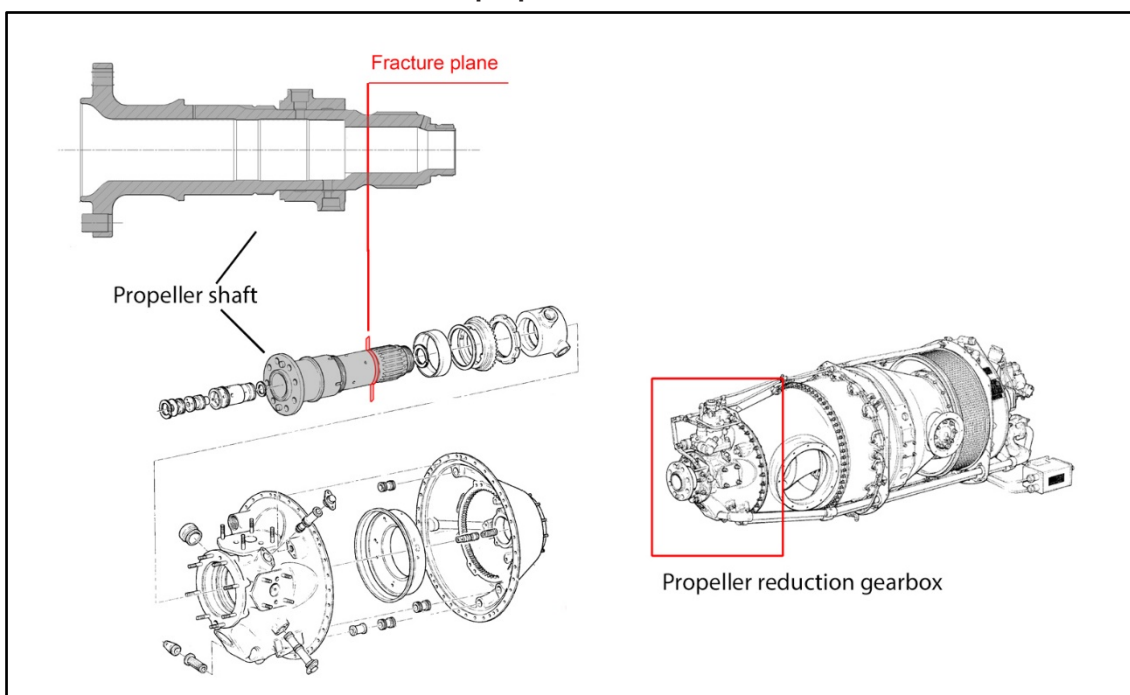
Figure 44: Pratt & Whitney Canada PT6A-42 engine showing the general layout of the RGB in relation to the location of the propeller shaft fracture

Visual examination of the propeller shafts from the left and right engines revealed that they had fractured at almost identical locations (Figure 44, Figure 45 and Figure 46). The fracture features from both shafts were also near-identical in appearance. Both were inclined at 90° to the shaft axis with a smooth and regular surface texture. A high-magnification examination of the fracture surfaces was completed using a scanning electron microscope (SEM), which confirmed the presence of ductile tearing from overstress associated with the accident sequence. No evidence of pre-existing defects that might have contributed to the propeller shaft fractures were identified. The fracture surfaces were consistent with torsional loads being the dominant load case that led to the failure of the shafts, rather than bending loads from ground impact.

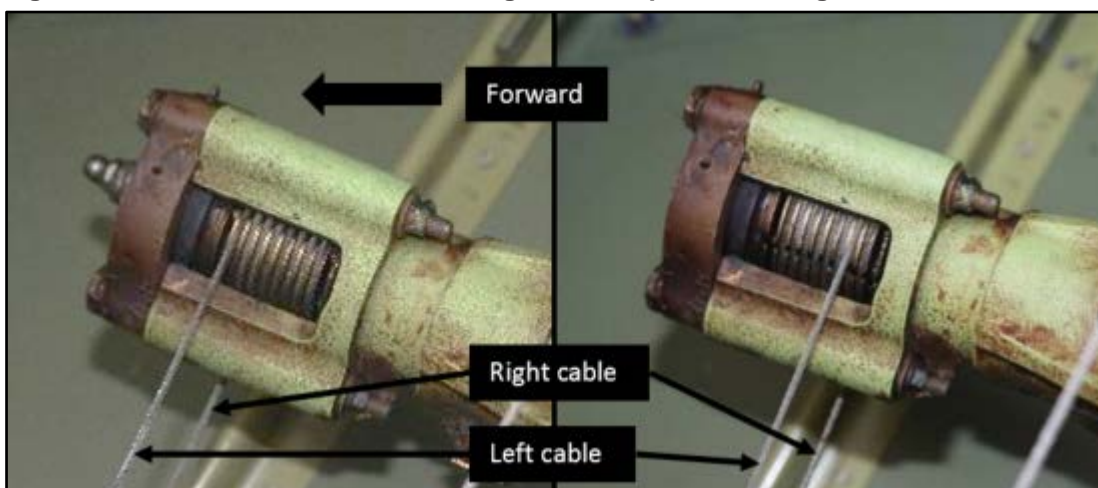
Figure 49: Rudder trim actuator showing the cable position along the barrel

The range of movement of the rudder trim tab is 15 degrees either side of neutral. Adjusting the trim wheel position moves the left and right cables, which in turn either extends or retracts the actuator through its range of movement (Figure 48). Tension on the right cable translates the cable forward along the actuator barrel and retracts the actuator. Conversely, tension on the left cable translates the cable rearward along the barrel and extends the actuator (Figure 49).

When the actuator is fully retracted, the rudder trim tab is at 15 degrees to the right, corresponding to an aircraft nose-left yaw. When the actuator is fully extended, the trim tab is at 15 degrees to the left, corresponding to a nose-right yaw. (Refer to the ‘*Aircraft systems information*’ section of this report for more details on aircraft flight controls).
